# SPORT ENGLAND TYPE 1 MUGA TEST REPORT

Facility Reference	Clovenfords Primary School
Facility Address:	Muscat Brae Clovenfords Primary School Galashiels TD1 3LD
Report Number:	17092 / 2617s
Report Status:	FINAL
Issue Date:	17/05/2016
Client:	Scottish Borders Council Council Headquarters Newtown St Boswells TD6 0SA

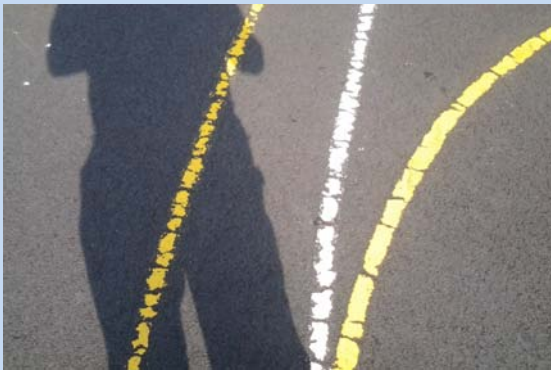
Property	Condition
Visual Inspection	Aesthetics	Damage	Small cracks in areas.
		Colour	None present
		Line Markings	Line markings are broken and cracked. Re application required
		Fencing	In good condition
		Goals, Equipment	Equipment in good condition. Goals in good condition and no damage visible. Backboards beginning to show signs of wear
		Housekeeping (Litter etc)	Litter and organic detritus scattered around edges of surface

Broken Lines

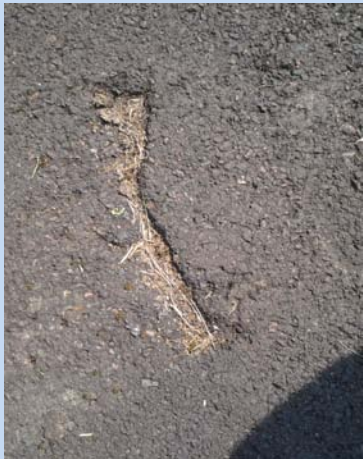
Cracking of surface

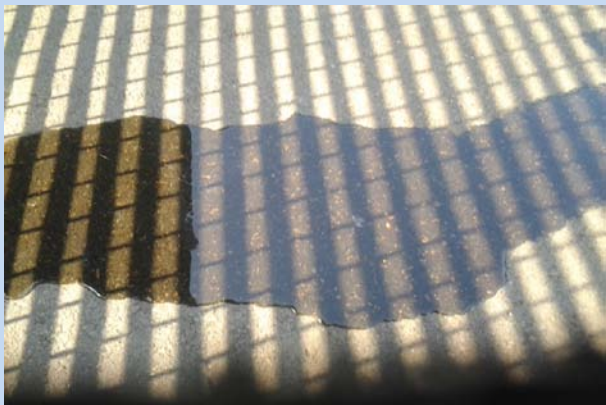
Permeability

**Permeability:** The 3 areas examined were out with the requirements of permeability. The surface may have been designed to be no permeable

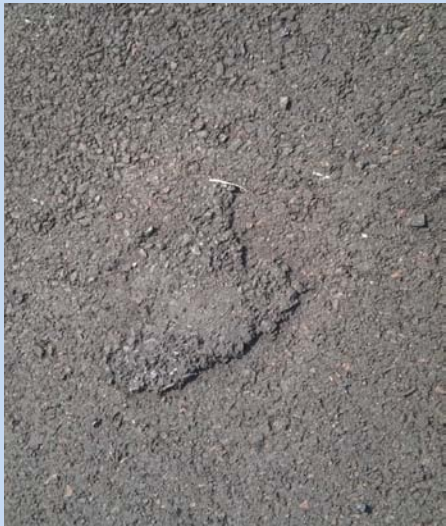
uneven surface
