## FIELD PERFORMANCE REPORT

**BS EN 15330-1:2013 – Hockey & Football [Short Pile]**

**Field Reference:** Galashiels Academy

**Report Number:** 17092/2616

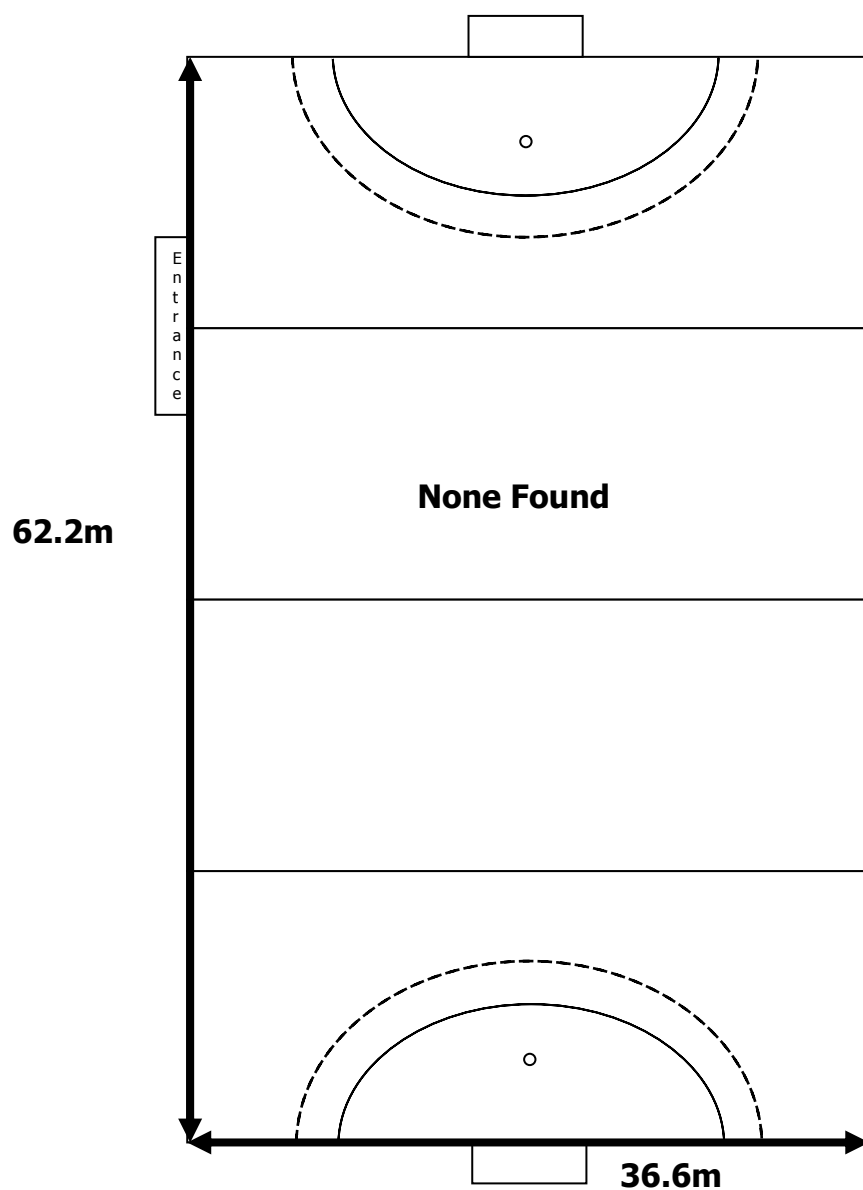
### 3.1 SURFACE REGULARITY AND DIMENSIONS

In the surface measured there were 0 deviations found in excess of this requirement, as shown in the diagram below.

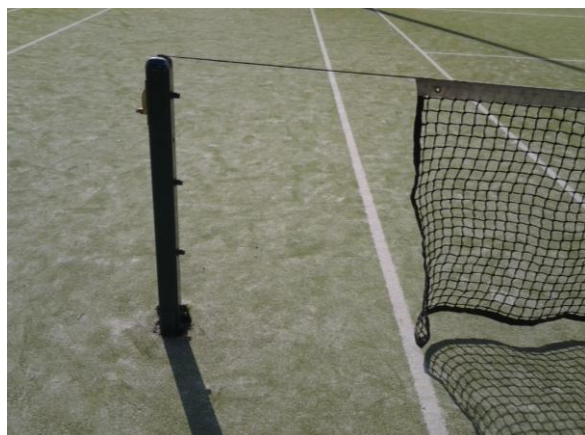
**Net stretched and not meeting post**

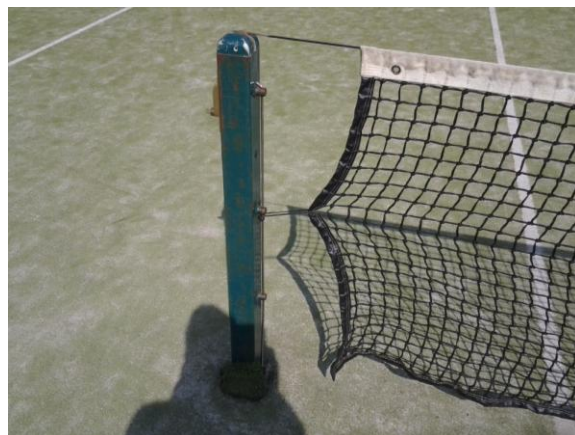
**Net stretched and not meeting post**

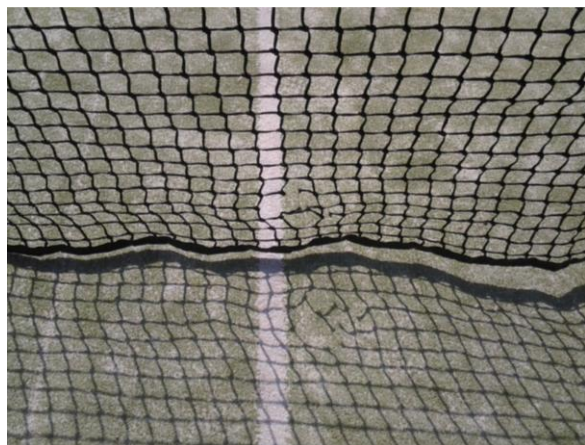
**Slight damage to nets**

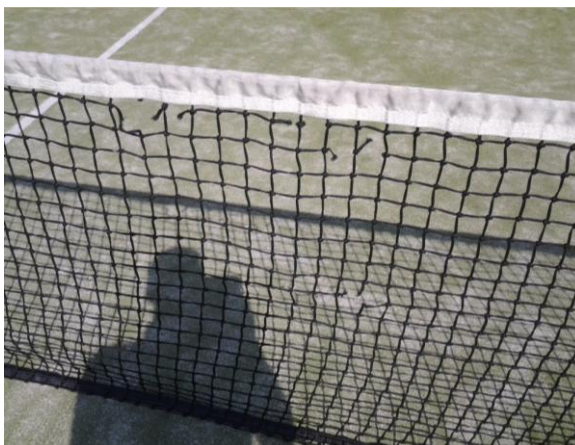
**Slight damage to nets**
