## FIELD PERFORMANCE REPORT

**BS EN 15330-1:2013 – Hockey & Football [Short Pile]**

**Field Reference:** Hawick High School

**Report Number:** 17092/2613s

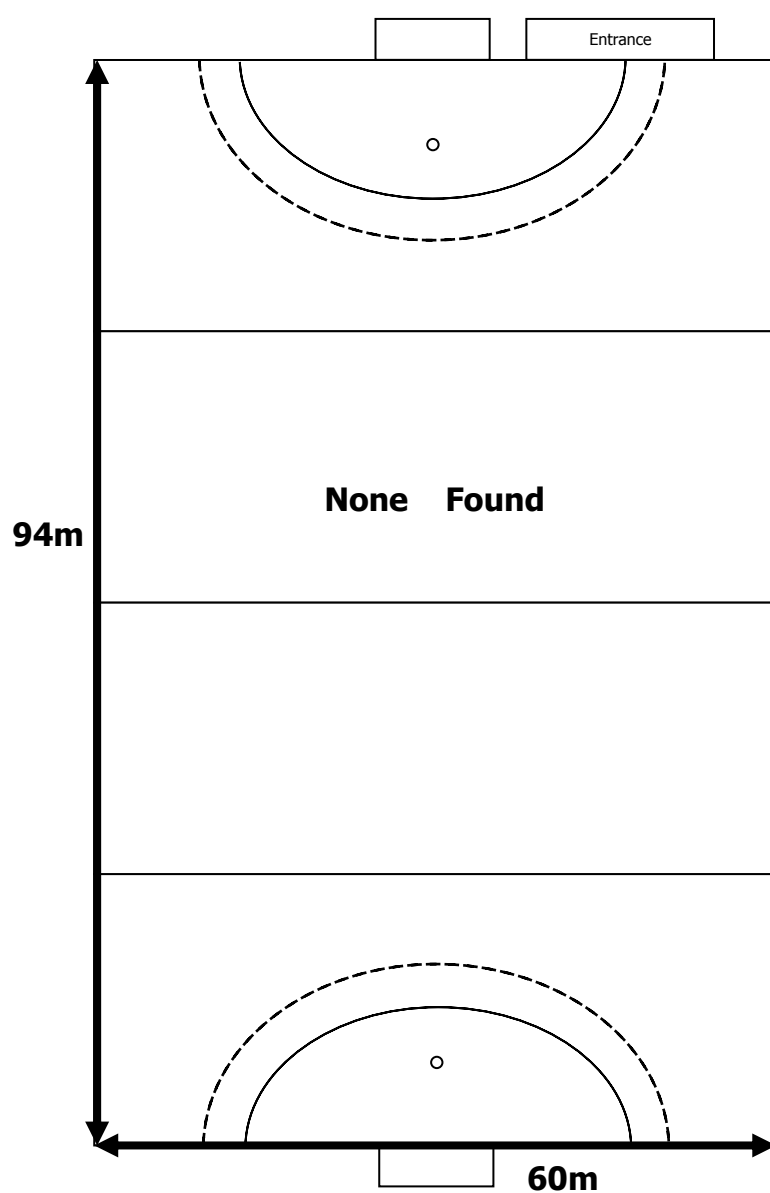
### 3.1 SURFACE REGULARITY AND DIMENSIONS

Plan showing surface irregularities exceeding maximum requirement of 6mm under a 3m straight edge.

In the surface measured there were 0 deviations found in excess of this requirement, as shown in the diagram below.

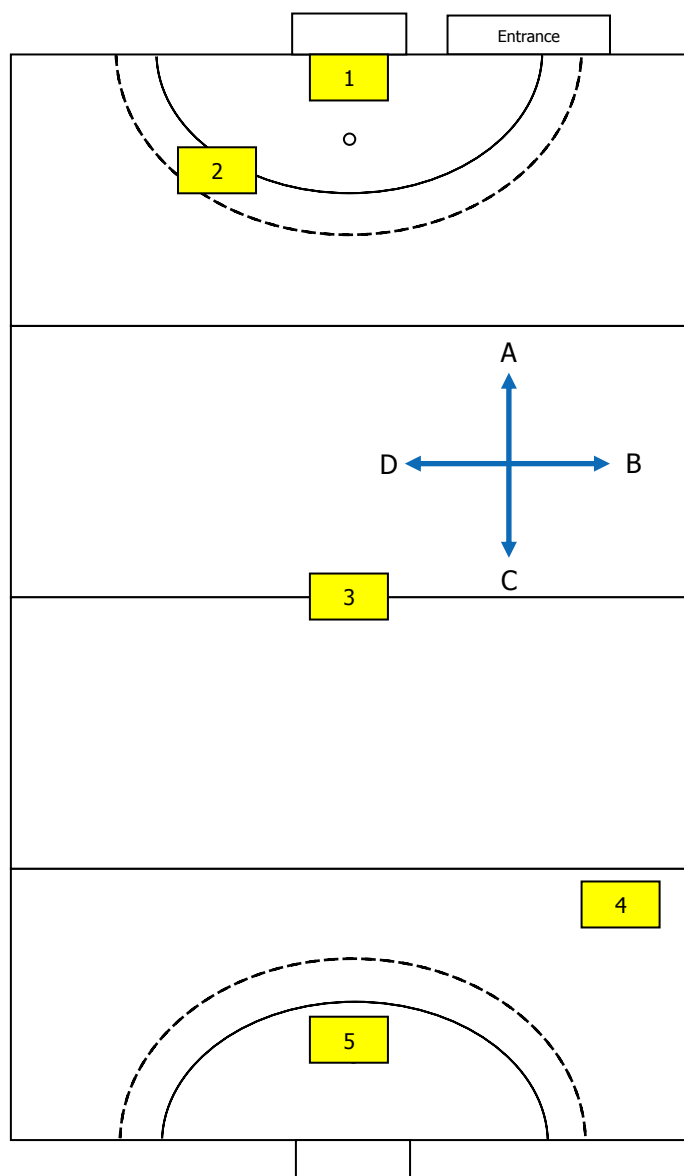
### TEST LOCATIONS

Test	Requirements	Location					Pass / Fail
		1	2	3	4	5	
Rotational Resistance	25Nm to 50Nm	20	22	21	21	22	Fail
Shock Absorption	40-70%	46	55	52	57	53	Pass
Vertical Deformation	3.0 – 10.0mm	5.7	7.4	6.8	7.9	6.9	Pass
Water Permeability	≥180mm/h	2316	3130	3818	3406	3247	Pass
Surface Regularity	No deviations >6mm	0					Pass

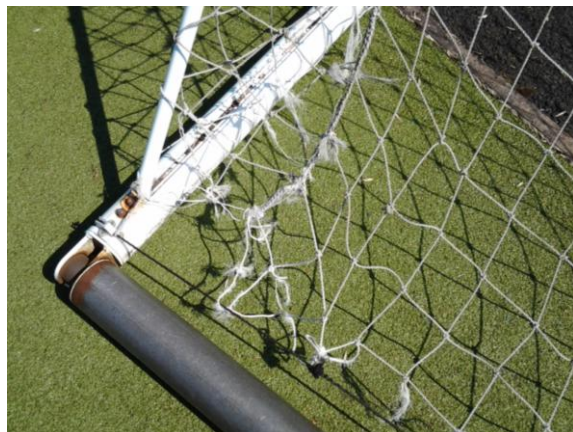
Goals: - The Football goal frames were in generally good condition. The nets are in a poor condition with only two of the small sized nets in good condition. The goals should be inspected and tested in accordance with the BS EN 748 and BS EN 8462 if this has not been undertaken in the past two years. This will ensure that the goals conform with the minimum safety standards for goals.

**Goal netting damaged**

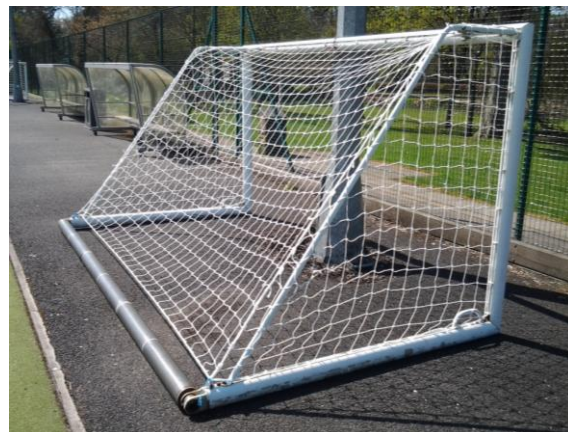
**Goal netting in Good condition**

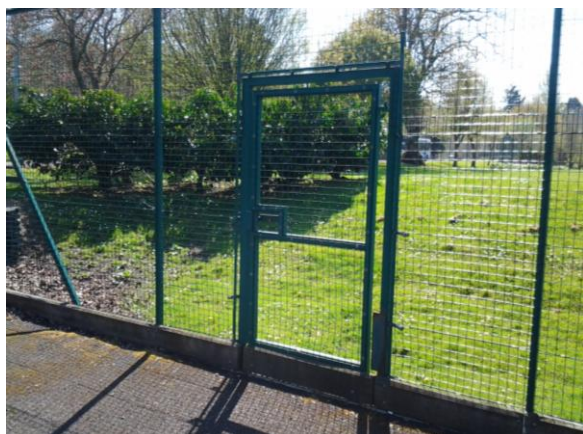
4.3 Fencing: - Lower Rebound boards: The Rebound boards are generally in good condition some boards are starting to loosen and should be checked and tightened accordingly.

Fencing: - Upper Weld Mesh: The Weld Mesh fencing is in good condition.

**Fencing in good condition**

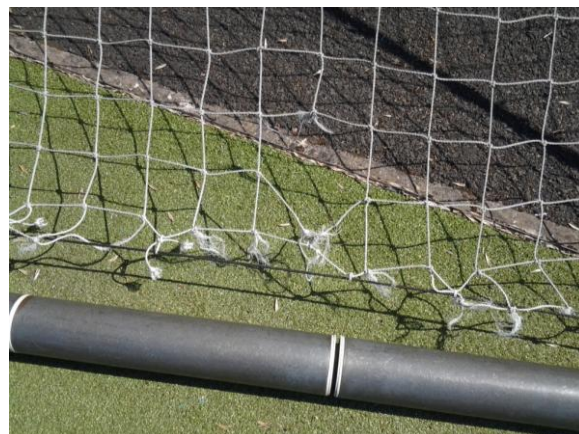
**Goal netting damaged**
