## FIELD PERFORMANCE REPORT

**BS EN 15330-1:2013 – Hockey & Football [Short Pile]**

**Field Reference:**                      **Jedburgh Grammar School**

**Report Number:**                      **17092/2663s**

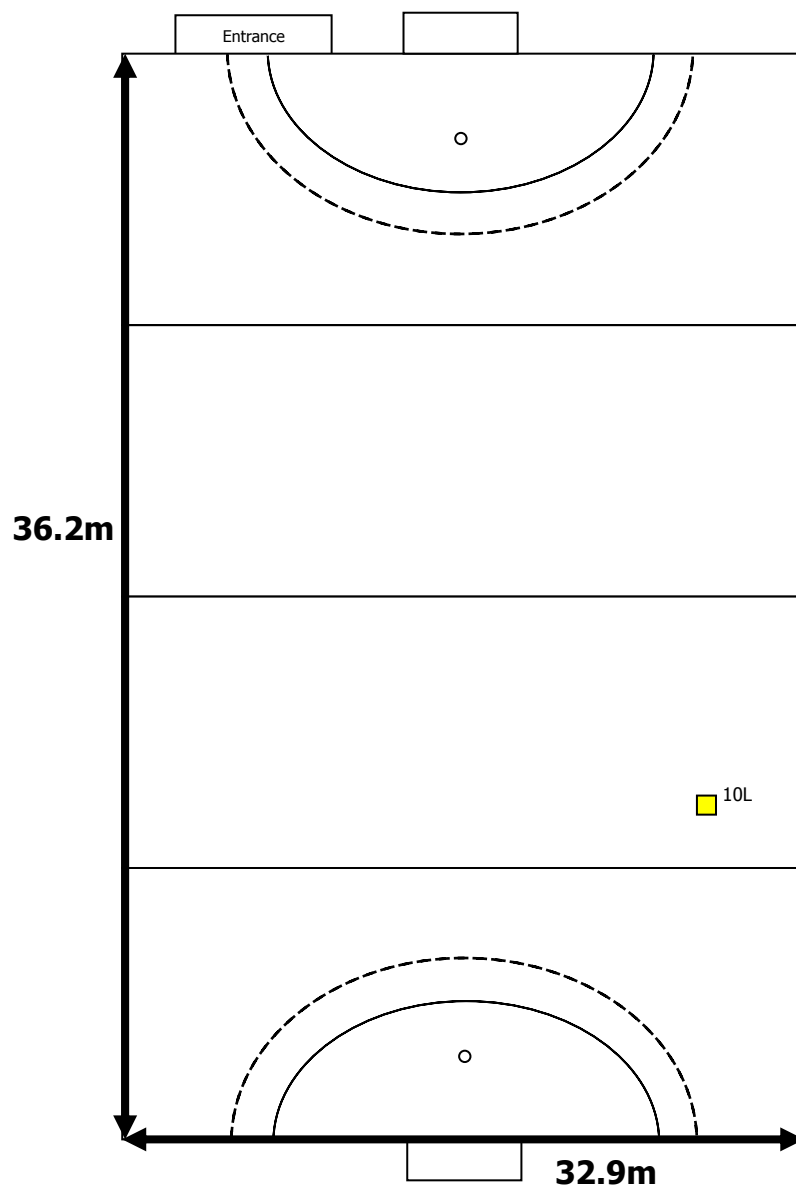
### 3.1 SURFACE REGULARITY AND DIMENSIONS

Plan showing surface irregularities exceeding maximum requirement of 6mm under a 3m straight edge.

In the surface measured there were 1 deviation found in excess of this requirement, as shown in the diagram below.
