FIELD PERFORMANCE REPORT

BS EN 15330-1:2013 – Hockey & Football [Short Pile]

Field Reference: Kelso High School

Report Number: 17092/2614s

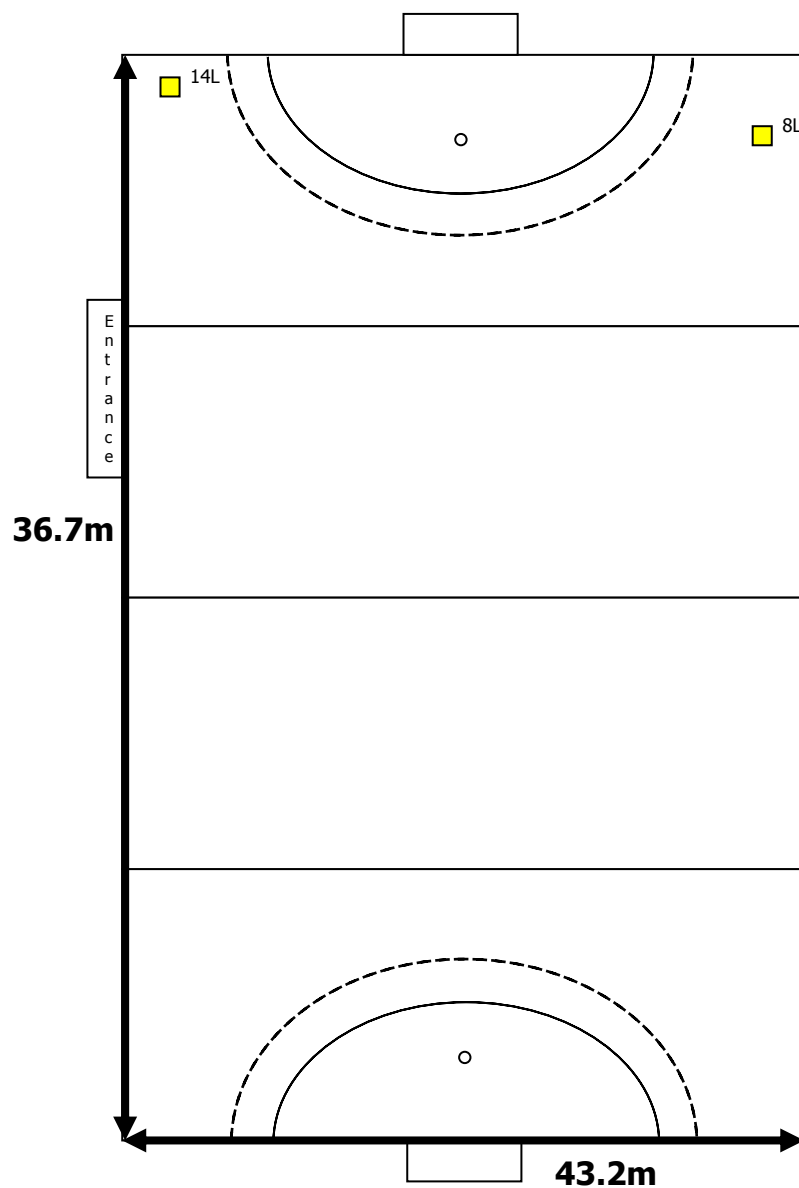
3.1 SURFACE REGULARITY AND DIMENSIONS

Plan showing surface irregularities exceeding maximum requirement of 6mm under a 3m straight edge.

In the surface measured there were 2 deviations found in excess of this requirement, as shown in the diagram below.

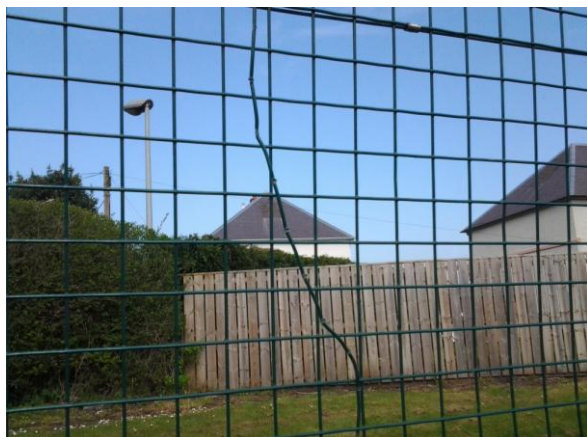
4.3 Fencing: - Lower mesh fencing: Generally in good condition, either side of the hockey nets the fencing at ground level is showing considerable wear, due to the fact there are no rebound boards. The welds have broken but no wire is protrude as yet, this should be monitored closely.

Broken weld mesh fencing

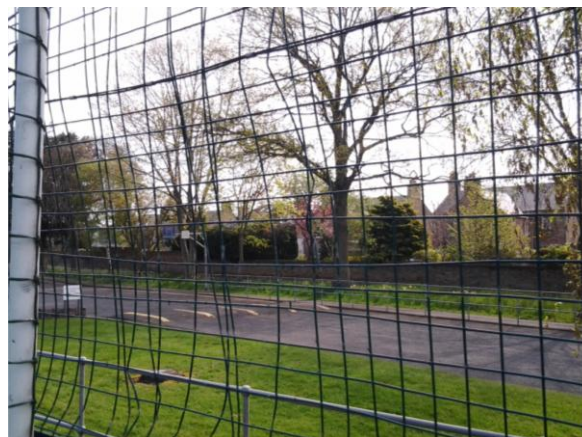
Fencing: - Upper Weld Mesh: The Weld Mess fencing is in generally in good condition. As with the lower mesh fencing areas around the goals are showing signs of damage from ball strikes. The welds have broken and in some cases this has resulted in wires protruding at eye level, these should be rectified.

Damaged Weld Mesh fencing

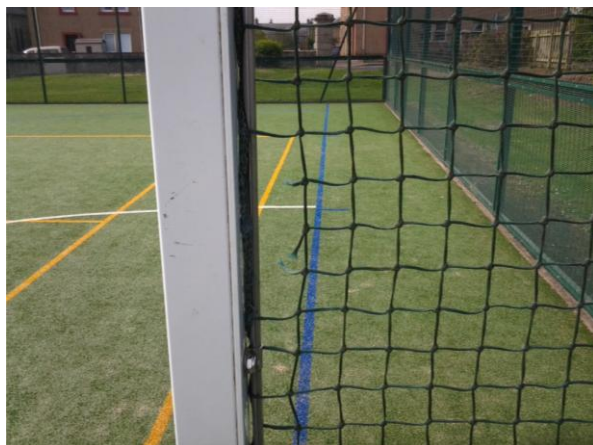
4.4 Goals: - The Hockey goals were in generally good condition. The nets have small areas of damage but are generally in good condition in the main they are in tacked and the frames are in good condition. Some paint is starting to flack and should be sanded and repainted to protect the frames from the elements.

Slight damage to Hockey nets

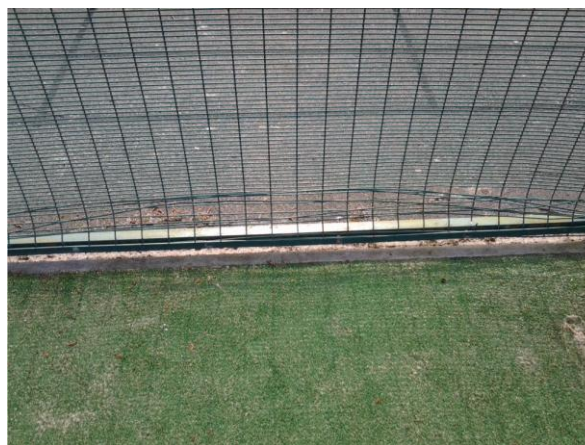
Damaged mesh fencing close to goals
