SPORT ENGLAND TYPE 1 MUGA TEST REPORT

Facility Reference	Kingsland Primary School
Facility Address:	Neidpath Road Peebles EH45 8NN
Report Number:	17092 / 2615s
Report Status:	FINAL
Issue Date:	17/05/2016
Client:	Scottish Borders Council Council Headquarters Newtown St Boswells TD6 0SA

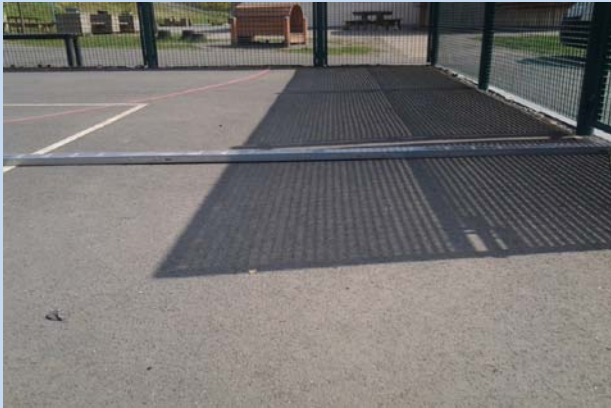
Deviation

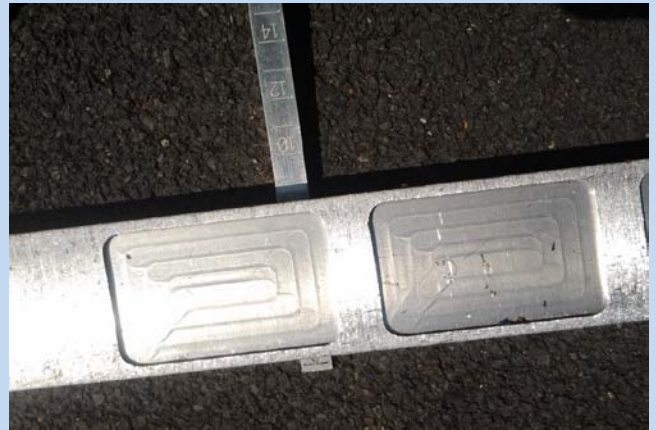
Deviation
