SPORT ENGLAND TYPE 1 MUGA TEST REPORT

Facility Reference	Lauder Primary School
Facility Address:	Allanbank Gardens Lauder Berwickshire TD2 6AB
Report Number:	17092 / 2615s
Report Status:	FINAL
Issue Date:	17/05/2016
Client:	Scottish Borders Council Council Headquarters Newtown St Boswells TD6 0SA

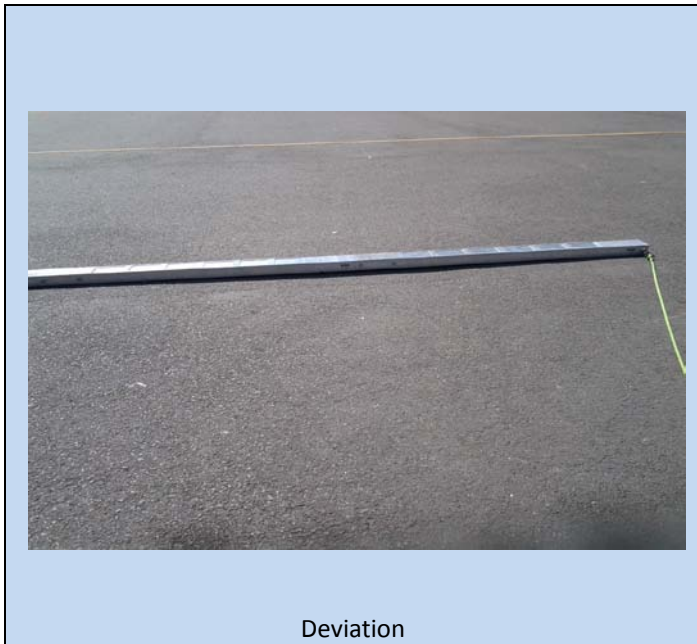
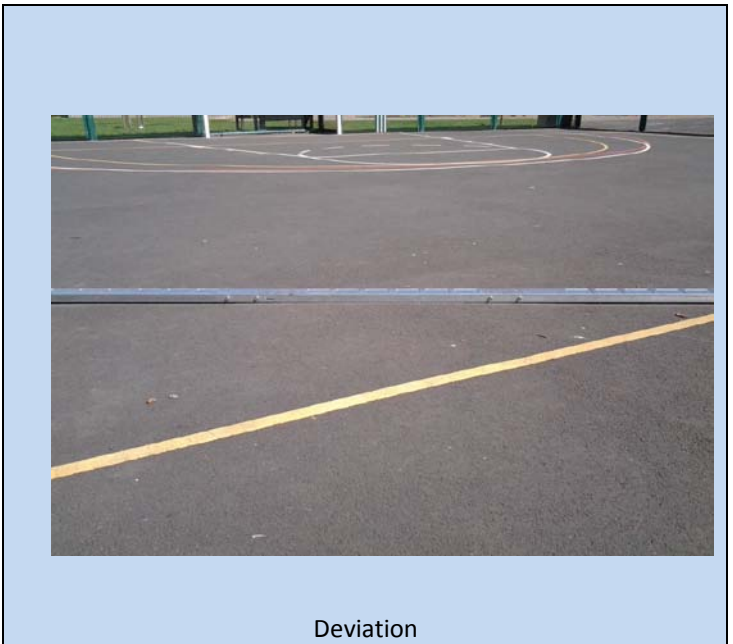
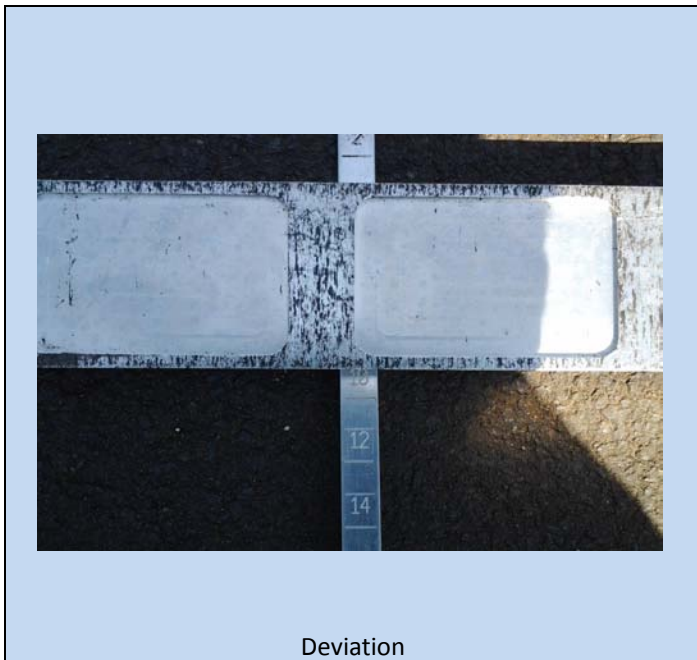
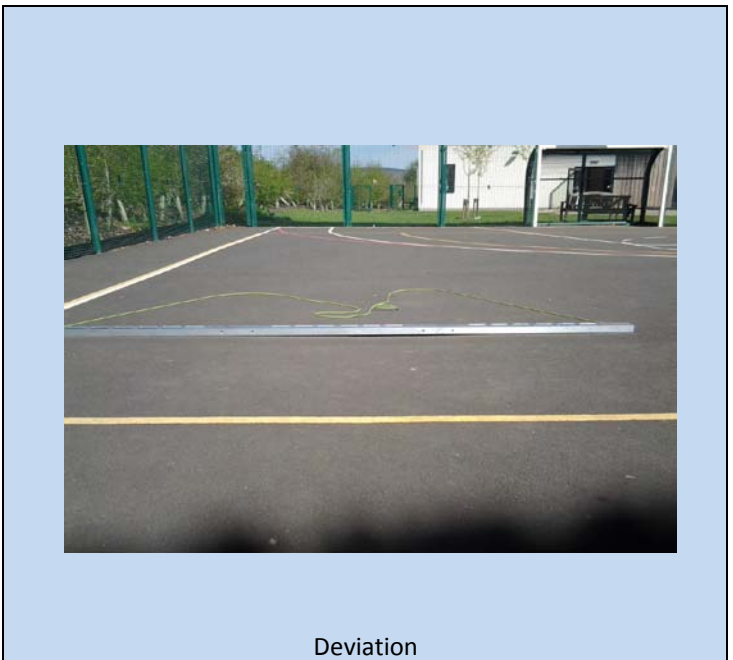
Site Photographs - Example Defects (If Any)

Property	Condition
Visual Inspection	Aesthetics	Damage	No damage visible
		Colour	None present
		Line Markings	Line markings are showing signs of cracking and should be monitored
		Fencing	Fencing is in good condition
		Goals, Equipment	Equipment in good condition. Goals in good condition and no damage visible.
		Housekeeping (Litter etc)	Some debris and litter around edges
