FIELD PERFORMANCE REPORT

BS EN 15330-1:2013 – Hockey & Football [Short Pile]

Field Reference: Newcastleton Polysport

Report Number: 17092/2612s

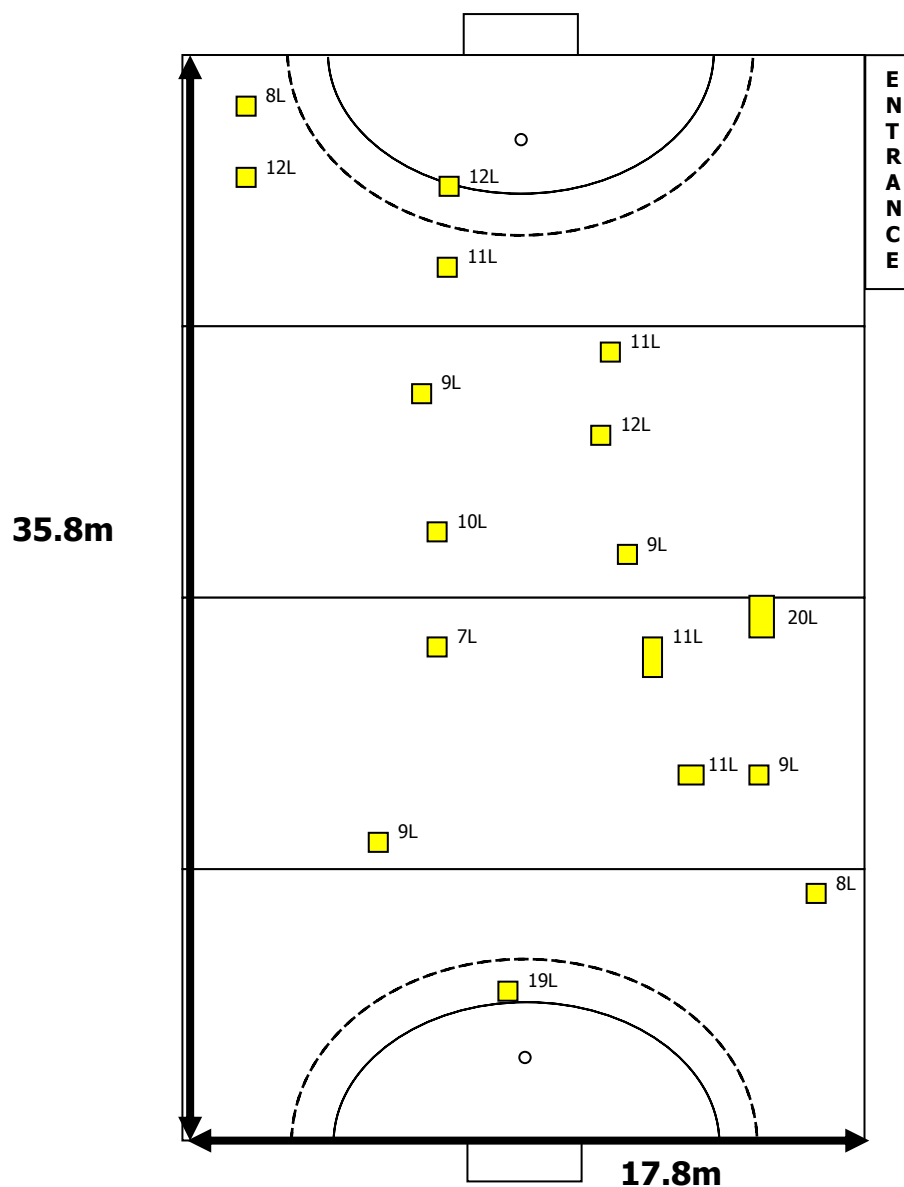
3.1 SURFACE REGULARITY AND DIMENSIONS

Plan showing surface irregularities exceeding maximum requirement of 6mm under a 3m straight edge.

In the surface measured there were 17 deviations found in excess of this requirement, as shown in the diagram below.

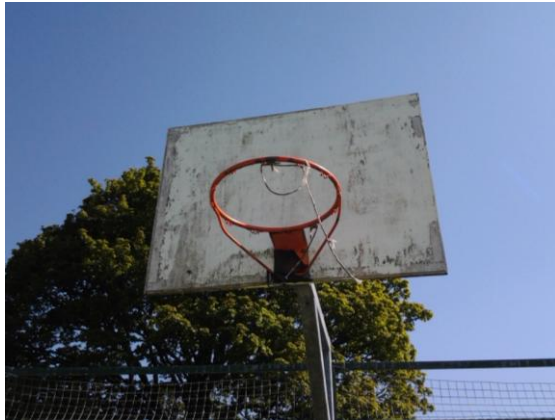
4.4 Goals: - The basketball hoops were in poor condition one hoop is missing a net entirely the other net is damaged. Both back boards are showing signs of wear and have no markings present. The frames are in good condition on both ends of the court.

Basketball hoops missing net

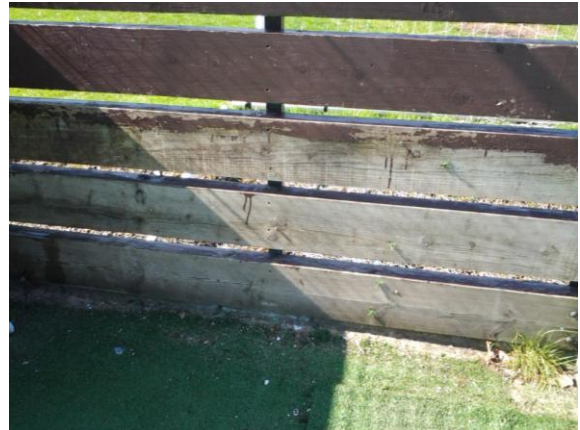
4.3 Fencing: - Lower Rebound boards: The Rebound boards are generally in good condition some boards are starting to loosen and should be checked and tightened accordingly. Boards have previously been painted and could be with repainting, however this is purely aesthetical.

Rebound boards require paint

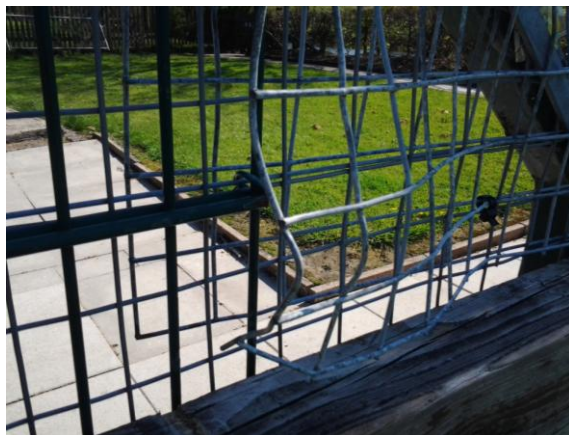
Fencing: - Upper Weld Mesh: The weld Mesh fencing is in poor condition especially at the ends of the court around the goals. On several panels the welds have broken and have left wire fencing protruding. These have resulted in hand and finger traps and also wires exposed at eye level. These pose a significant risk to the end user.

Finger/Hand trap on fence

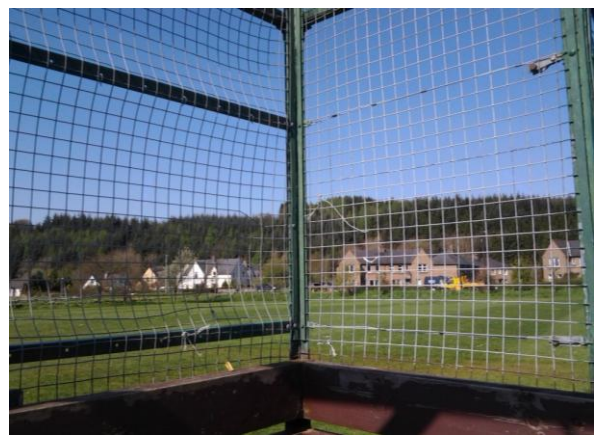
Burst welds with wire protruding
