# SPORT ENGLAND TYPE 1 MUGA TEST REPORT

<b>Facility Reference</b>	Tweedbank Play Park
<b>Facility Address:</b>	Cotgreen Road Tweedbank TD1 1RR 0
<b>Report Number:</b>	17092 / 2621s
<b>Report Status:</b>	FINAL
<b>Issue Date:</b>	17/05/2016
<b>Client:</b>	Scottish Borders Council Council Headquarters Newtown St Boswells TD6 0SA

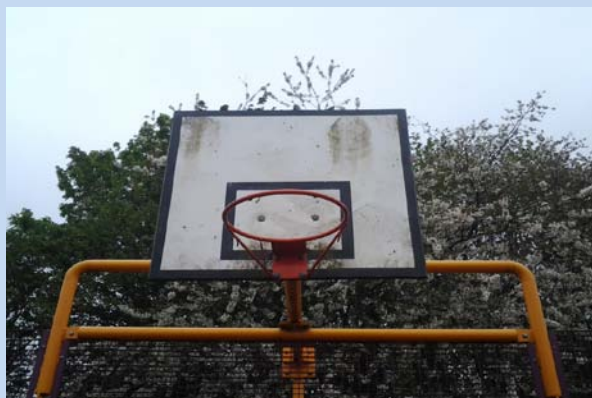
Property	Condition
Visual Inspection	Aesthetics	Damage	No Visible damage
		Colour	None present
		Line Markings	Line markings faded, requires repainting.
		Fencing	Good condition
		Goals, Equipment	Goals frames in good condition. Painted chipped paint, looks poor aesthetically. Basketball nets missing and backboards in poor condition
		Housekeeping (Litter etc)	Chewing gum on surface, some debris in playing area

Basketball nets missing

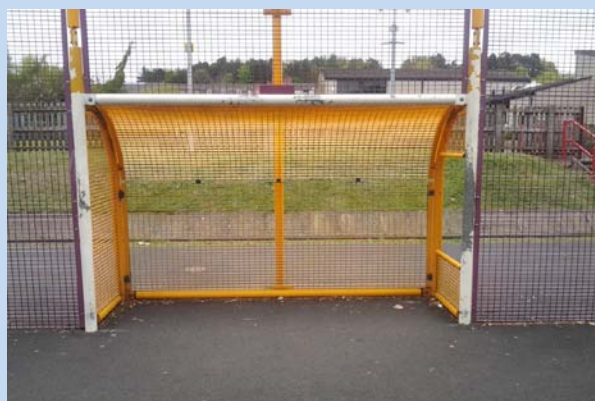
Paint damage on posts

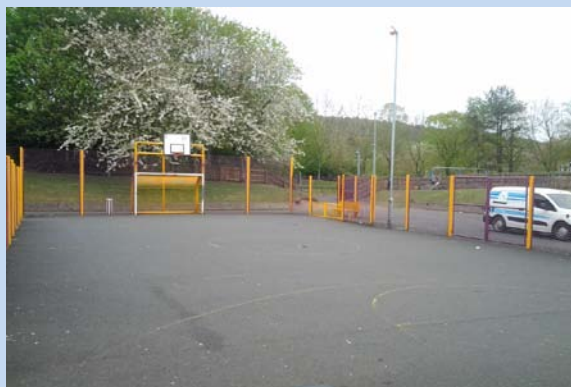
Line markings faded

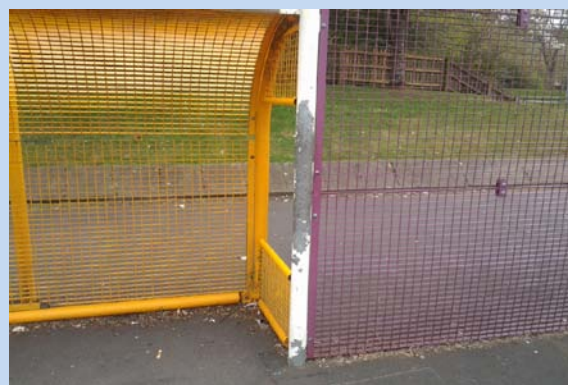
Paint damage on posts
