FIELD PERFORMANCE REPORT

BS EN 15330-1:2013 – Hockey & Football [Short Pile]

Field Reference:	Tweedbank Sports Ground
Field Address:	Tweedbank Industrial Estate Tweedbank Galashiels TD1 3RS
Report Number:	17092/2622s
Report Status:	FINAL
Issue Date:	13/05/2016
Client:	Scottish Borders Council Council Headquarters Newtown St Boswells TD6 0SA

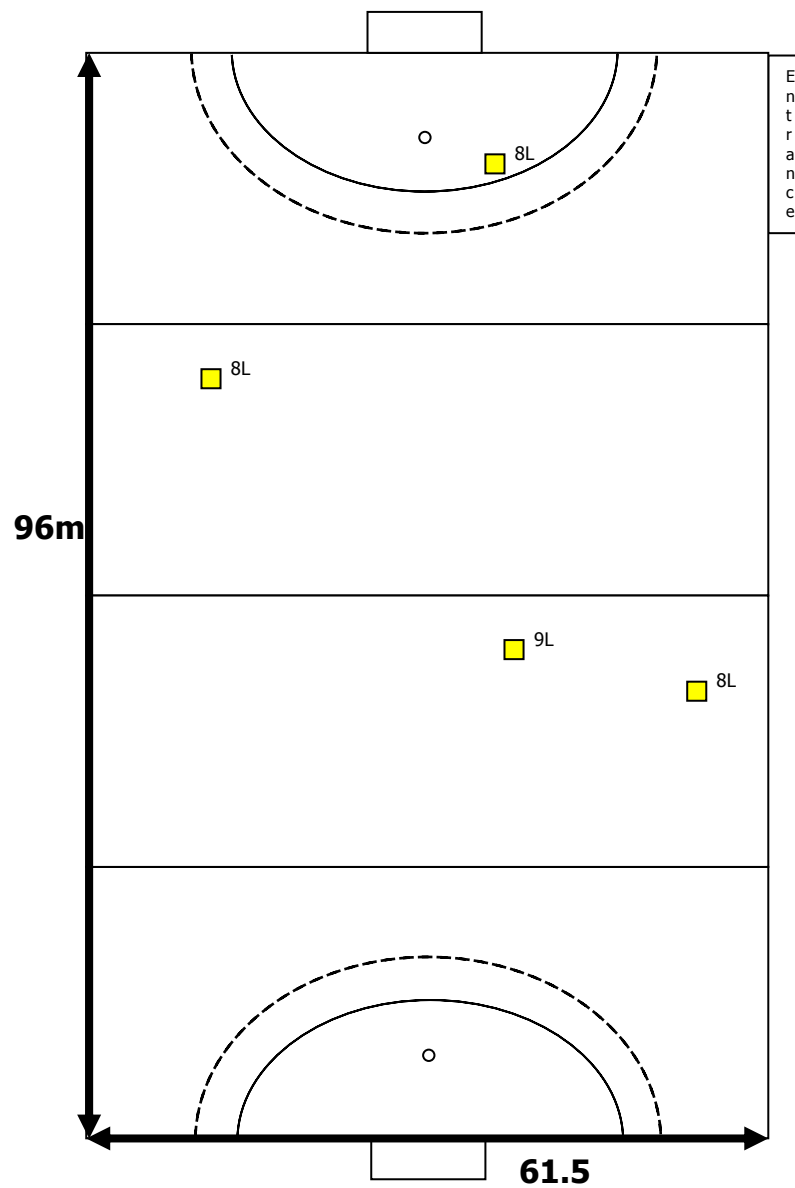
Plan showing surface irregularities exceeding maximum requirement of 6mm under a 3m straight edge.

In the surface measured there were 4 deviations found in excess of this requirement, as shown in the diagram below.

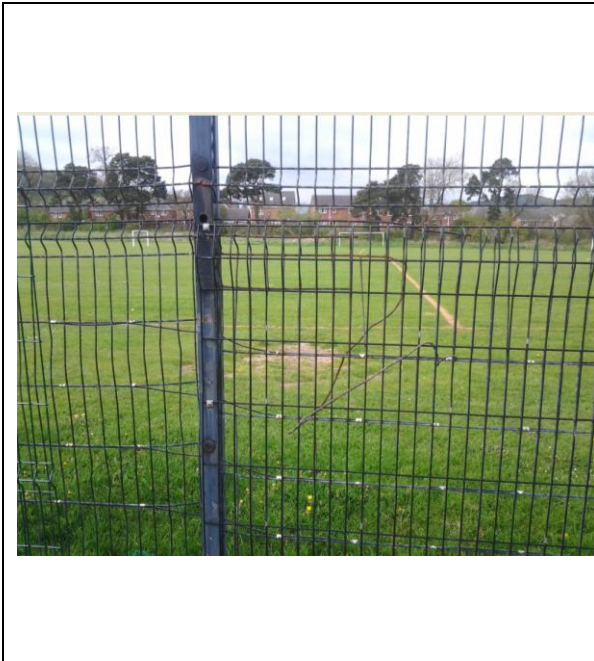
Fencing: - Upper Weld Mesh: The weld Mesh fencing is in the main in good condition however some areas are poor especially at the ends of the court around the goals. On several panels the welds have broken and have left wire fencing protruding. These have resulted in hand and finger traps and also wires exposed at eye level. These pose a significant risk to the end user.

Damage to Mesh fencing

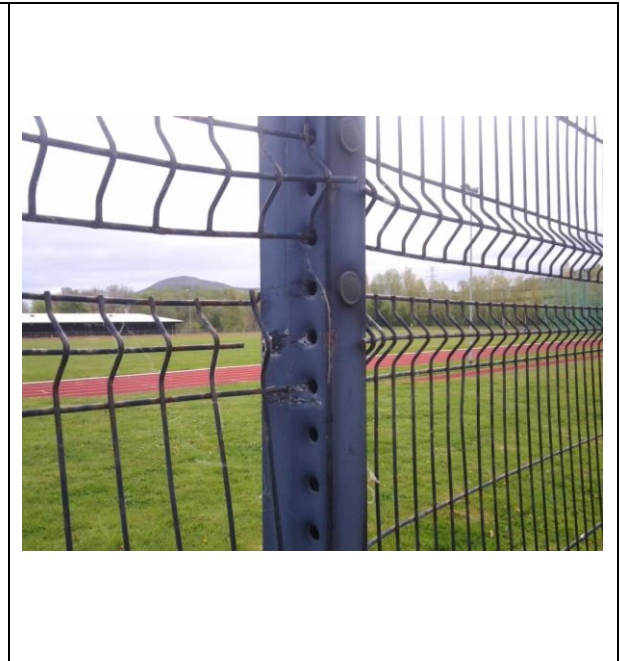
Damage to Mesh fencing

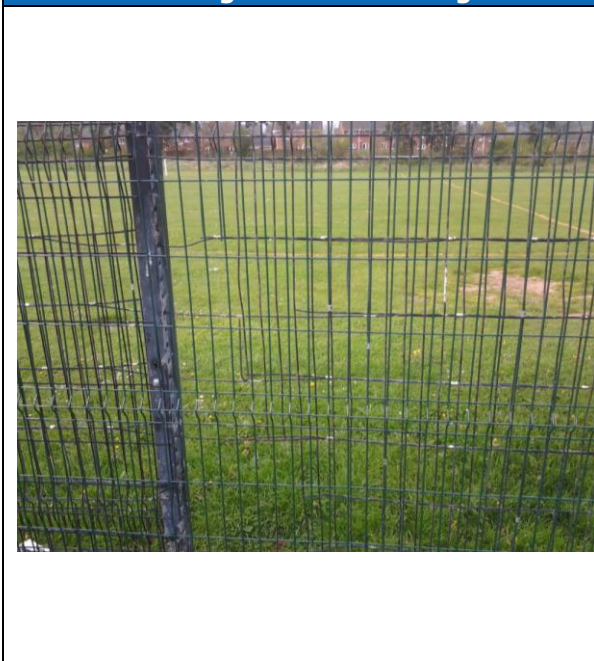
Damage to Mesh fencing

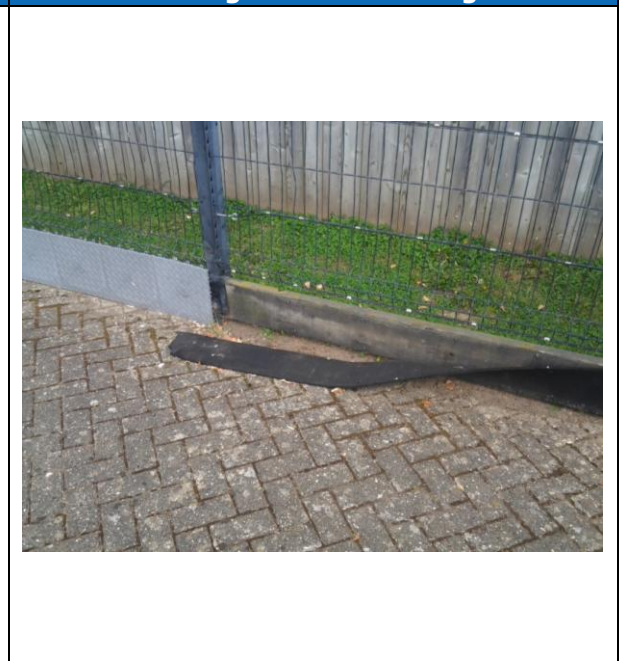
Rubber matting loose on boards.

4.3 Fencing: - Lower Rebound boards: The Rebound boards are generally in good condition some boards are starting to loosen and should be checked and tightened accordingly. Rubber matting behind the goals has become loose and should be reattached to the boards.
