## FIELD PERFORMANCE REPORT

**BS EN 15330-1:2013 – Hockey & Football [Short Pile]**

**Field Reference:** St Ronans Primary School

**Report Number:** 17092/2617s

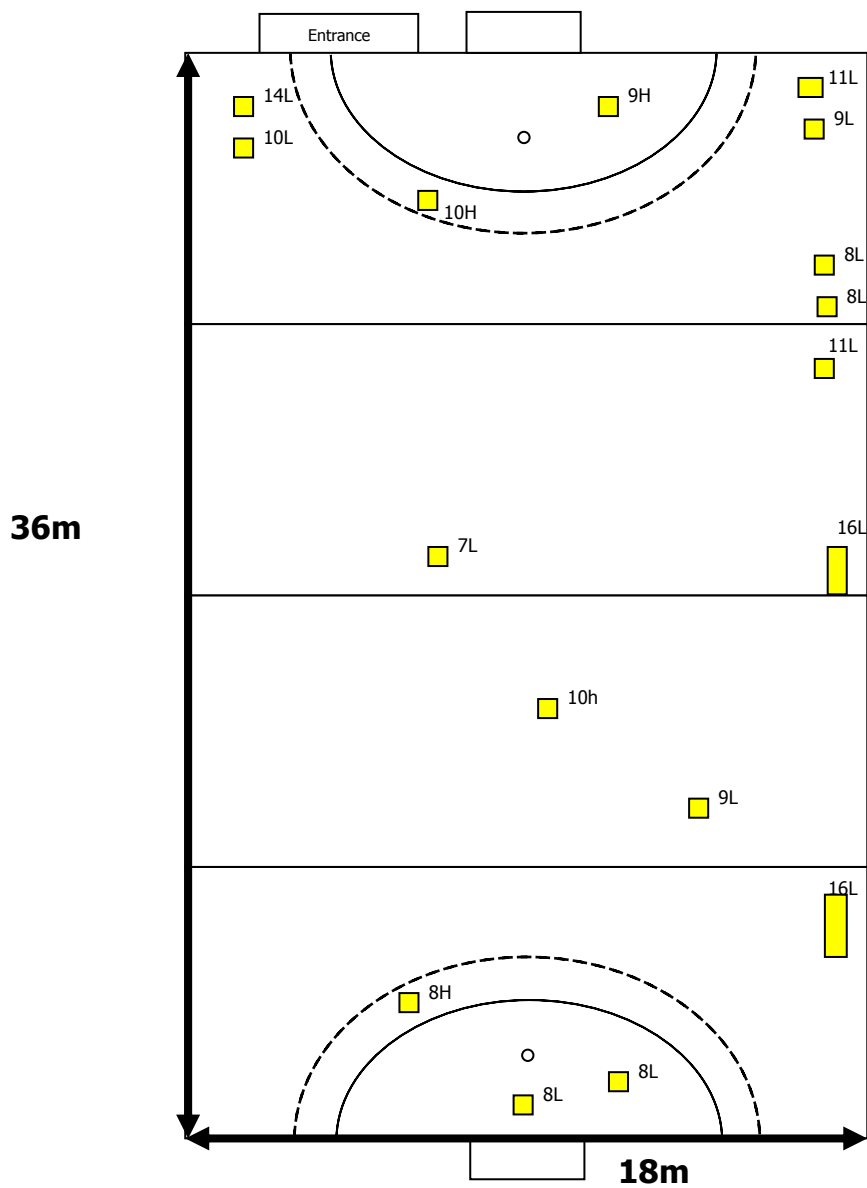
### 3.1 SURFACE REGULARITY AND DIMENSIONS

Plan showing surface irregularities exceeding maximum requirement of 6mm under a 3m straight edge.

In the surface measured there were 17 deviations found in excess of this requirement, as shown in the diagram below.

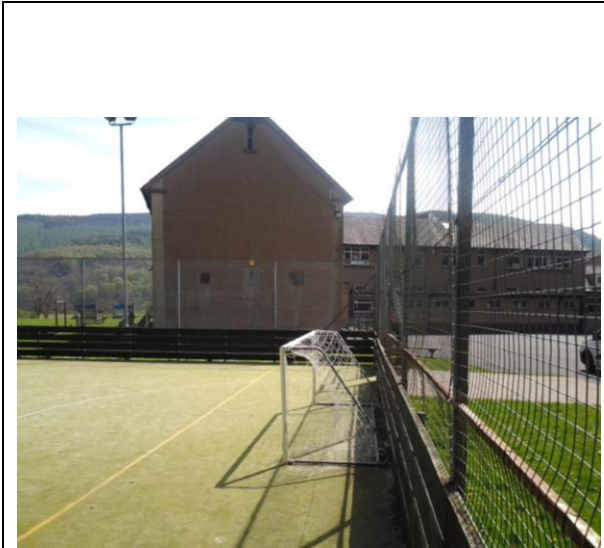
- 4.4 Goals: - The Football goal frames and nets were in good condition. The goals were not anchored at the time of the visit or self weighted, this should be rectified to avoid the possibility of goals tipping over . The goals should be inspected and tested in accordance with the BS EN 748 and BS EN 8462 if this has not been undertaken in the past two years. This will ensure that the goals conform with the minimum safety standards for goals.

**Goals not anchored**

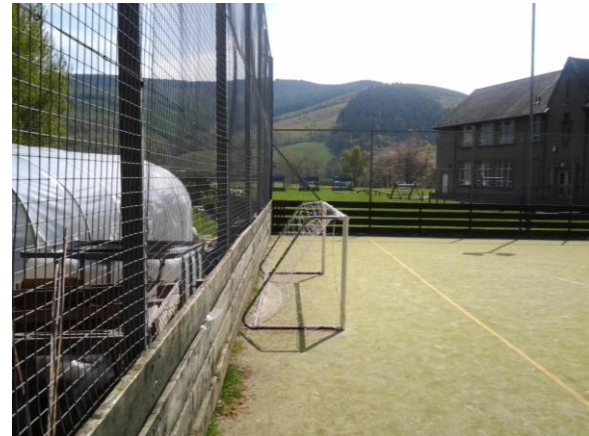
**Goals not anchored**

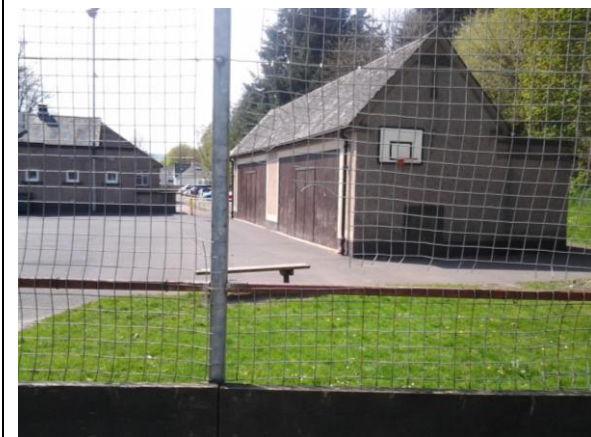
- Fencing: - Upper Weld Mesh: The weld Mess fencing is in poor condition especially at the ends of the court around the goals. On several panels the welds have broken and have left wire fencing protruding. These have resulted in hand and finger traps and also wires exposed at eye level. These pose a significant risk to the end user.

**Damage to Mesh fencing**

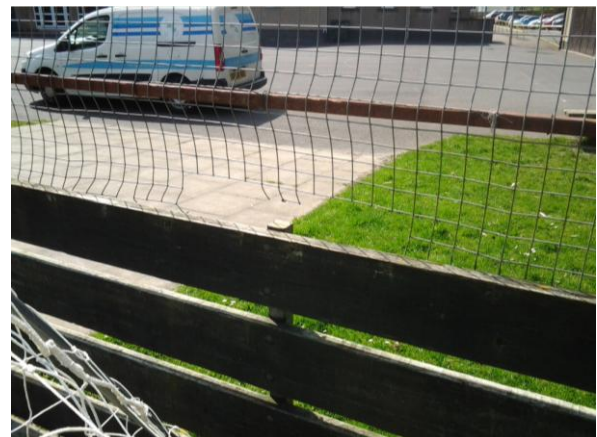
**Damage to Mesh fencing**
