REPORT OF AN INSPECTION MADE UNDER SECTION 10
OF THE RESERVOIR ACT 1975

Williestruther Reservoir

October 2015

Report Title: Williestruther Reservoir - Report of an Inspection made under Section 10 of the Reservoirs Act 1975

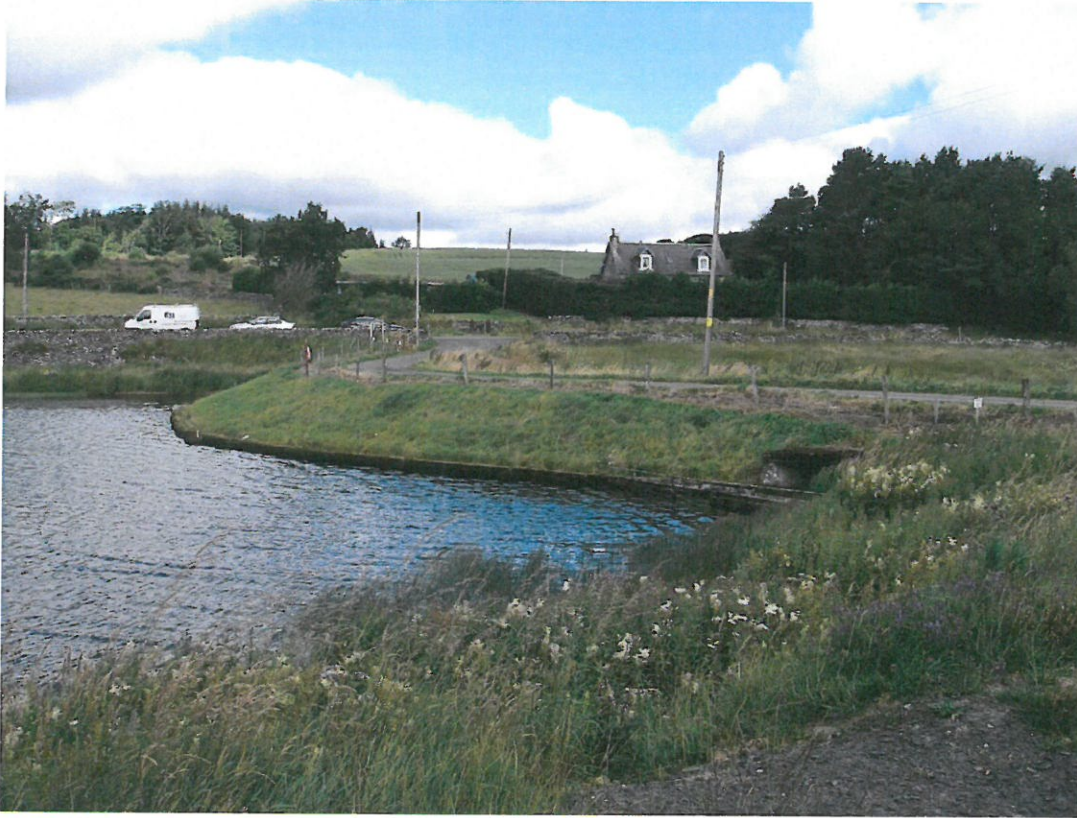
The upper part of the upstream face is now fully covered by grass which has grown up through the stone pitching (see photo 1). The grass is being cut three times per year and has good grass cover. The grass will be helping to stabilise the stone pitching.

Photo 1 – Upstream face of embankment viewed from right abutment

- maintain the existing practice for cutting the grass on the upstream face of the embankment
- cut the grass on the downstream face of the embankment three time per year (as for the upstream face),
- operate the outlet valve at intervals of no more than 6 months

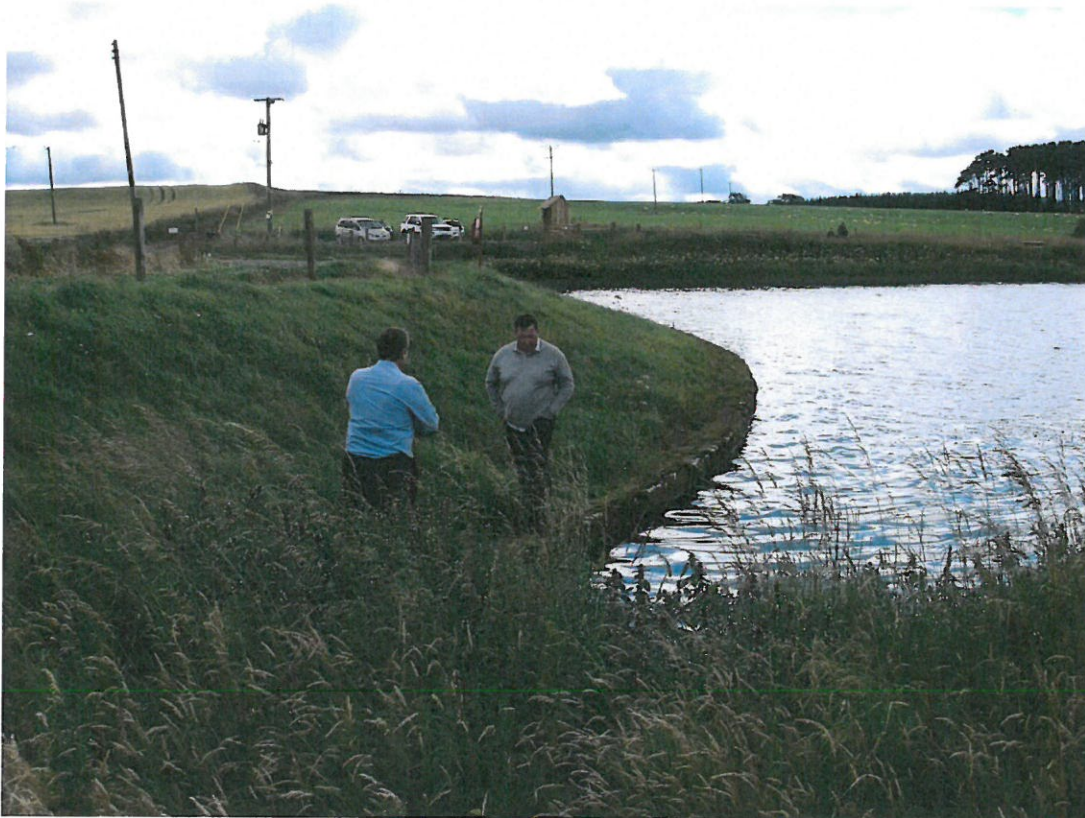
Photo 2 – Upstream face of embankment viewed from left abutment

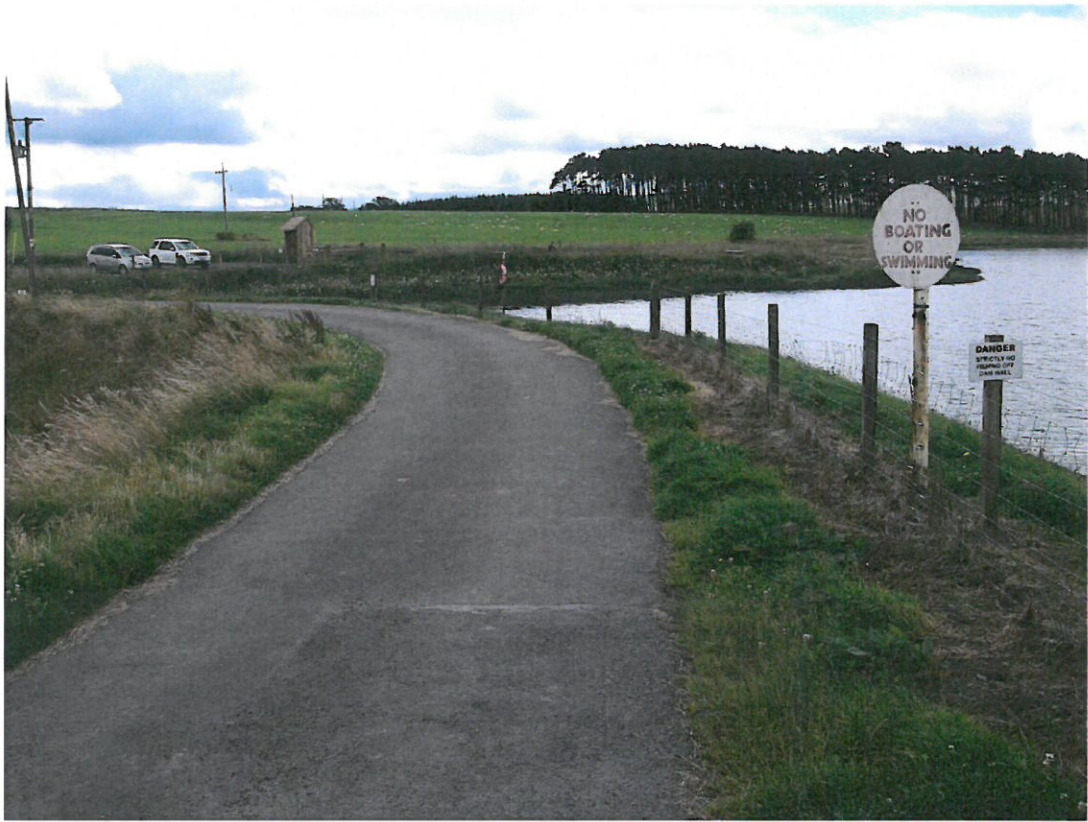
The crest road is in good condition (see photo 3).

Photo 3 – Embankment crest

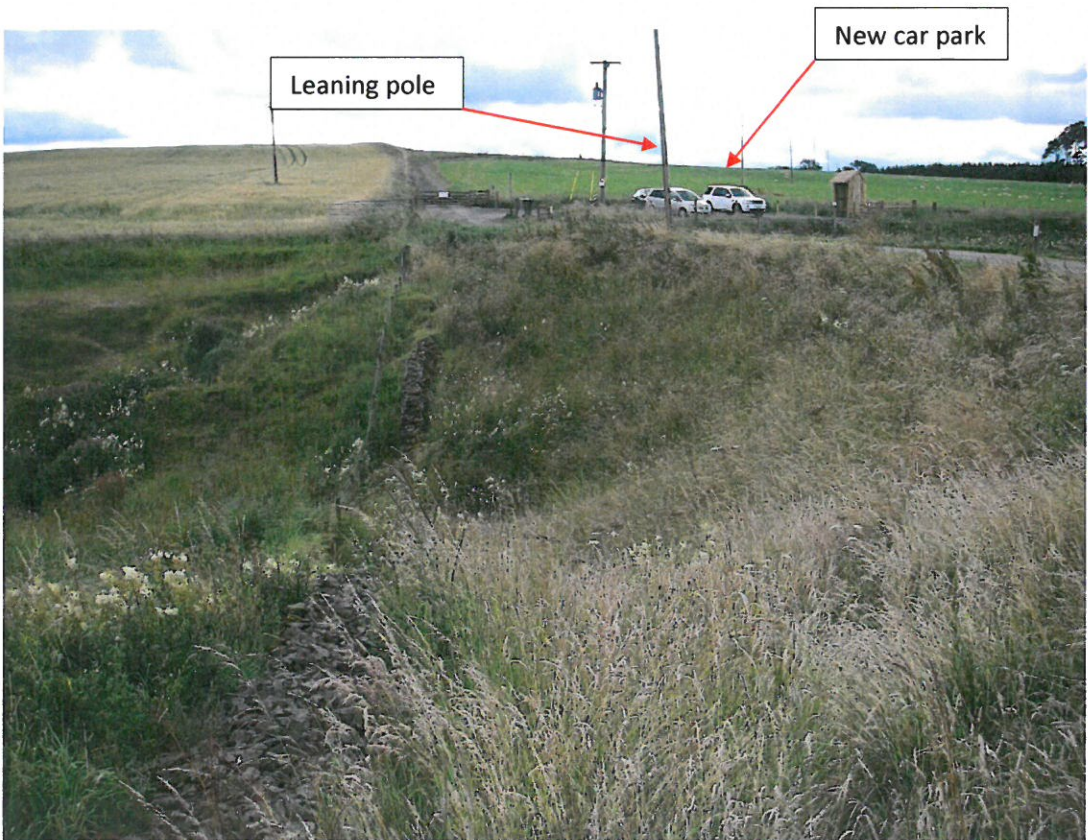
The downstream face was fully accessible but quite overgrown with this season's growth of grass and wild flowers (see photo 4). It is recommended that the downstream face should be maintained in the same condition as the grassed portion of the upstream face ie cut three times per year.

An overhead electricity cable runs along the crest of the dam. One of the posts is leaning slightly (see photo 4) but this is understood to be unchanged in recent years and is not considered to be an indication of instability.

A new car park has recently been constructed on the natural ground at the right end of the dam (see photo 4). This provides access to a footpath around the reservoir.

Photo 4 -Downstream face of embankment viewed from right abutment

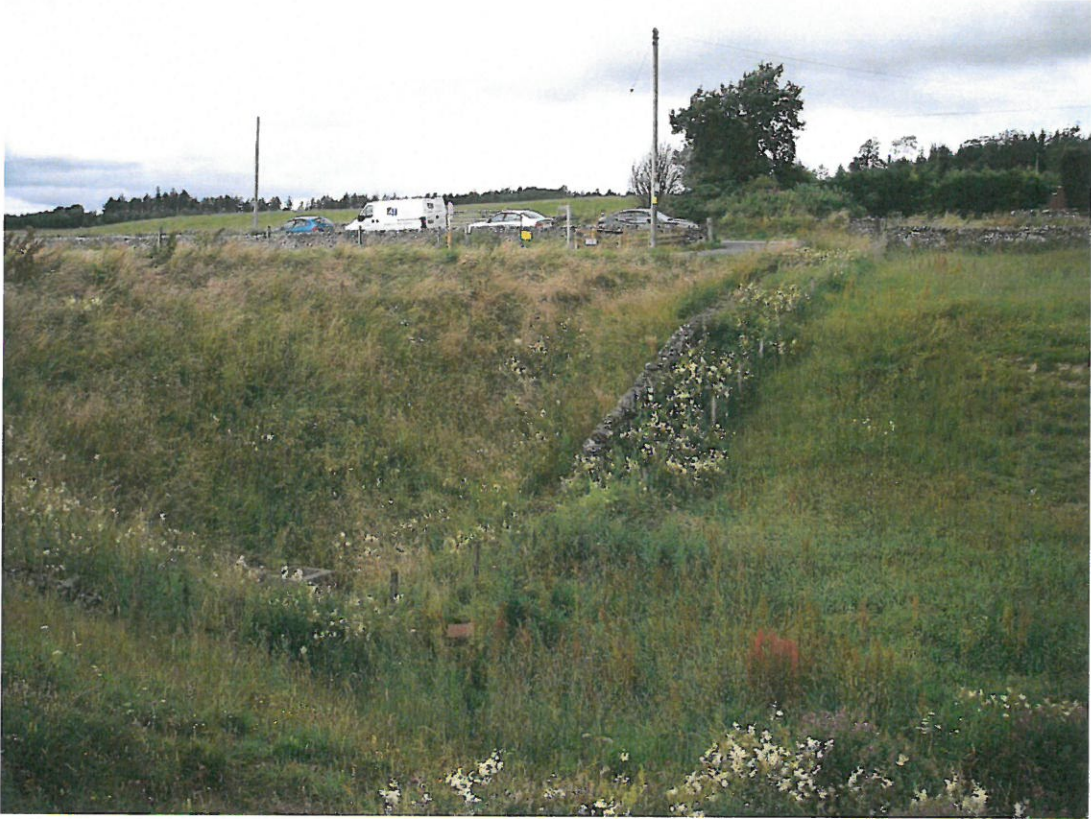
Photo 5 - Downstream face of embankment viewed from right flank

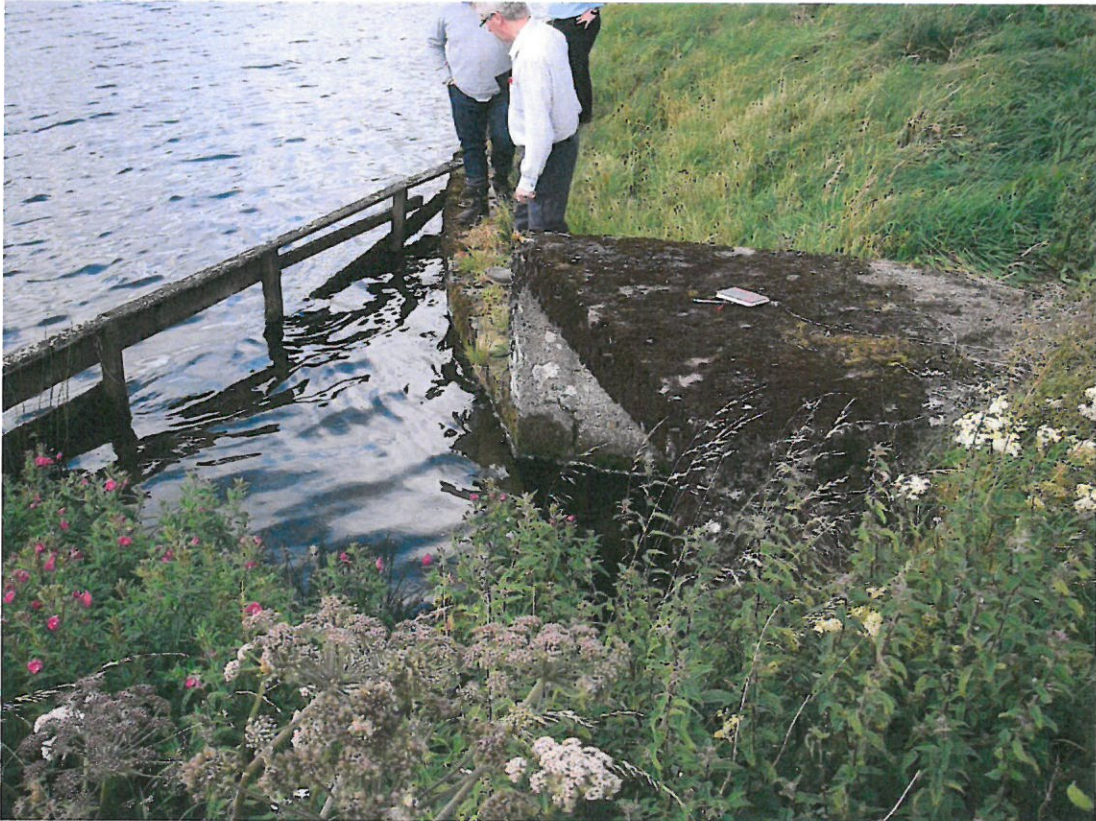
The baffle boards in front of the spillway have been partially dislodged and should be reinstated (see photo 6).

Photo 6 – Spillway inlet showing damaged baffle board

- the gauge board should be replaced
- repair the baffle at the spillway inlet

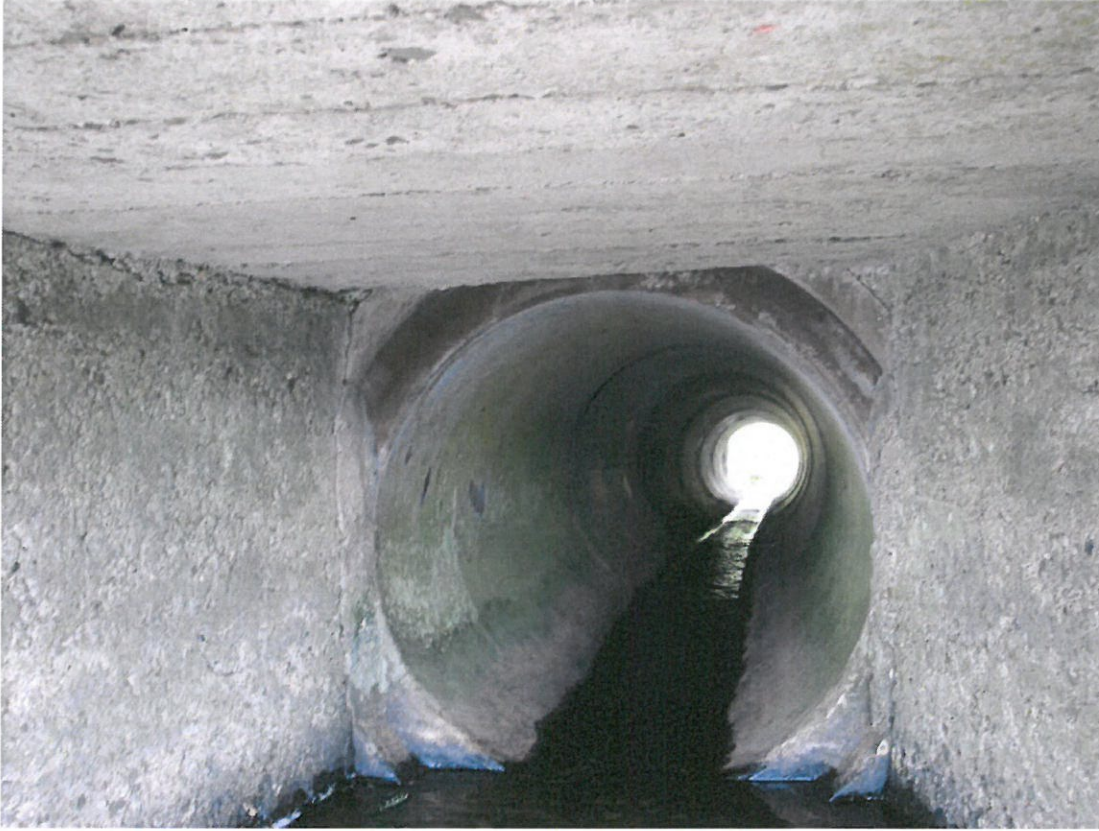
The spillway and outlet channel are in satisfactory condition. The pipes were all discharging freely with no blockages (see photo 7).

Photo 7 – Internal arrangement of 750mm dia outlet pipe (looking downstream)

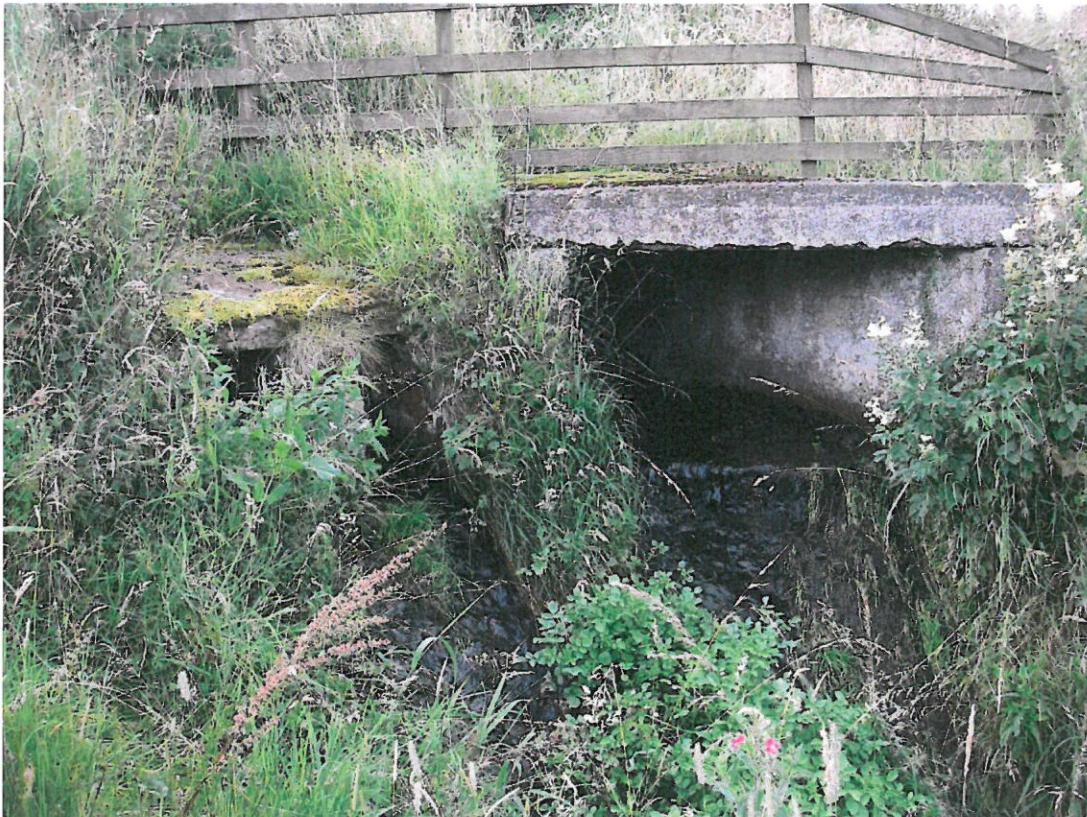
Photo 8 – Outfall from spillway pipes

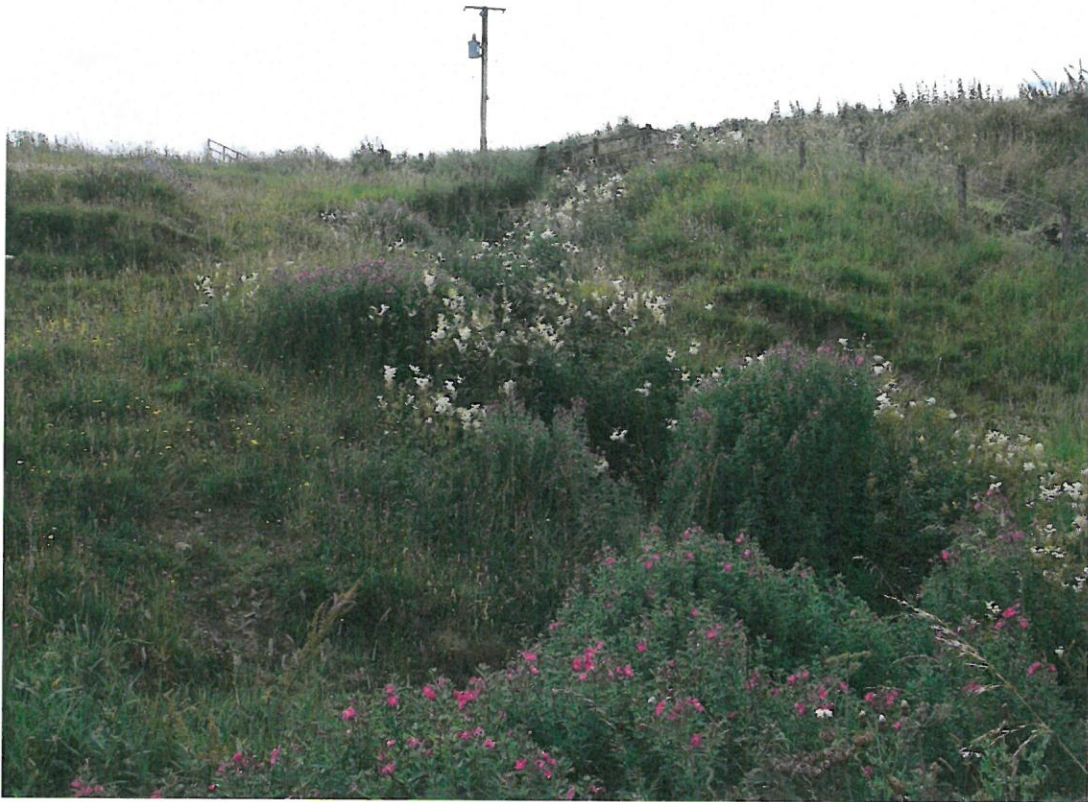
The outlet channel is unlined but appears stable with no indications of ongoing erosion (see photo 9).

Photo 9 – Spillway channel between outlet from pipes and stream bed

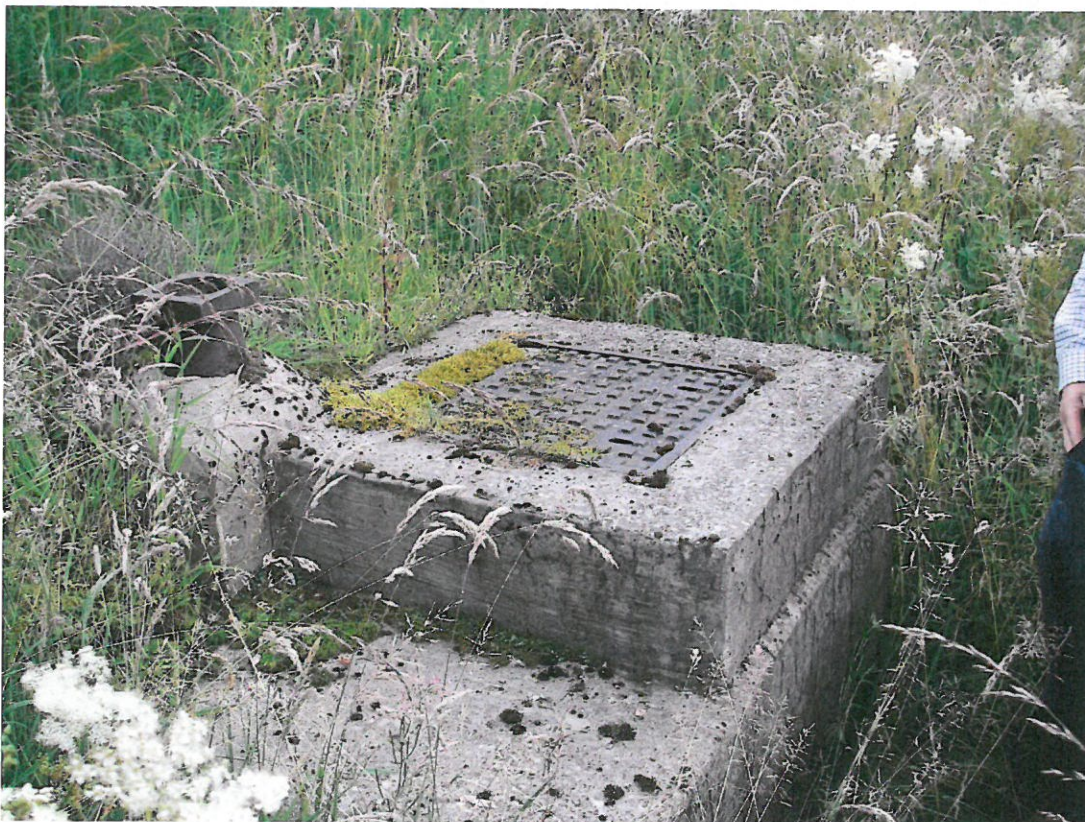
The valve chamber was full of water to a level 1120mm below cover level. This is understood to be usual and is considered to be a reflection of the groundwater level in the adjacent area. Because the chamber was flooded it was impossible to inspect the valve. It would be worthwhile to arrange for the chamber

to be pumped out at the time of the next Statutory Inspection. The water level was unchanged when the valve was opened which demonstrates that there is no leakage from the valve.

Photo 10 – Manhole on scour valve

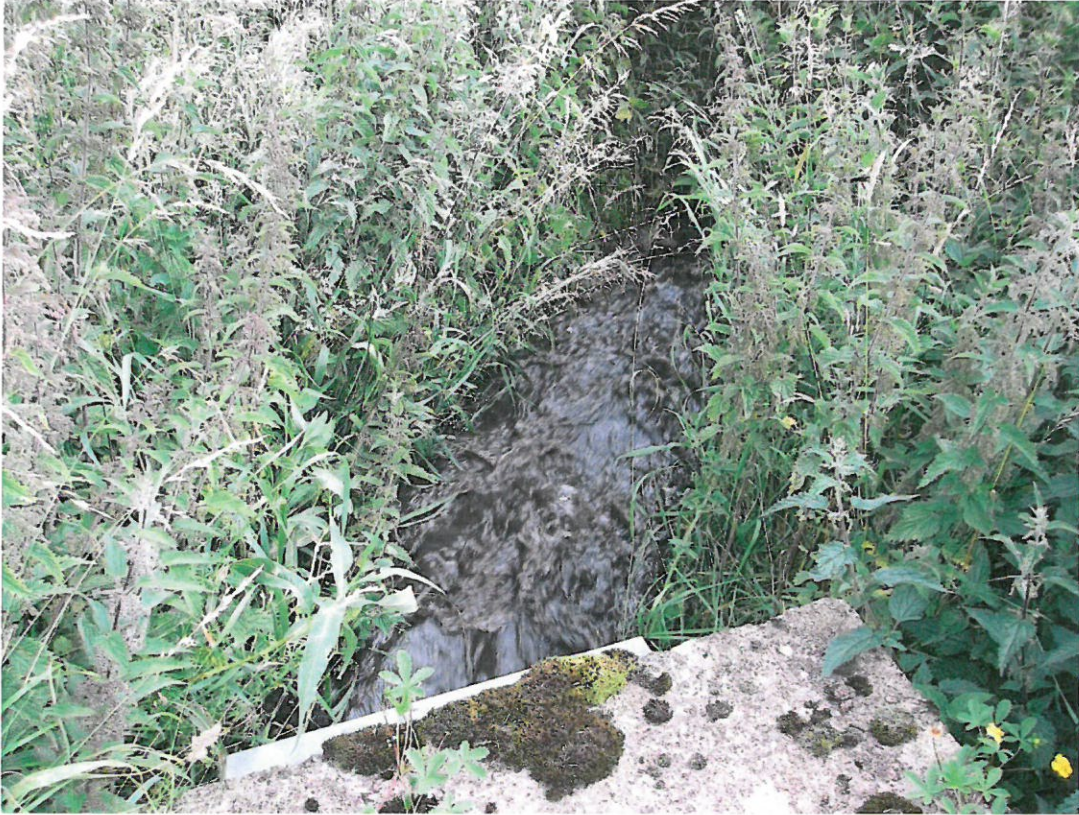
The bottom outlet was tested on the day of the visit. The valve operated freely and the outlet was seen to discharge to the stream. The flow was initially very silty, but cleared significantly over a ten minute period. Both chambers and their covers are in good condition.

Photo11 – Outlet discharging at full capacity

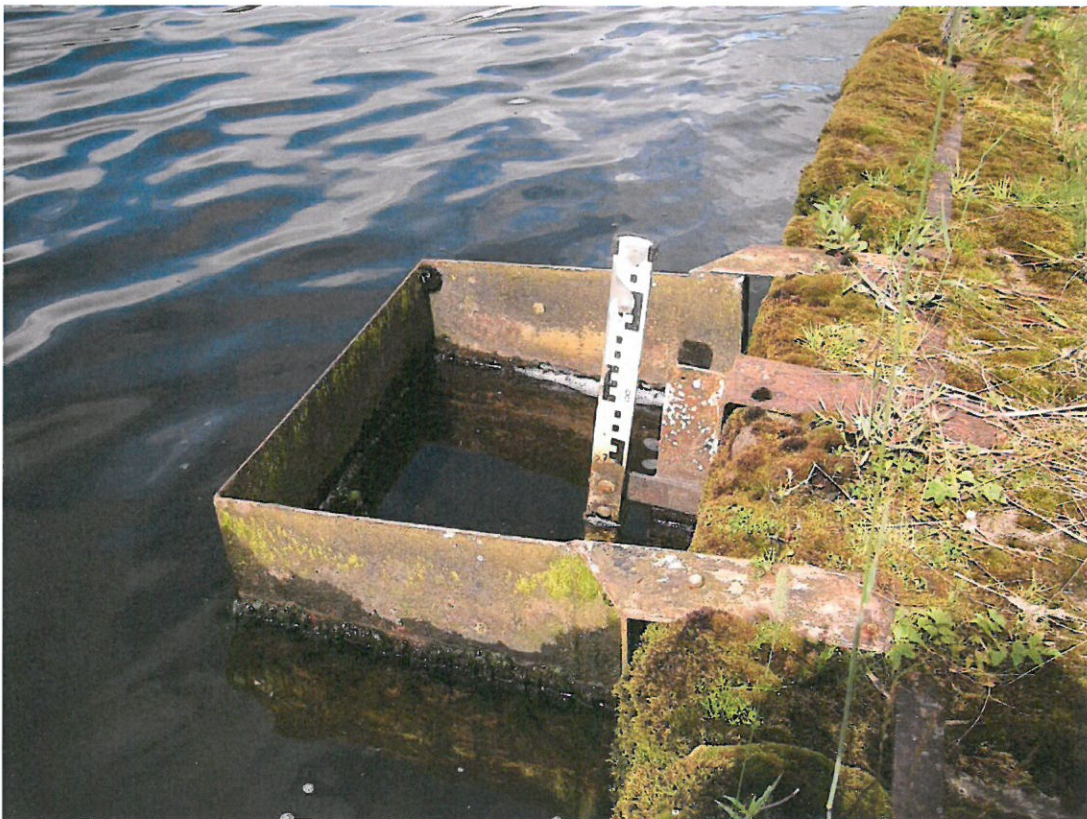
Water levels are recorded from a gauge board mounted on the masonry wall on the upstream face of the dam. The gauge is surrounded by a baffle to limit the effects of wave action. The numbers on the gauge board have been partially scoured off and are now difficult to read. It is recommended that the gauge board is replaced.

Photo 12 – Gauge board

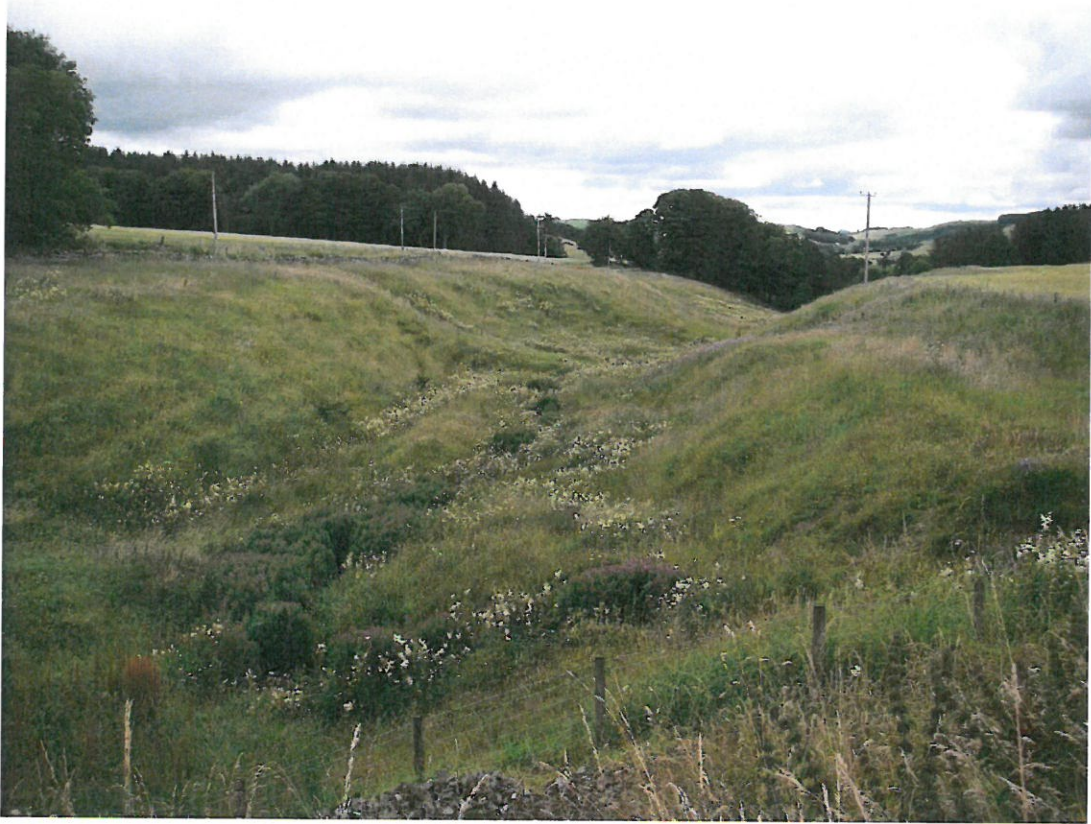
The area downstream of the dam was found to be unchanged from that shown of the latest Ordnance Survey mapping.

Photo 13 – Valley downstream of dam
