**The Black Barn, Eckford**

**Structural Inspection Report**

**Client: Buccleuch Estates**

**Date: April 2021**

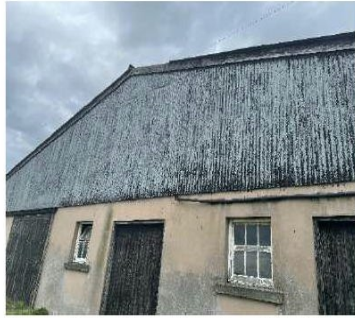
Figure 2.0 - West elevation of the Black Barn

The west elevation of the building was found to be in reasonable condition for the age of the building and given that it appears to have been vacant for some time. The main elevation of the barn appears to be constructed in blockwork up to dado height (see Figure 3.0) and be rendered externally with a smooth concrete finish (See Figure 2.0). Some localised cracking of the render was evident in places but cracks were small in nature and pose no cause for concern structurally.

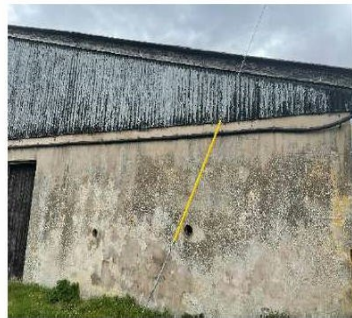
There were a number of penetrations on the west elevation that have been made for services or similar; one to the top of the rendered section of wall allowing telephone cable entry and a further two cores towards the south (see Figure 4.0).

Figure 4.0 - View indicating small cores on southern elevation

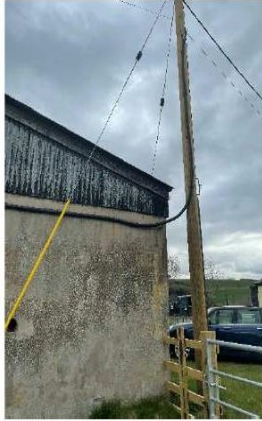
It should be noted that a telegraph pole to the south west corner of the building (see Figure 5.0) was located just outside the fence line. This pole appears to service both the barn and several adjacent properties.

Figure 5.0 - Telegraph pole at SW corner of the barn

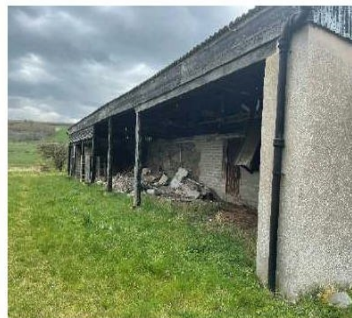
The north elevation was partially open (see Figure 6.0) and permitted visual access to the roof structure internally. Further internal access was not available as all external doors were locked.

Figure 6.0 - North elevation of the Black Barn with partial access to the inside of the barn

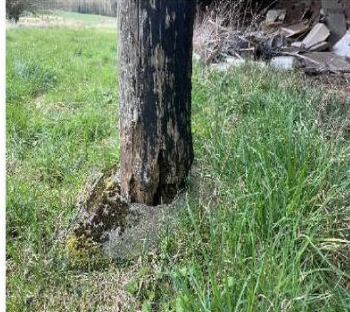
Four timber D-shaped columns approximately 200mm in diameter and located at 3.5m centres were evident on this elevation. The columns were founded on 500mm square concrete plinths which extend to a maximum of 200mm above ground level. Shakes were evident in the columns but these appeared historical and pose no cause for concern. There was evidence of rotting timber at the base of the columns as indicated in Figure 7.0. Further rotting of the timbers below ground level is anticipated given the likelihood of standing water gathering within the concrete plinths.

**Figure 7.0** - Base of timber column with evidence of rot

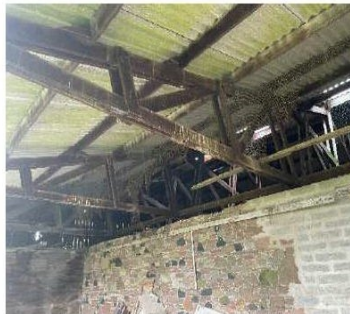
The timber columns extend to approximately 3.7m in height and support roof trusses over. The trusses are constructed using doubled up 150mm x 50 mm timbers. The trusses in turn support timber purlins at approximately 1.2m centres (See Figure 8.0). Triangular blocking pieces sit atop of the trusses preventing rotation of the purlins. From the visual inspection the timbers appeared to be in reasonable condition for their age and exposure and there was no immediate signs of rot or deterioration. There was however extensive evidence of roosting birds.

The roof cladding comprises solid corrugated sheeting with localised transparent (assumed plastic) corrugated panels to form rooflights. From the visual inspection it was not possible to determine the type of roof sheeting that has been used but given the age of the building, asbestos sheets may be likely.

**Figure 8.0** - View of timber roof trusses and roof sheeting

Structurally the barn appears to be in a sound condition with no evidence of major cracks or movement in the external envelope. There appear to be a number of broken or missing roof sheets, these should be replaced if possible. Prior to any work being carried out on the roof however specialist advise should be sought to determine whether the roof sheets contain any asbestos.

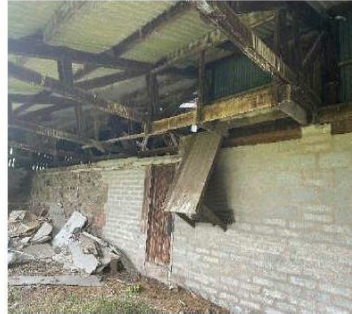
Internally the walls were formed in a mixture of materials; concrete block laid flat, concrete blocks laid conventionally, random rubble and timber. It is clear that a number of alteration works have been carried out on the barn over a number of years, using materials available at the time (see Figure 9.0).

Figure 9.0 - Internal walls of various construction

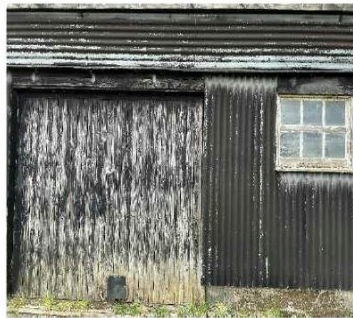
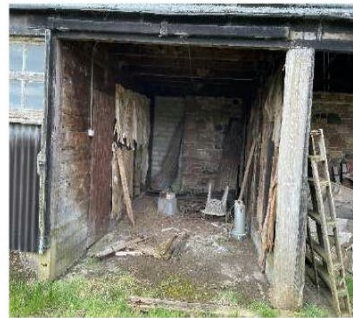
Toward the eastern end of this elevation there were two small spaces with lowered timber ceilings. It is assumed that these areas have previously been used as garages for storage of small farm machinery (See Figures 10.0 and 11.0). The walls and ceilings within these areas are constructed in timber whilst the floor slab is constructed in concrete. The timber doors and windows to these areas are in a poor state of repair and require attention. Externally, the walls are clad in painted metal corrugated sheeting.

Figures 10.0 and 11.0 - Small "garages" located to the north east corner of the barn

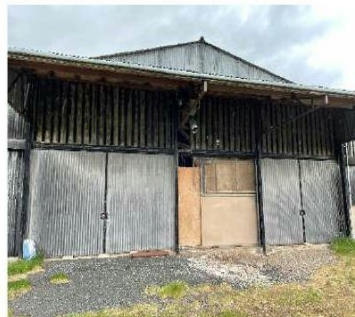
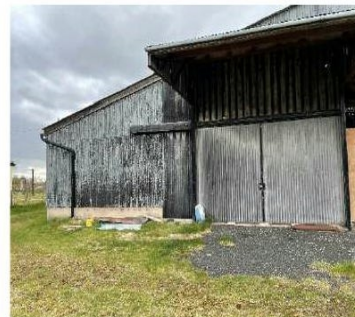
Two timber large sliding doors with timber ventilation grilles over covered most of the east elevation (see Figures 12.0 and 13.0). The remainder, unlike the west elevation comprised a rendered block wall extending only to dwarf height with corrugated metal cladding above.

Figures 12.0 and 13.0 - Sliding doors with ventilation grille over

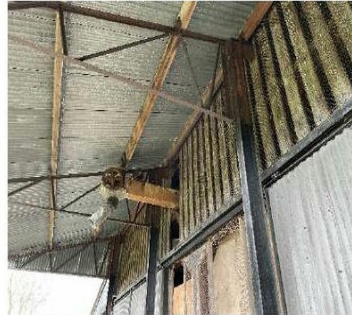
Figure 14.0 - Canopy Structure to East Elevation

A canopy, which appears to be a later addition, is positioned over the sliding doors. The canopy is of steel construction and comprises 3 no. steel columns tied back the main barn frame. The columns support a half truss which in turn supports timber purlins and corrugated roof cladding (see Figure 14.0).

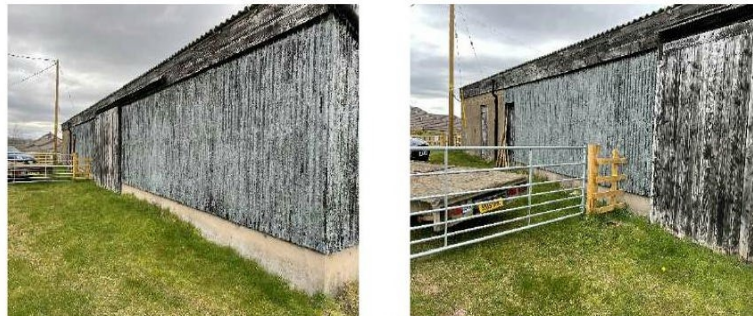
Figures 15.0 and 16.0 - South Elevation

The southern elevation of the barn was similar to the east elevation in that a dwarf wall was evident with corrugated metal cladding above. The metal has previously been painted black but is flaking extensively. The metal however appears to be galvanized and there was no evidence of corrosion.

Two rainwater pipes were evident on this elevation, one to the south east corner and one to the south west. As the north elevation, the gutter was not present therefore it is likely that the timber at eaves level may have suffered some water damage and/or rot due to the lack of rainwater goods.

One large timber sliding door and two small access doors were located on this elevation. All were in a poor state of repair and will require attention.

At the point of writing the proposals for the barn are unknown. However, assuming that the barn is to be retained it would be prudent to allow for an element of repair and maintenance. In particular, the gutters to the north and south elevations should be reinstated and connected into the existing rainwater pipes. As mentioned within the report a specialist timber survey should also be instructed and any recommended remedial works be undertaken.
