Structural Design Consultants

2nd March 2021

Building Survey
26963 – Haughhead, Innerleithen

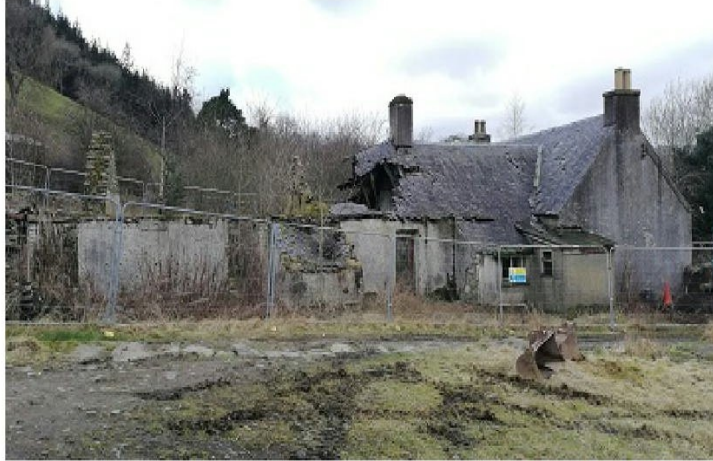
Unit three (left) and unit one (right)

The roof to the first section, adjoining Unit One, is severely distressed and needs to be removed and replaced. The walls, where the roof is missing, are heavily weathered and in some places cracked. Given the deterioration of Unit Three and the extent of alterations and repairs which would be required to bring it up to habitable status, it is recommended that this portion of the building be demolished and rebuilt as desired.

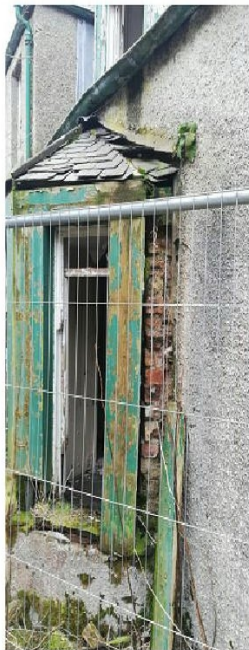
Unit one (bay window)

The bay windows are showing their age with lichen and moss growing on the sills and the exposed brickwork weathering. The bays will need to be rebuilt.

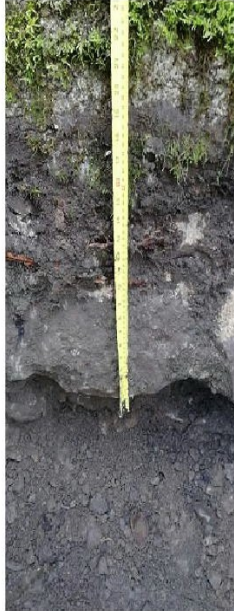
Unit one (foundation)

The existing foundations to the west gable were exposed for inspection and found to be comprise of large stones, with minimal scarcement, set with the underside at approximately 450-500mm below external ground level. The bearing strata is compacted gravel.

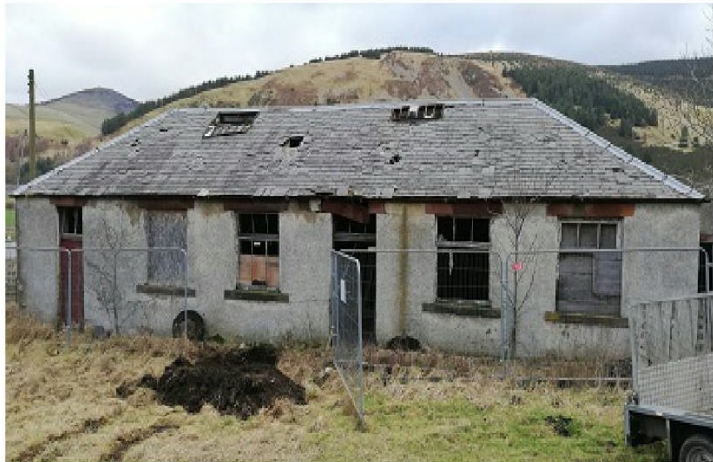
Unit two (south elevation)

Where the render has spalled off, there is moss and lichen growing on the stone and mortar which suggests that the walls are most likely damp throughout the building. This moisture is likely being retained by the render and if left without treatment will probably cause more damage as time progresses through freeze-thaw between the stone and render. The solution would therefore be to remove the render to allow the stonework to dry out. In removing the render, there will likely be damage to the stonework and mortar. This damage would necessitate repair. Whether that repair would be wholesale rebuilding, or more modest local stone repairs and repointing with lime mortar would only be determined once the work has started. However, the proposals to convert the building to a dwelling include the formation of several large new window openings in the North elevation. This, coupled with the damp issues, and the general rubble core nature of the walls will lead to extensive rebuilding of this elevation.

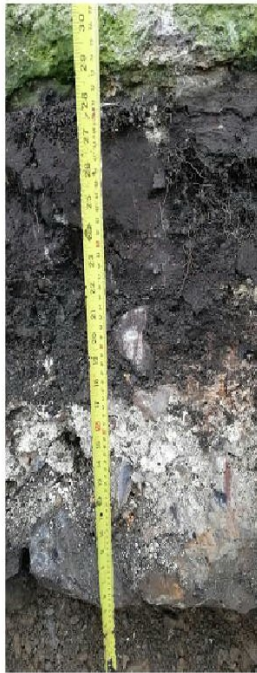
Unit two (foundation)

The existing foundations to the west gable were exposed for inspection and found to be comprise of large stones, with approximately 150mm scarcement, set with the underside at approximately 700mm below external ground level. The bearing strata is compacted gravel.
