ROAD SAFETY REVIEW OF TEMPORARY TRAFFIC MANAGEMENT, IN JEDBURGH TOWN CENTRE.

Report Ref 120422

Issue Date 11-May-22

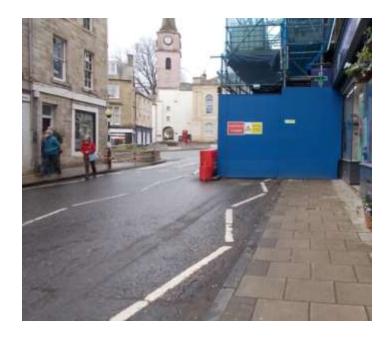
- 3.1. The review team visited Jedburgh between 11:45 and 14:00 hours on Tuesday 26th April 2022. During the visit the weather was cloudy and cold, it had been raining and the road surface was wet. The review team drove and walked along the roads effected by the diversion whilst observing road user behaviour and noted the following;
- 3.2. Pedestrian and traffic flows were considered to be light at the time of the site visit.
- 3.3. The remnants of the Zebra crossing (road markings, zig-zag markings and Belisha beacon) on High Street are misleading and confusing as the crossing has been closed by temporary scaffolding acting as a barrier on the east side.
- 3.4. The lack of intervisibility between northbound drivers entering High Street and pedestrians attempting to cross High Street at Boots, where the footway is terminated.

Termination of footway on High Street.

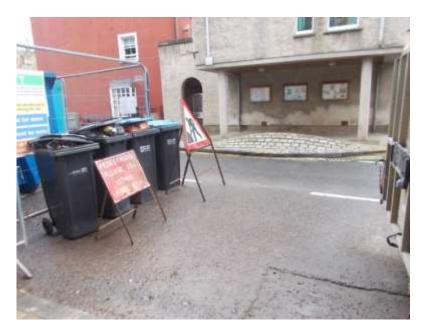
- 3.5. The need for pedestrians walking between Exchange Street and High Street to cross 3 roads.
- 3.6. The lack of intervisibility between drivers exiting Exchange Street and pedestrians attempting to cross Exchange Street due to parked vehicles, and the lack of dropped kerbs and a level footway on the opposite side of the road.

Exchange Street. Footway termination and pedestrian crossing location.

- 6.1. Pedestrian drop kerbs are provided on both sides of Exchange Street at the termination of the east footway.
- 6.2. Pedestrian drop kerbs are provided on both sides of Market Place near to its junction with Exchange Street.
- 6.3. The remnants of the Zebra crossing on High Street are removed.
- 6.4. A new controlled pedestrians crossing is provided on High Street near to No. 11.
- 6.5. The one-way operation on Exchange Street remains.
- 6.6. The Co-Op car park is not used as a turning point for public road traffic therefore the No Entry signs on High Street at the junction with Jewellers Wynd should remain.
- 6.7. Where practical, temporary signs in standalone sign frames and on temporary sign pole bases should be mounted on permanent poles or fixtures. The use of more permanent street furniture is expected to improve compliance to the restrictions.
