BS5837:2012 Tree Survey

Proposed Development Site
at Friarshaugh Farm
Gattonside

December 2020

Document Reference: BS_011220-SR Revision 00

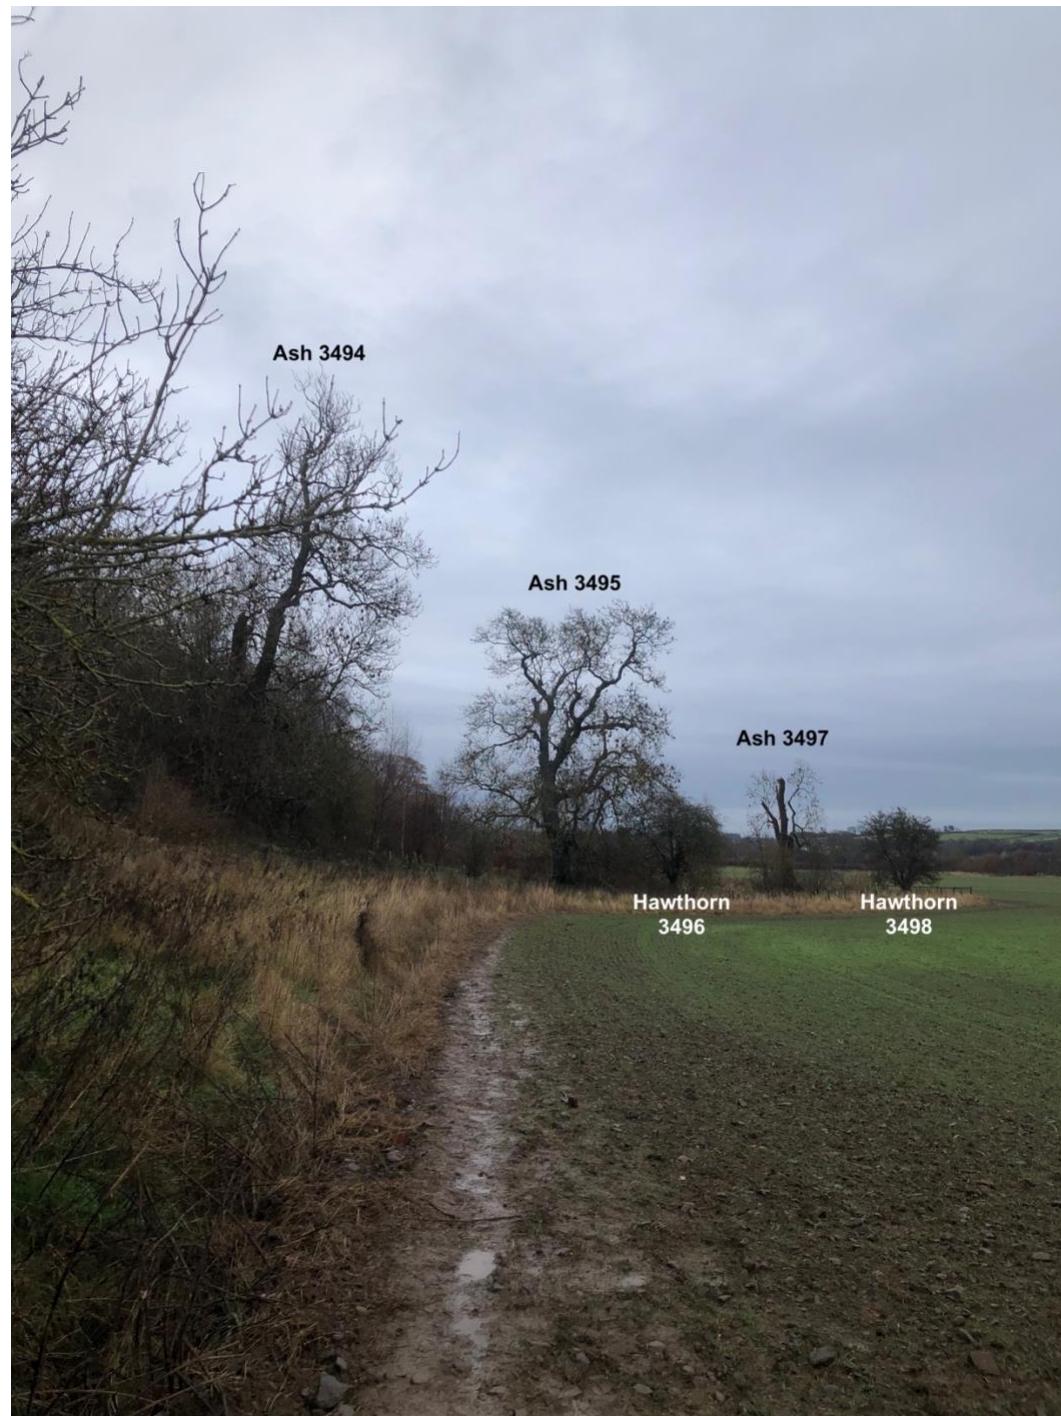
BS_021220 Land at Friarshaugh Farm, Gattonside Image No 01

7.2.1 Ash Nos 3494, 3495 & 3497

Substantial veteran specimens, two of which are already in an advanced state of decline, and all now symptomatic of Chalara Ash Dieback (see s5.2, above for further information on this disease).

In this condition these trees offer a very high ecological/habitat value and in the present circumstances would appear to present no practical hazard (see s3.9, above in this connection). However their retention may not be consistent with the safe development of the adjacent land.

Veteran Ash specimens 3494, 3495 & 3497 are graded at Category C in reflection of their severely limited SULE (see 5.2, above). However, these trees have an extremely high ecological value and, whilst their retention remains consistent with safe management of the land, may be retained.

Trees No 3494-3497 viewed from west, showing declining structural condition of Ash specimens

Tree Reference Number	Grid Reference	Species, Taxa	Age Class	Height (m)	Stem Diameter (mm)	Constituent Stem Diameter of Multistem sps (mm)	Crown Spread (m)	Height (m) & direction of Lowest Branch	Crown Clearance (m)	Root Protection Area	Physiological Condition	Structural Condition	Condition Notes	Preliminary Management Recommendations	Timeframe for Recommended Works	Estimated Remaining Contribution	BSS837 Retention Category	Photo Reference
3493	NT 54643.18 35054.51	Wild Cherry, <i>Prunus avium</i>	Early Mature	6	260	—	N:2 E:3 S:3 W:2	1(N)	0.5	Radius: 3.1m. Area: 30 sq m.	Good	Fair	Multiple wounds from historic tree surgery to raise clear canopy level	—	—	20+ Years	C2	—
3494	NT 54774.24 35025.39	European Ash <i>Fraxinus excelsior</i>	Overmature	14	1050	—	N:6 E:6 S:7 W:5	4(S)	2	Radius: 12.6m. Area: 499 sq m.	Poor	Poor	2 co-dominant stems from 4.0m via tension union NE co-leader fractured at 7.0m with descending decay column from stump Veteran specimen in poor condition symptomatic of Chalara Ash Dieback	—	—	<10 Years	C2	Image No 01

3495	NT 54786.62 35007.39	European Ash <i>Fraxinus excelsior</i>	Overmature	15	1150	—	N:7 E:6 S:8 W:8	2(W)	1	Radius: 13.8m. Area: 598 sq m.	Poor	Fair to Poor	Veteran specimen symptomatic of Chalara Ash Dieback	—	—	<10 Years	C2	Image No 01
3496	NT 54788.50 34998.22	Common Hawthorn, <i>Crataegus monogyna</i>	Mature	6	390	—	N:4 E:3 S:4 W:3	1.5(E)	1	Radius: 4.7m. Area: 69 sq m.	Fair to Good	Fair	Multiple co-dominant stems from 1.8m via compression union Substantial fracture wound 1.8m with wound-wood developing Linear trunk wound from 0.0m to 1.2m S with wound-wood developing Minor deadwoods Sites of bark necrosis on lower bole Branch extensions roughly lopped in lower crown	—	—	20+ Years	B2	Image No 01
3497	NT 54800.94 34983.14	European Ash <i>Fraxinus excelsior</i>	Overmature	9	930	—	N:3 E:3 S:5 W:1	4(S)	1	Radius: 11.2m. Area: 394 sq m.	Poor	Poor	3 co-dominant stems from 3.0m via compression union W co-leader fractured at bifurcation with extensive decay cavity and descending decay column into bole S co-leader fractured at 6.0m Veteran specimen in poor condition, symptomatic of Chalara Ash Dieback	—	—	<10 Years	C2	Image No 01

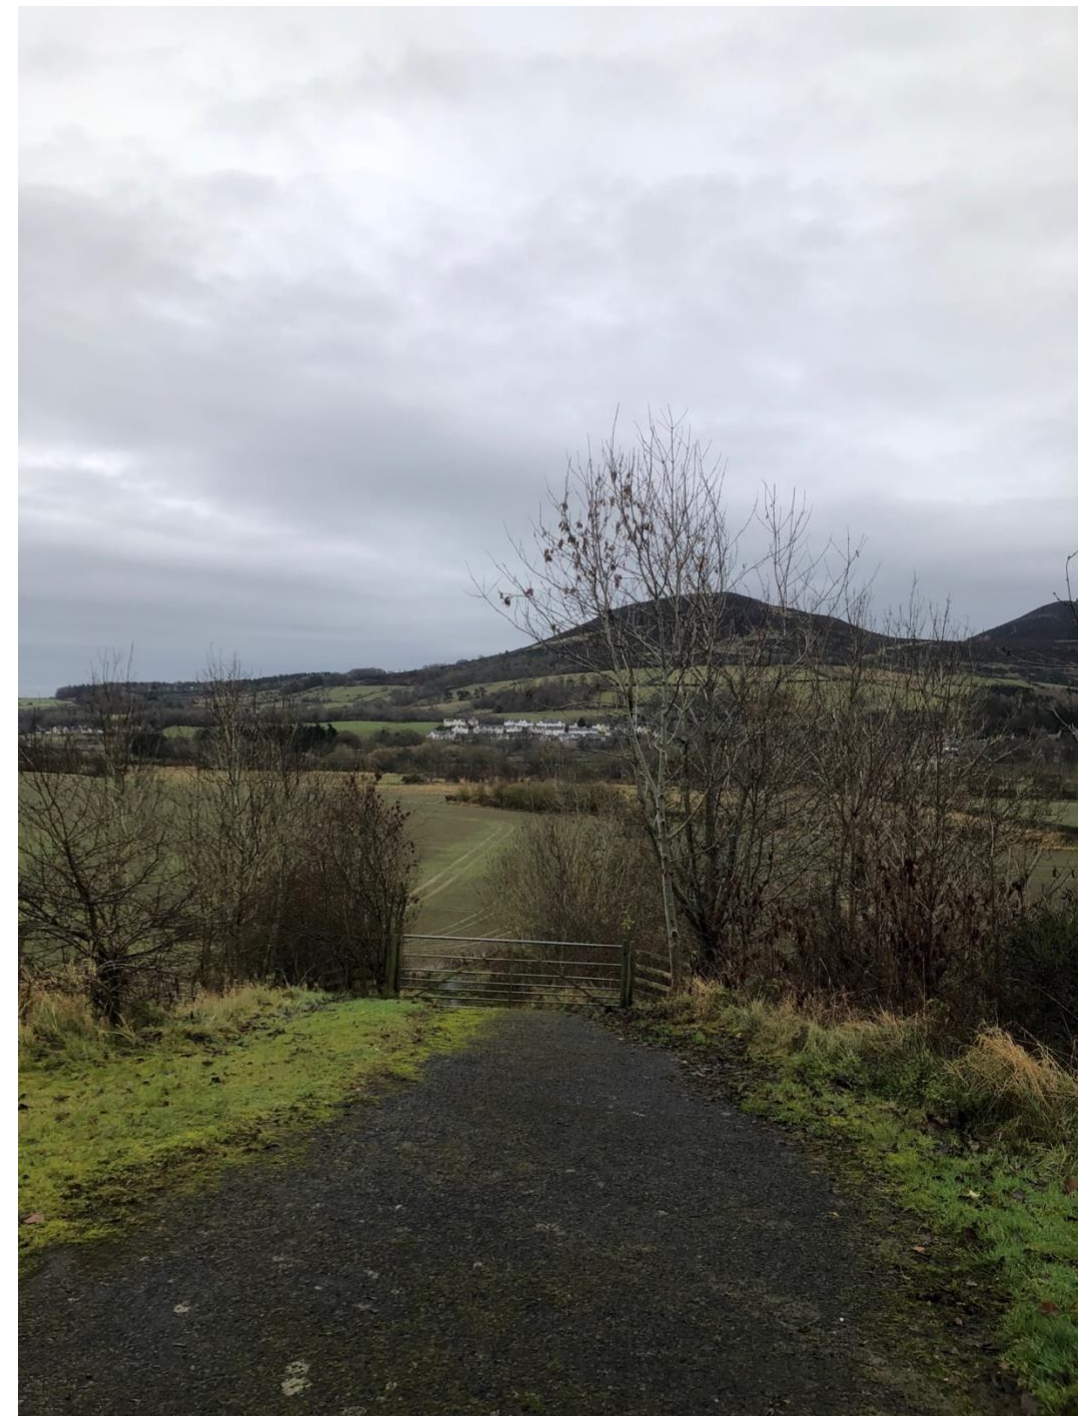
BS_021220 Land at Friarshaugh Farm, Gattonside Image No 02

7.2.3 Tree Group G1

Sporadic self-seeded young broadleaves on the edge of a surfaced access track.

The group features a high proportion of Ash, all of which are symptomatic of Chalara Ash Dieback.

Tree No 3494 is a slightly larger Wild Cherry in early maturity standing at the entrance to the track from the B6360 carriageway. It has been rather severely lopped and is of limited arboricultural value.

Tree group G1 viewed from north (roadside)

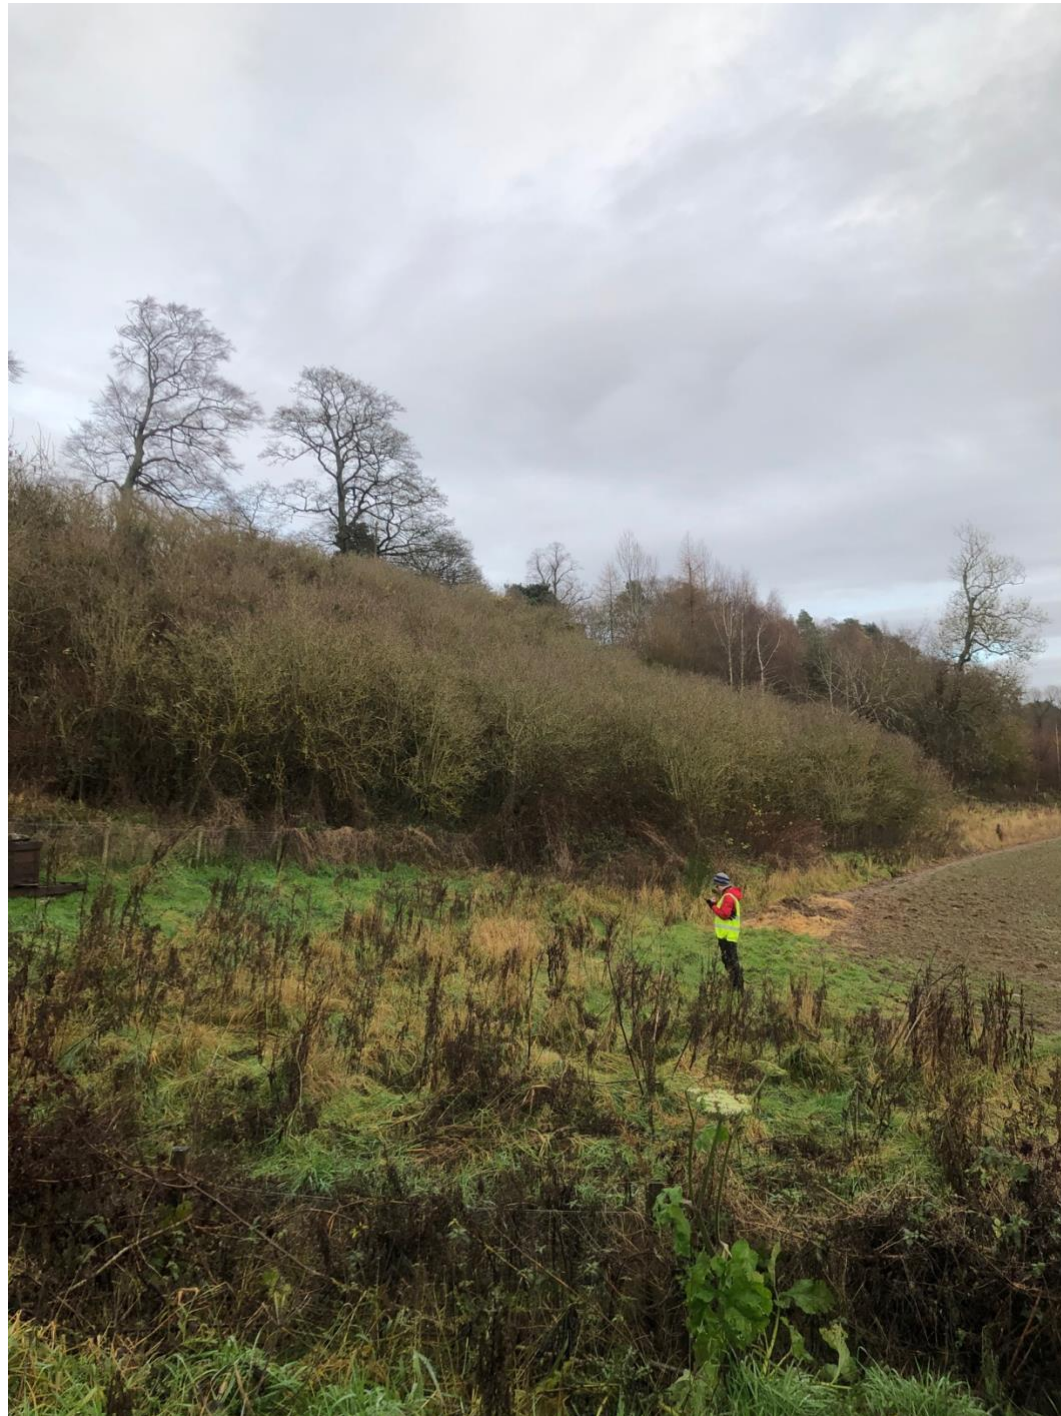
BS_021220 Land at Friarshaugh Farm, Gattonside Image No 03

7.2.4 Shrub Group G2

Well-established shrub scrubland on a south-facing aspect, comprising Gorse and Elder.

The group is in adequate condition with a good ecological/habitat value, but offers limited visual amenity.

Shrub group G2 viewed from west

3498	NT 54802.38 34973.06	Common Hawthorn, <i>Crataegus monogyna</i>	Mature	6.5	—	390, 350	N:3 E:4 S:3 W:3	1.5(NE)	1	Radius: 6.3m. Area: 125 sq m.	Good	Fair	2 co-dominant stems from 0.5m via compression union with adaptive rib Slightly congested crown structure Minor snags, deadwoods and decay cavities	—	—	20+ Years	B2	Image No 01
Tree and Shrub Groups																		
G1	NT 54659.48 35032.88	Common Hawthorn, <i>Crataegus monogyna</i> European Ash, <i>Fraxinus excelsior</i>	Semi Mature	<8	<200	—	N:0 E:0 S:0 W:0	0(N)	0	Area: 280.98 sq m.	Fair	Fair	Young broadleaf specimens on margins of access track All Ash specimens symptomatic if Chalara Ash Dieback	—	—	10+ Years	C2	Image No 02
G2	NT 54703.06 35043.65	Gorse, <i>Ulex europaeus</i> Elder, <i>Sambucus nigra</i>	Mature	<5	<180	—	N:0 E:0 S:0 W:0	0(N)	0	Area: 2653.78 sq m.	Fair to Good	Fair	Naturally generated scrub area on S facing slope, locally dense	—	—	20+ Years	C2	Image No 03

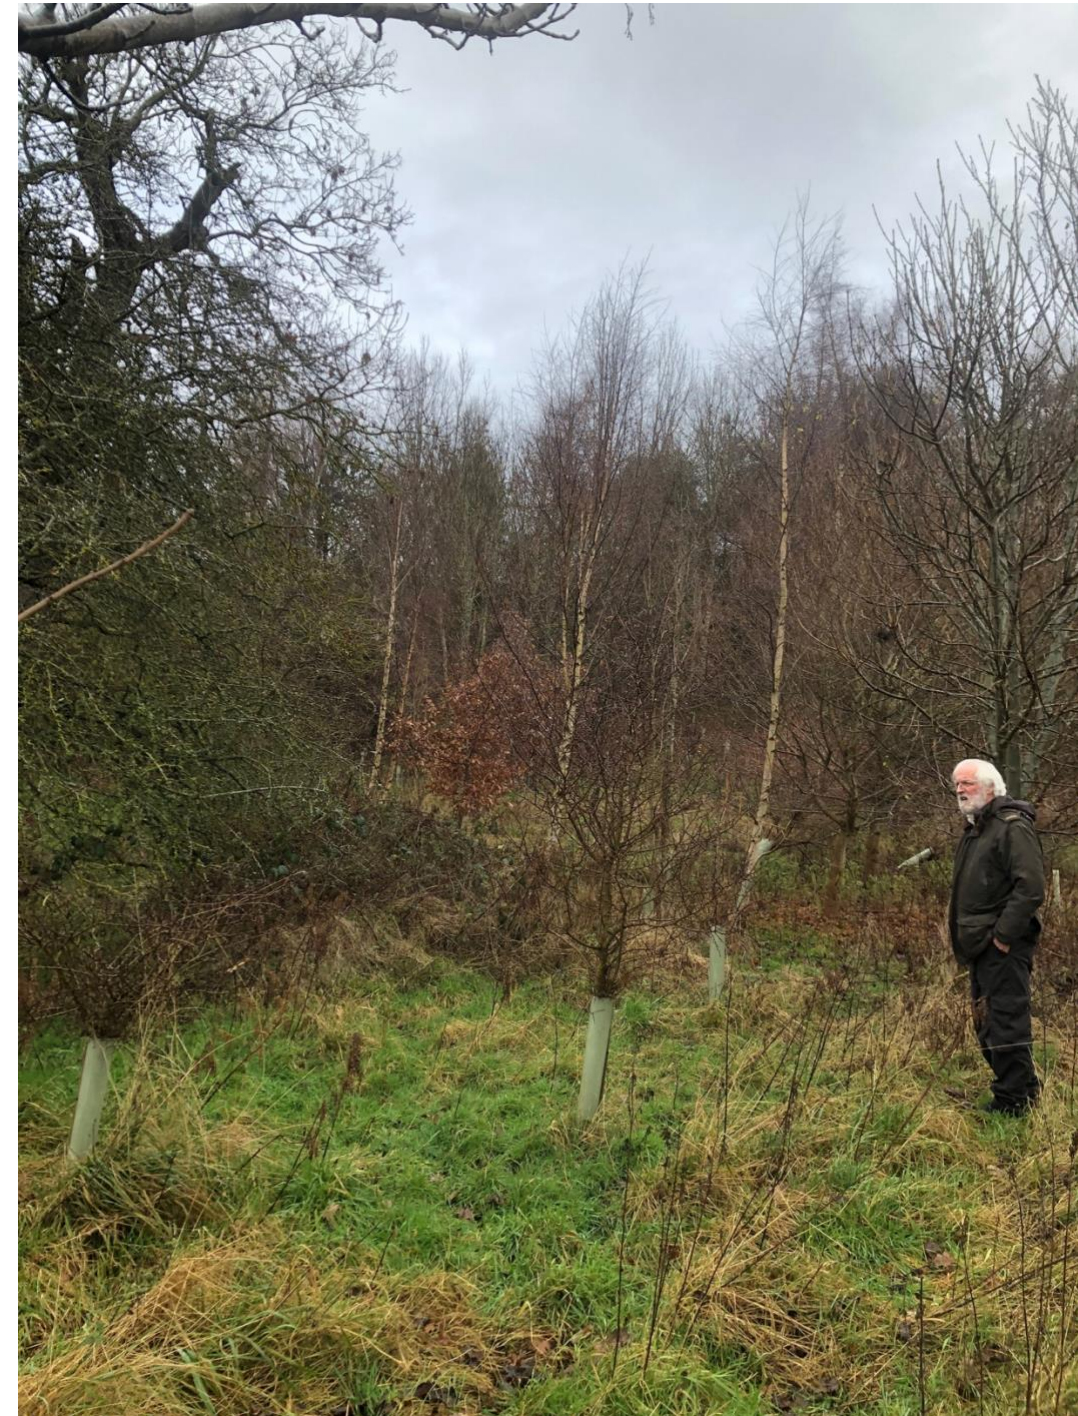
BS_021220 Land at Friarshaugh Farm, Gattonside Image No 04

7.2.5 Tree Group G3

A young plantation featuring a diverse range of (mainly) Scottish native species.

Most specimens are reasonably well-established although there are occasional instances of anchorage failure and some poorly-structured crowns.

All Ash specimens within the group are symptomatic of Chalara Ash Dieback.

The group offers good development potential in terms of visual amenity and ecological value, but would benefit from a more active management regime.

Tree group G3 (interior)

Tree Reference Number	Grid Reference	Species, Taxa	Age Class	Height (m)	Stem Diameter (mm)	Constituent Stem Diameter of Multistem sps (mm)	Crown Spread (m)	Height (m) & direction of Lowest Branch	Crown Clearance (m)	Root Protection Area	Physiological Condition	Structural Condition	Condition Notes	Preliminary Management Recommendations	Timeframe for Recommended Works	Estimated Remaining Contribution	BS5837 Retention Category	Photo Reference
G3	NT 54792.04 35004.74	Blackthorn, <i>Prunus spinosa</i> Hazel, <i>Corylus avellana</i> Common Hawthorn, <i>Crataegus monogyna</i> Guelder Rose, <i>Viburnum opulus</i> Downy Birch, <i>Betula pubescens</i> Field Maple, <i>Acer campestre</i> European Ash, <i>Fraxinus excelsior</i> Whitebeam, <i>Sorbus aria</i> Rowan, <i>Sorbus aucuparia</i> Silver Birch, <i>Betula pendula</i> English Oak, <i>Quercus robur</i> Sycamore, <i>Acer pseudoplatanus</i>	Semi Mature	<9	<180	—	N:0 E:0 S:0 W:0	0(N)	0	Area: 906.64 sq m.	Good	Fair	Young plantation of predominantly native broadleaf species lacking active arboricultural management Most specimens reasonably well-established with occasional instances of anchorage instability All Ash specimens symptomatic of Chalara Ash Dieback	—	—	20+ Years	B2	Image No 04

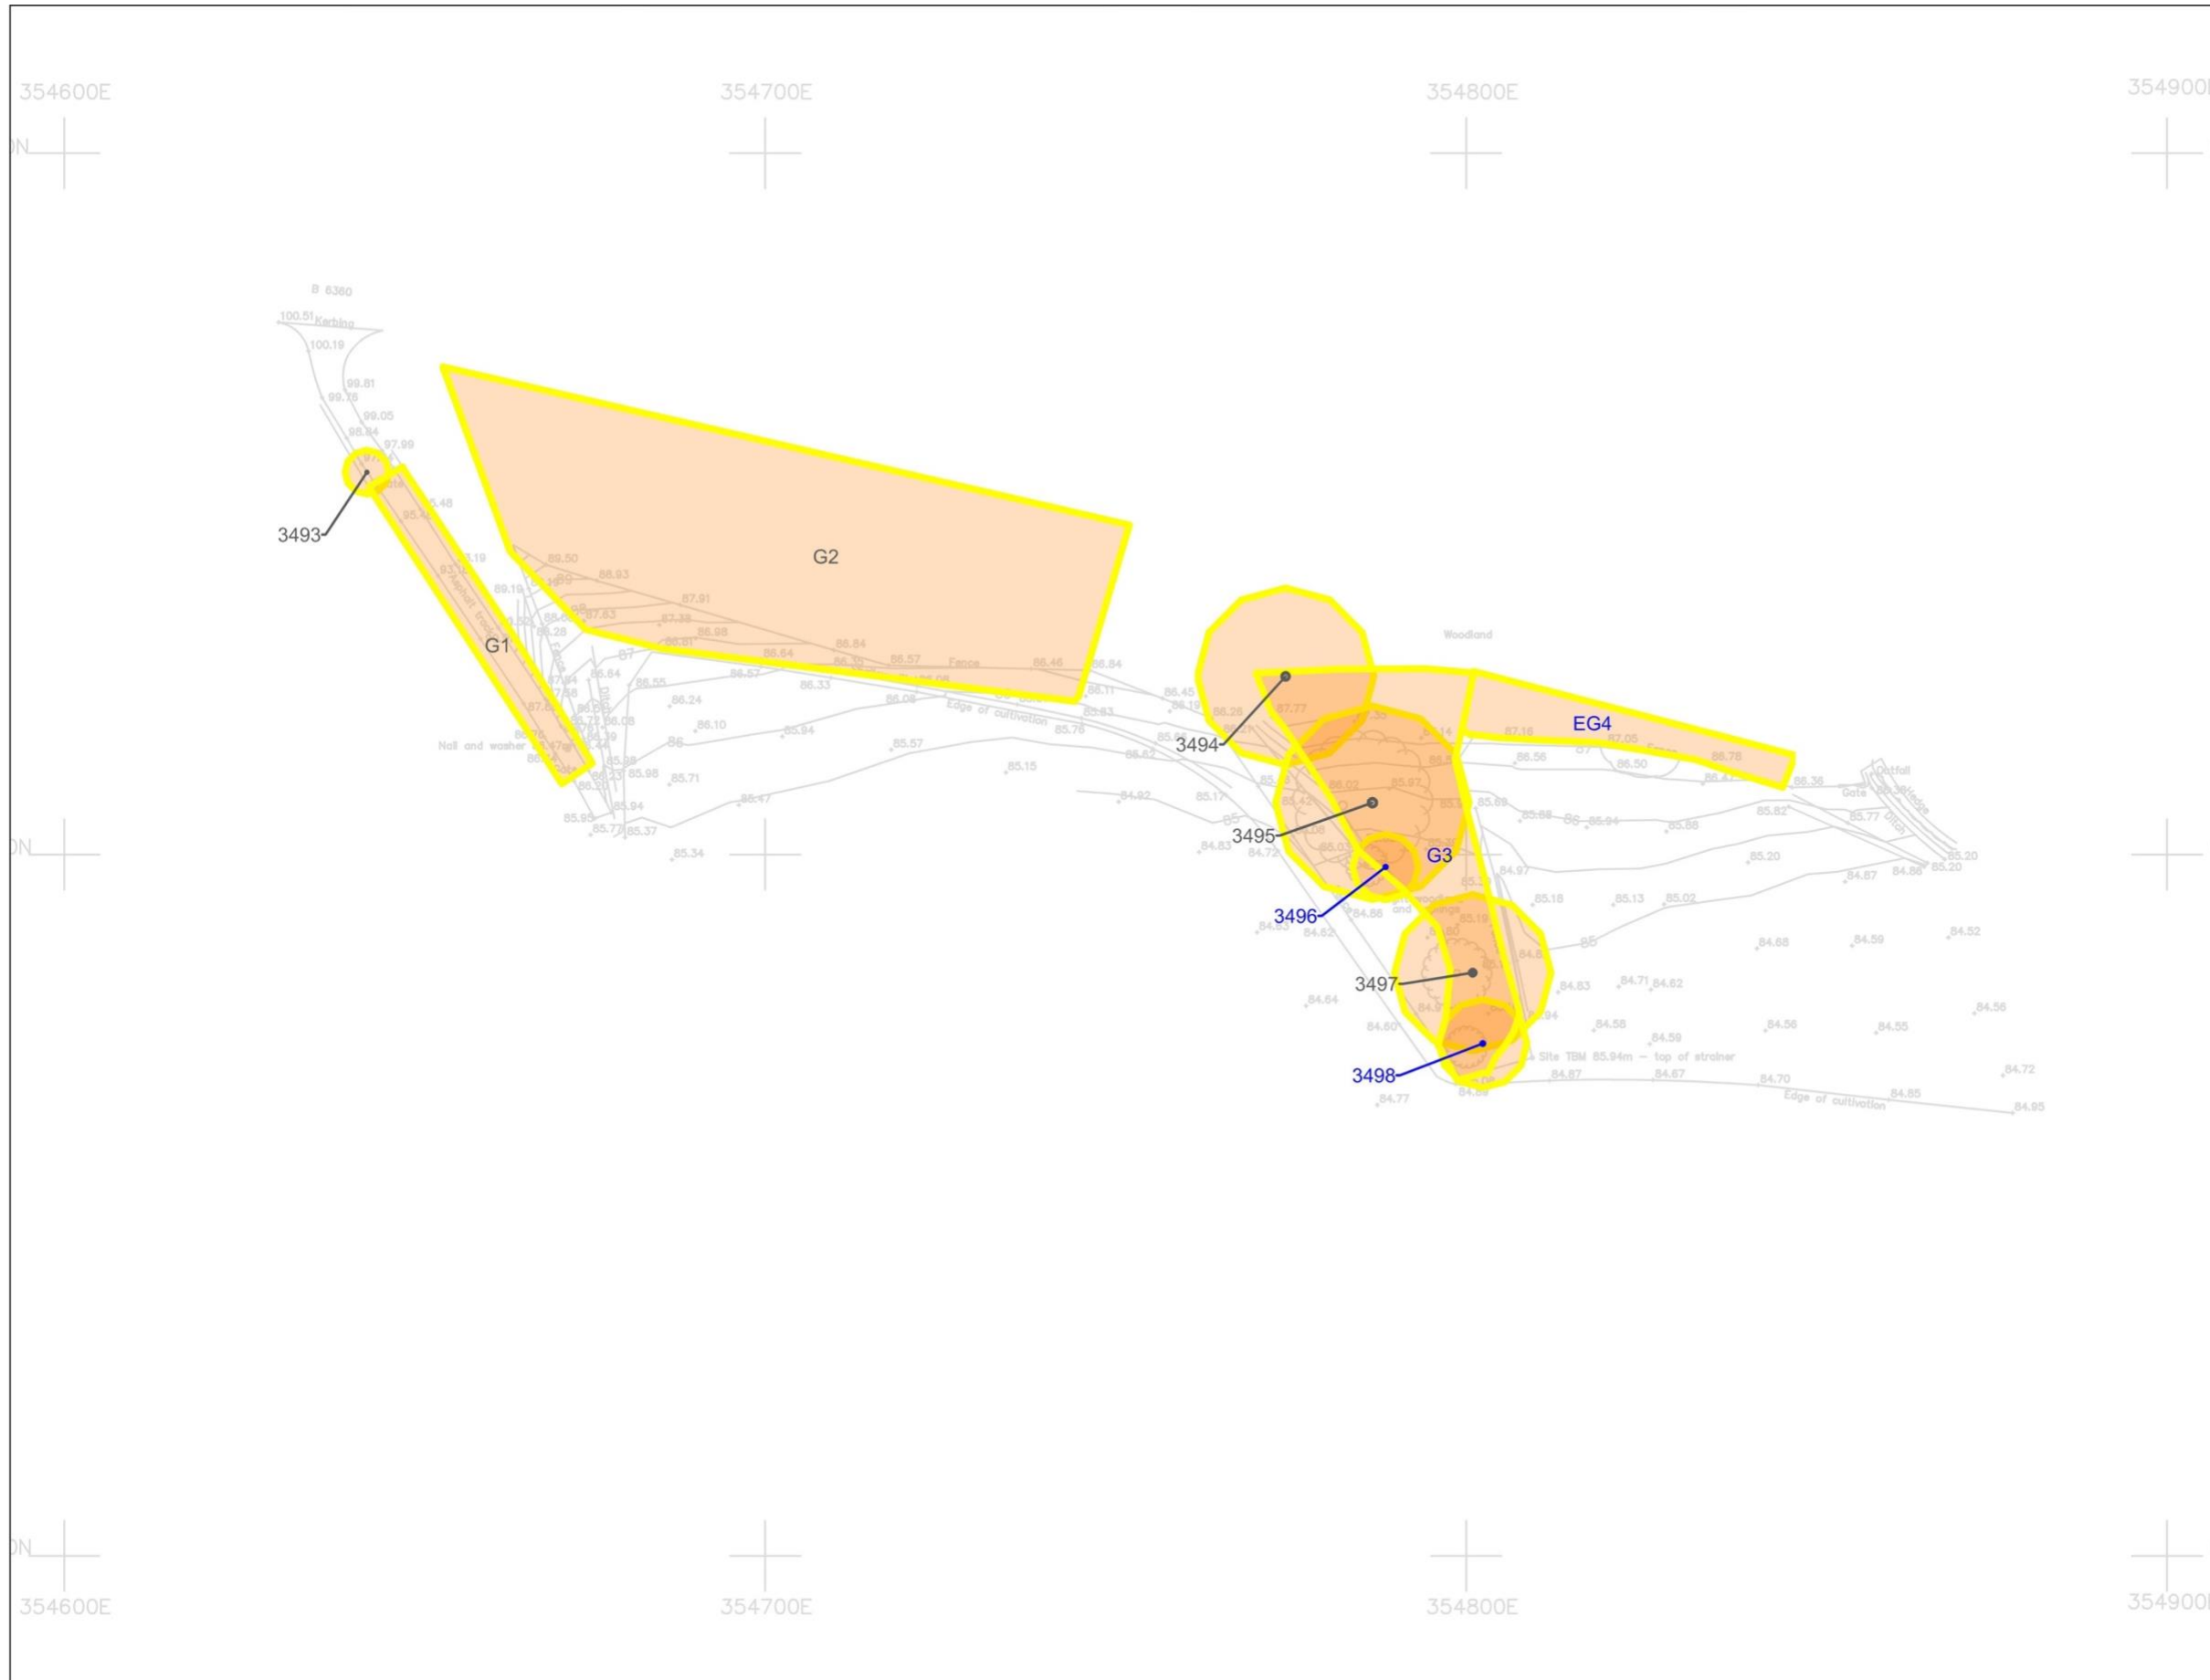
A2.2 Tree Constraints Plan -Below Ground -

The Below Ground Constraints Plan (Figures 2.3 & 2.4) plot the Root Protection Area (RPA) around all trees within the survey area. This illustrates the potential constraints to the proposed development presented by trees and their rooting systems.

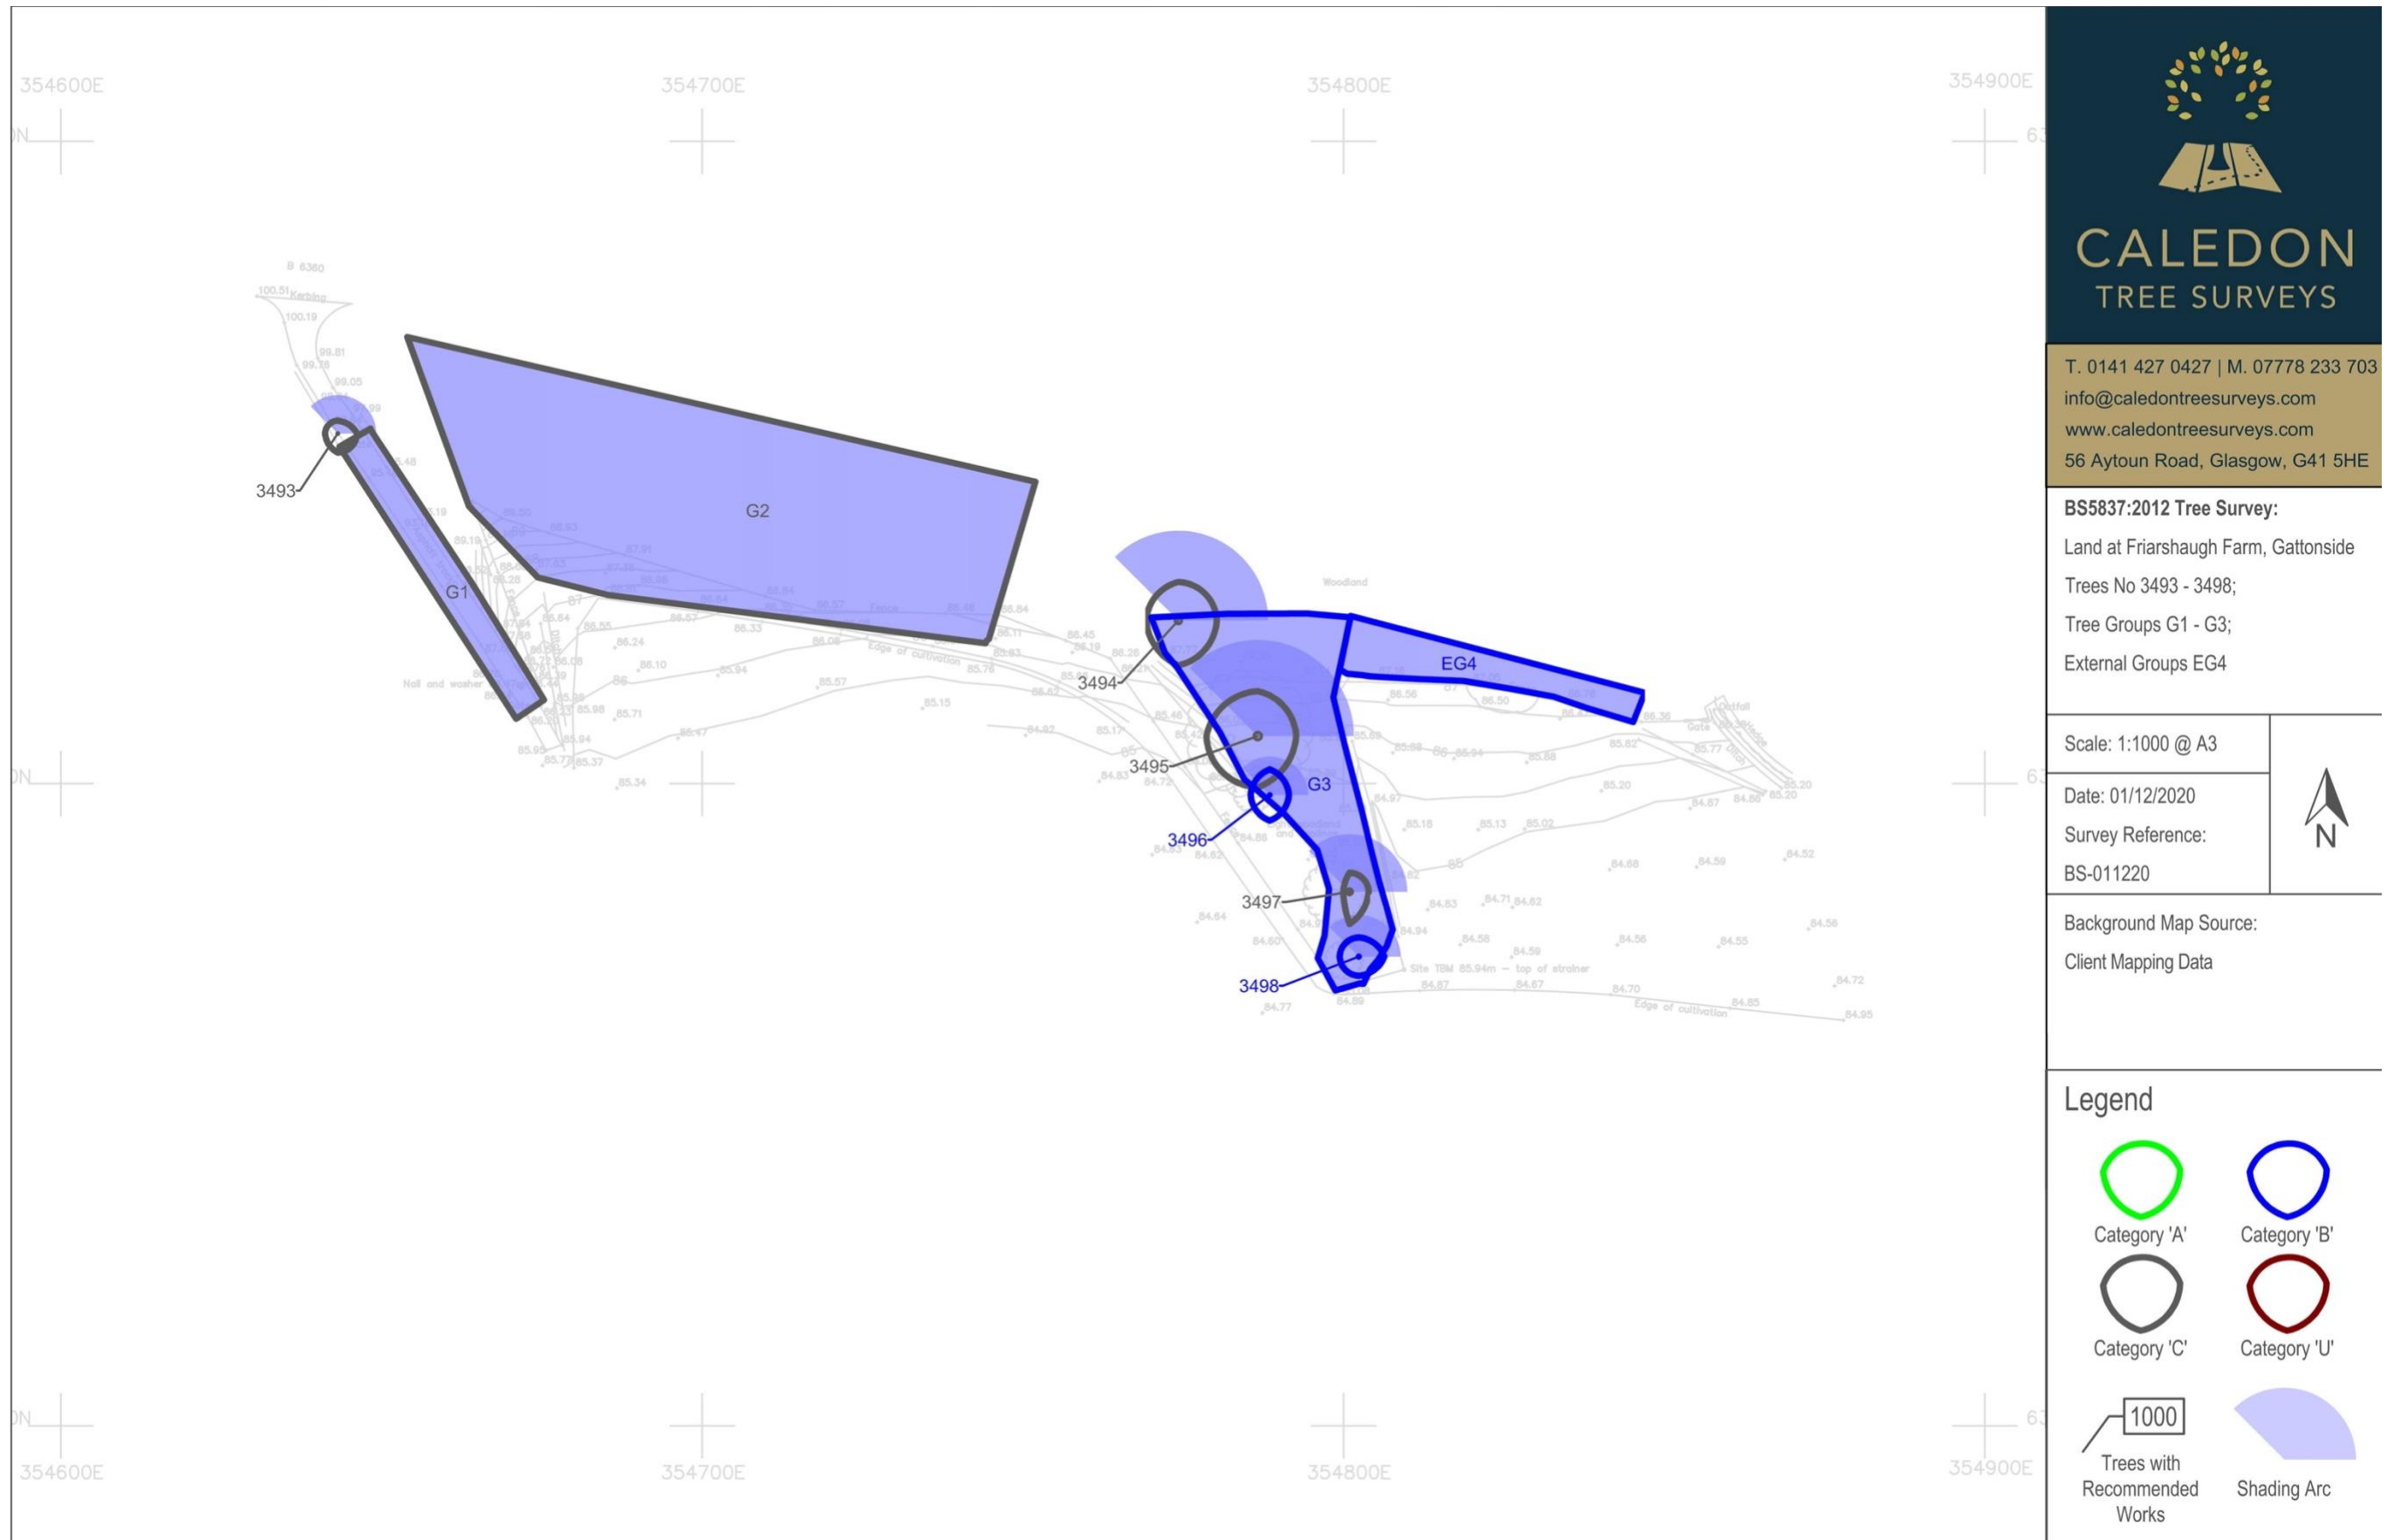
A2.3 Tree Constraints Plan -Above Ground

The appended Above Ground Constraints Plan (Figures 2.5 & 2.6) indicates that the shading profile of all trees within the survey area and should inform design detail.
