# Annex Five

## Strategic Review of Sports, Leisure, Culture & Community: Building Audits

**Alan Jones Associates**

September 2023

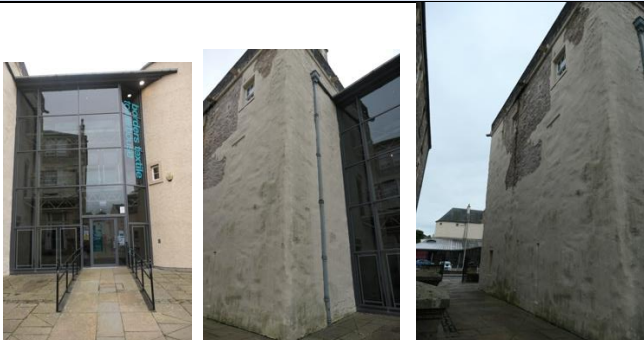
<b>Visual Audit 4 August 2023</b>		<b>Location:</b>	1 Tower Knowe, Hawick		
<b>Border's Textile Towerhouse</b>		<b>Facility Age:</b>	1700		
		<b>Ownership</b>	Scottish Borders Council		
		<b>Size:</b>	532m <sup>2</sup>		
		<b>Accessibility</b>		<b>Key Notes</b>	
<b>Car Parking &amp; Public Transport</b>		Very limited access particularly for wheelchair users		The building was generally in a good condition for its age. Normal age-related deterioration, maintenance issues	
No parking available					
<b>AUDIT TABLE</b> <b>Ratings</b> - A - Good condition / fit for purpose. B - Required moderate to significant investment C - question whether fit for purpose					
<b>Facility Aspect</b>	<b>Current Condition</b>	<b>Operational Rating</b>	<b>Photographic Evidence</b>		
Exterior fabric	Evidence of lime plasterwork failure on the facade	<b>B</b>

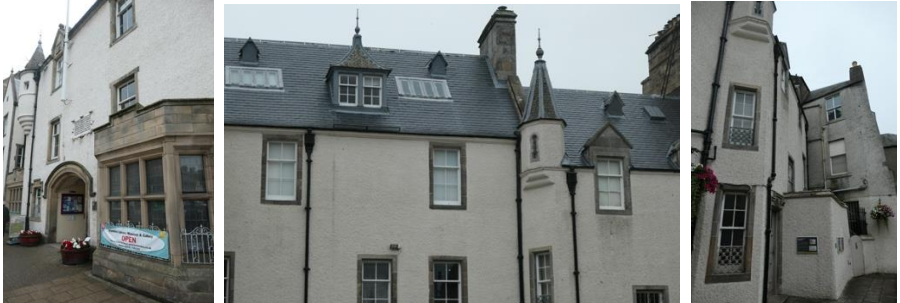
<b>Visual Audit 27 July 2023</b>		<b>Location:</b>	High Street, Peebles	
<b>Chambers Institute Museum &amp; Library</b>		<b>Facility Age:</b>	1859	
		<b>Ownership</b>	Scottish Borders Council	
		<b>Size:</b>	705m <sup>2</sup>	
		<b>Accessibility</b>		<b>Key Notes</b>
<b>Car Parking &amp; Public Transport</b>		Disabled access to the library only through a lift accessed via an adjacent property.		The building was generally in a good condition for its age but evidence of water penetration.
On-street parking				
<b>DETAILED AUDIT TABLE</b> <b>Ratings - A - Good condition / fit for purpose.</b> B - Required moderate to significant investment C - question whether fit for purpose				
Facility Aspect	Current Condition	Operational Rating	Photographic Evidence	
Exterior fabric	Generally in good for its age condition with ongoing maintenance required	<b>B</b>

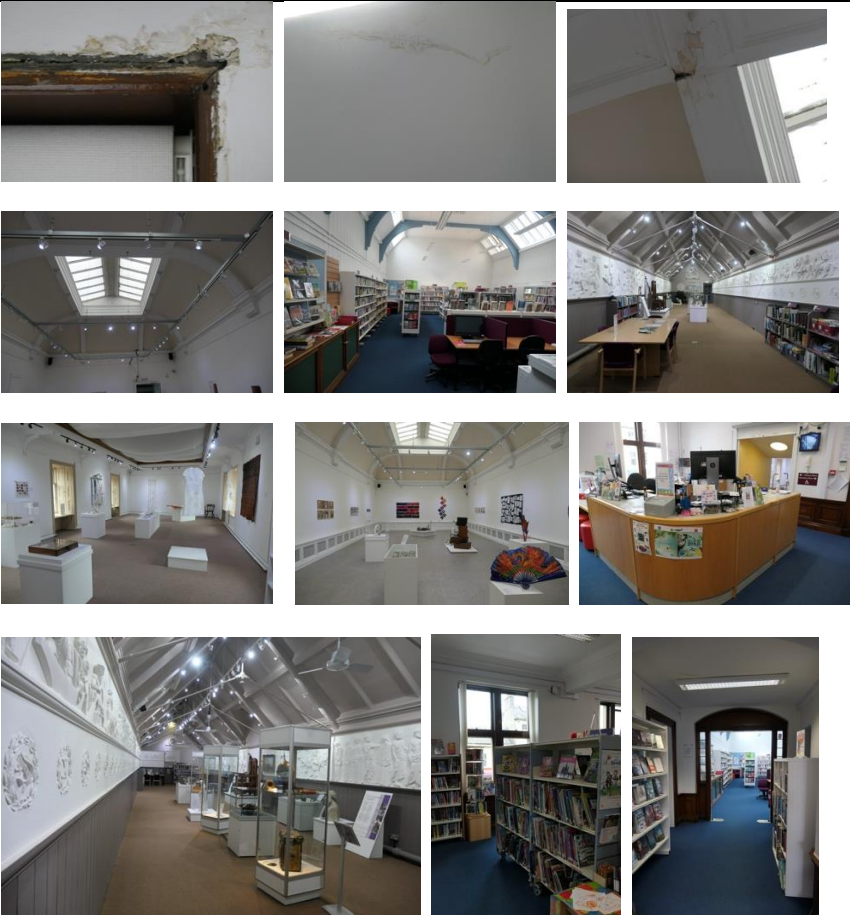
<p>Gallery/ display areas</p>	<p>Evidence of water ingress and maintenance required and inadequate lighting in the gallery areas. General décor was in good condition</p>	<p>C</p>

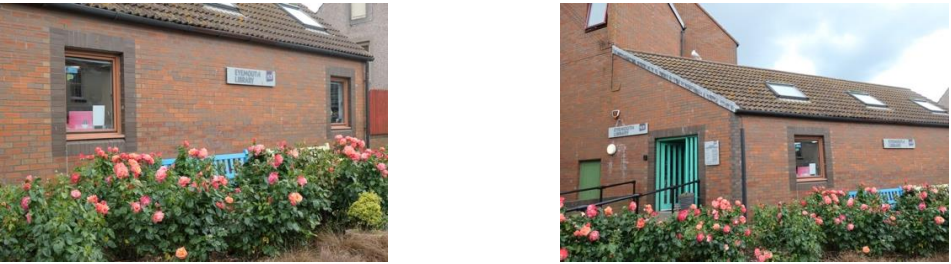
Facility Aspect	Current Condition	Operational Rating	Photographic Evidence
External	No defects noted	<b>B</b>

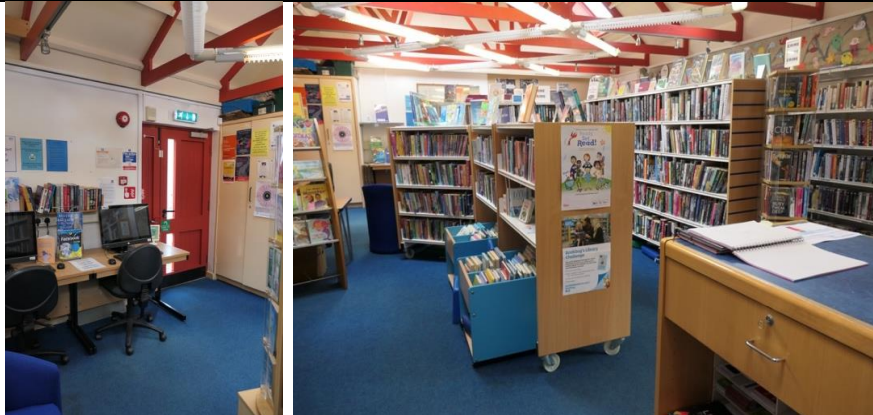
Internal	Overall, a very small space with racking that is difficult to move for any potential events or groups. The reception desk does not allow for anyone to sit at the desk for any length of time and the storage space is almost non-existent. The hot water in the toilet is from a small boiler which must be set to "scalding" for Legionella which makes it almost impossible to use in the small sink.	<b>C</b>

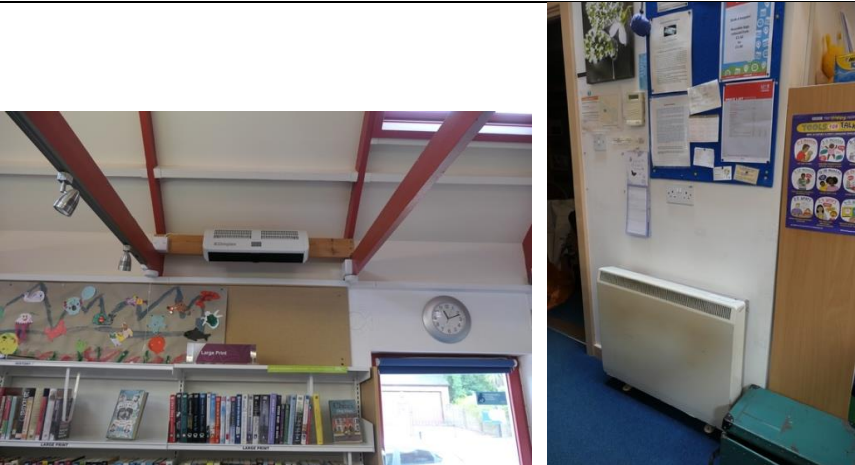
<p>Heating</p>	<p>Very inadequate. Storage heating and 2 electric wall-mounted fans</p>	<p>C</p>

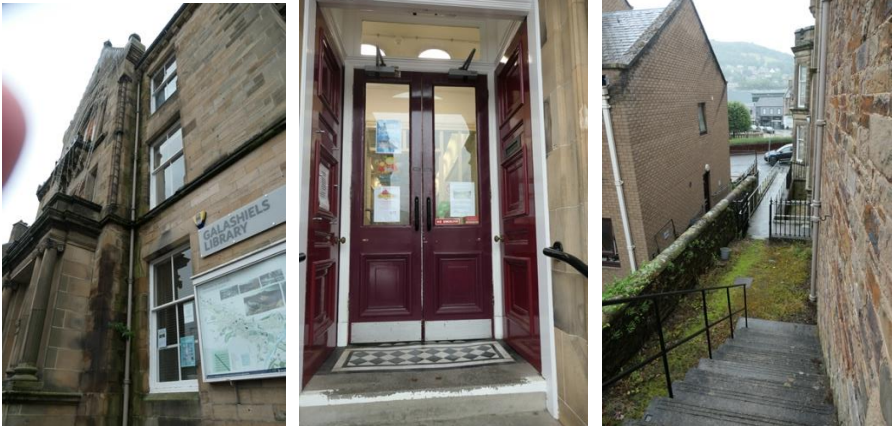
Facility Aspect	Current Condition	Operational Rating	Photographic Evidence
Exterior fabric	Requiring ongoing maintenance and evidence of water and vegetation on the façade and at the side emergency exit	B

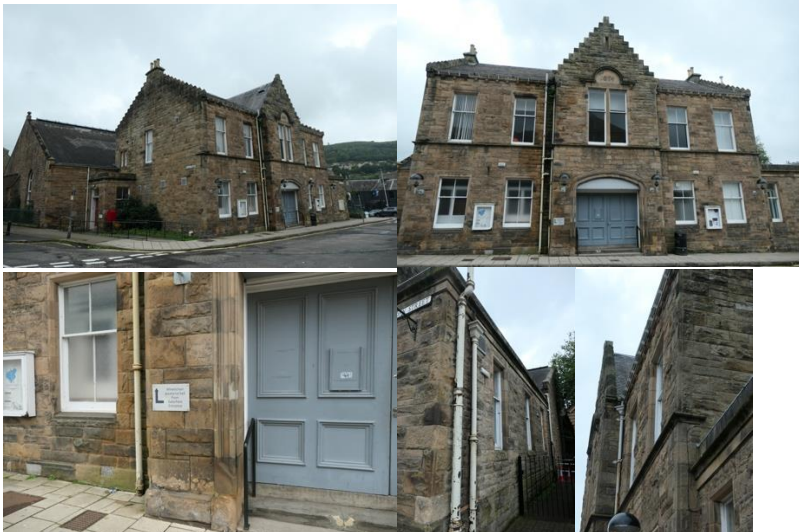
Facility Aspect	Current Condition	Operational Rating	Photographic Evidence
Exterior fabric	Generally, in good condition with regular maintenance required around guttering, windows stonework, and the whole external fabric	B

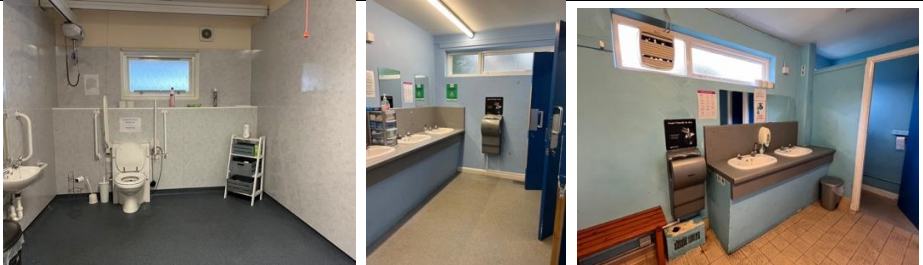
Toilets	Toilets are generally in good condition but require redecoration	B

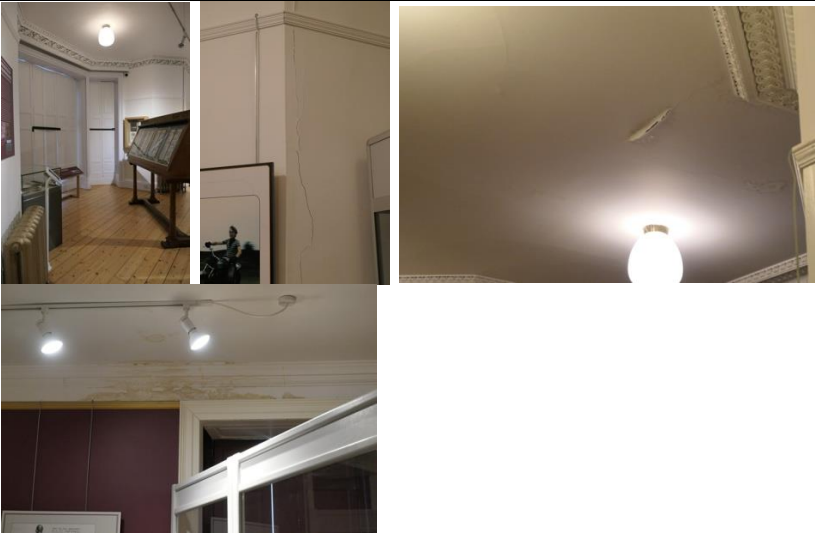
<p>Museum Rooms</p>	<p>Good condition but evidence of water ingress and staining in various locations. Poor lighting and requires to be upgraded. Some lighting cannot be replaced and will mean that eventually, certain exhibits will no longer be accessible. Cracking to plasterwork appearing to be caused by water ingress</p>	<p><b>B</b></p>

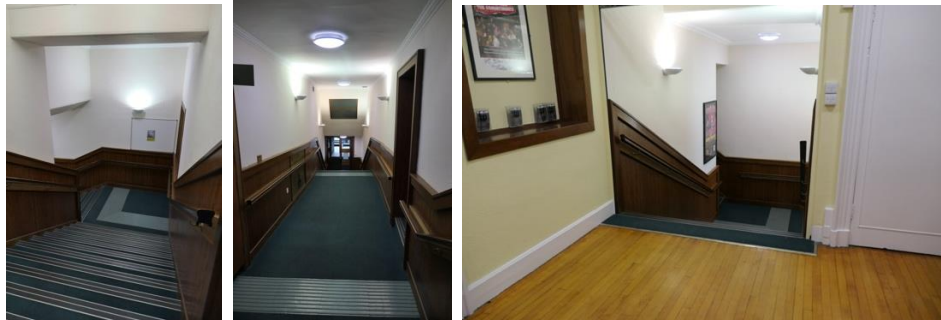
Entrance	Good condition and series of stairs	<b>A</b>

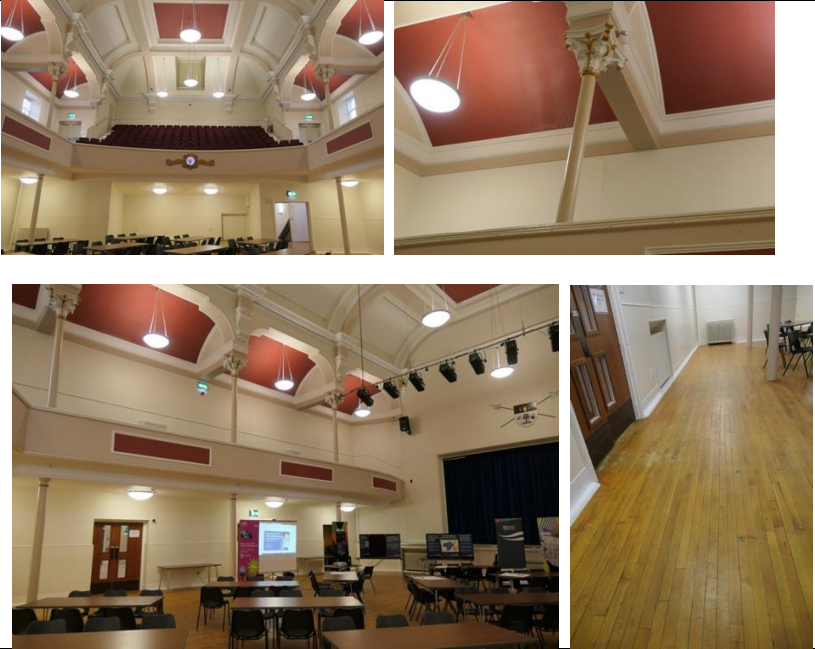
<p>Auditorium</p>	<p>Good condition with areas of the floor needing sanded and resealed</p>	<p>B</p>

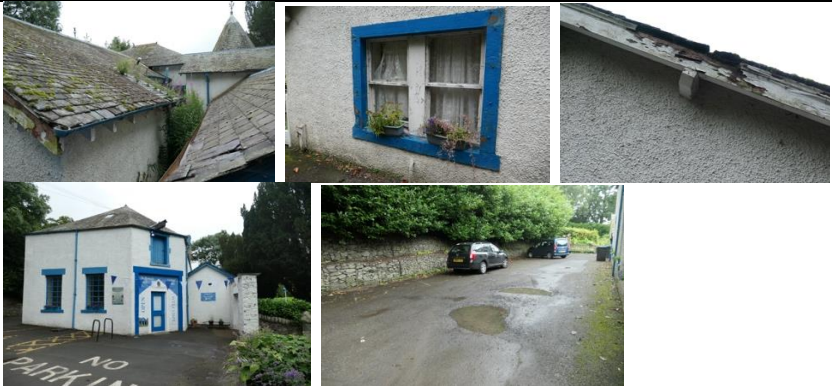
Facility Aspect	Current Condition	Operational Rating	Photographic Evidence
Exterior fabric	Generally in poor condition with evidence of a lack of maintenance. Car park requires maintenance as large potholes fill with water.	C

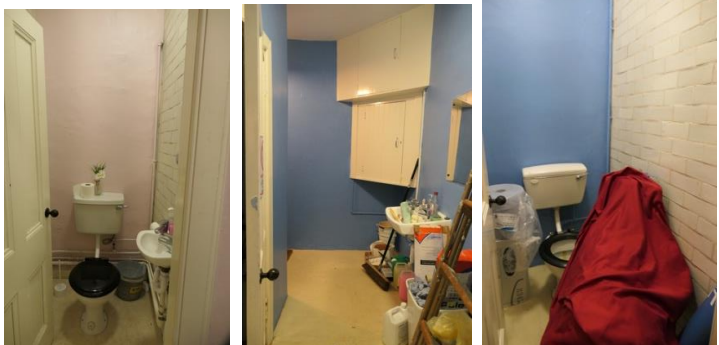
Toilets	No disabled access to toilets as there is steps up to the corridor where they are situated. Two of the three toilets are being used for storage.	C

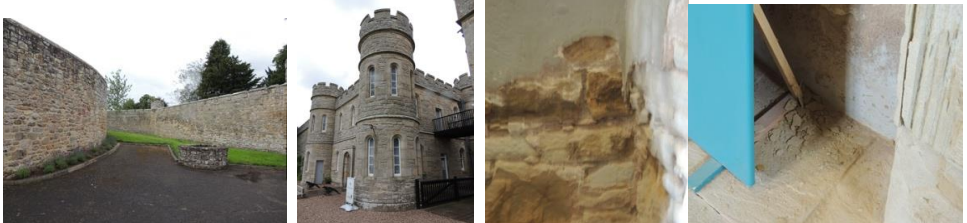
Facility Aspect	Current Condition	Operational Rating	Photographic Evidence	
Exterior fabric	Generally in good for its age condition with ongoing maintenance require, particularly to the stonework and pointing	<b>B</b>

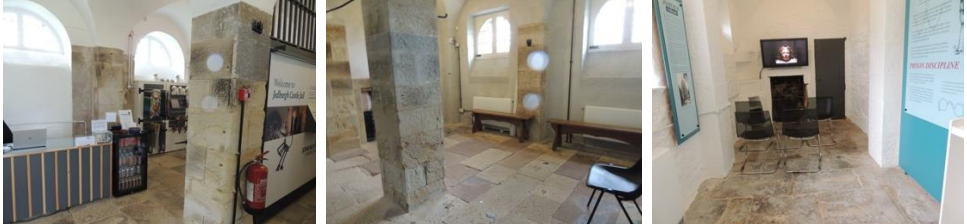
Reception	In good condition for age and use as a reception for the museum. Very inadequate heating with very low temperatures at the end of the season	<b>B</b>

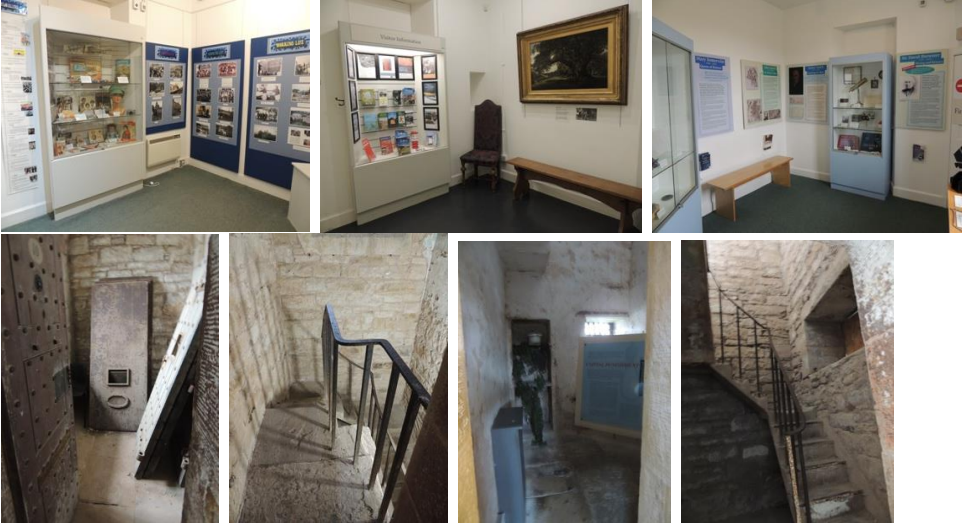
<p>Gallery/ display areas</p>	<p>Generally in good condition but with very inadequate heating and lighting. Evidence of internal stonework maintenance required</p>	<p><b>B</b></p>

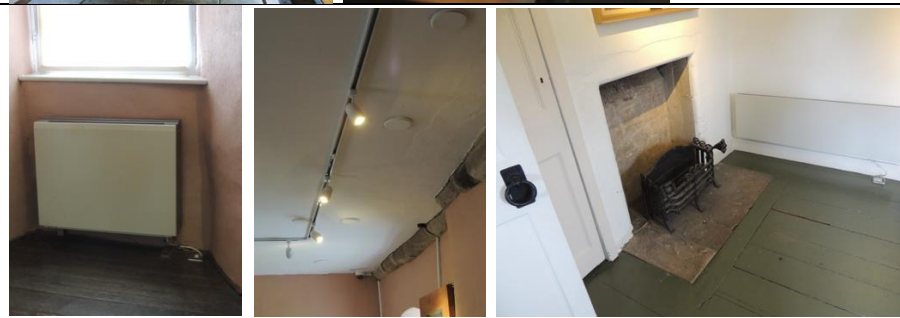
Gallery/ display areas	Generally in good condition but with very inadequate heating and lighting. Evidence of internal stonework maintenance required	<b>B</b>

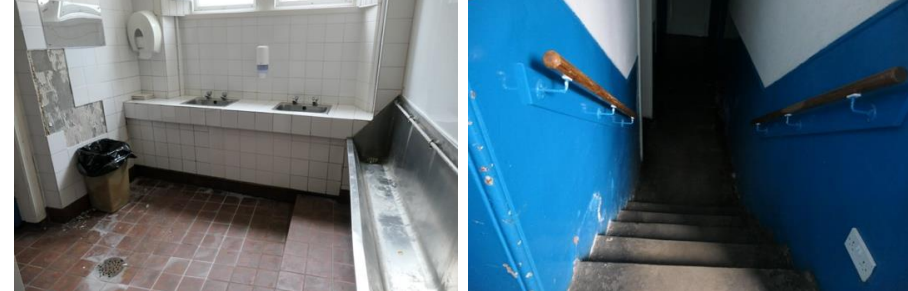
Toilets	Very Poor condition and access	C

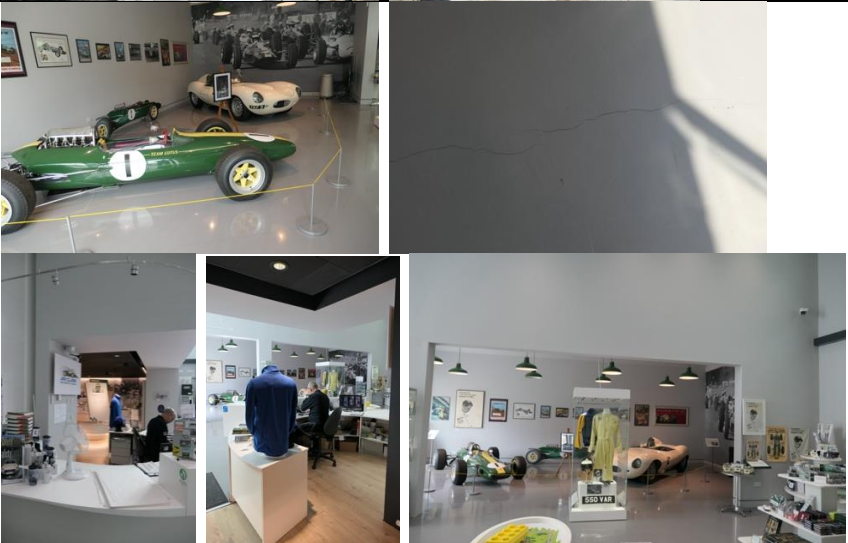
Internal spaces	Very good but evidence of settlement cracking in floor of the extension	A

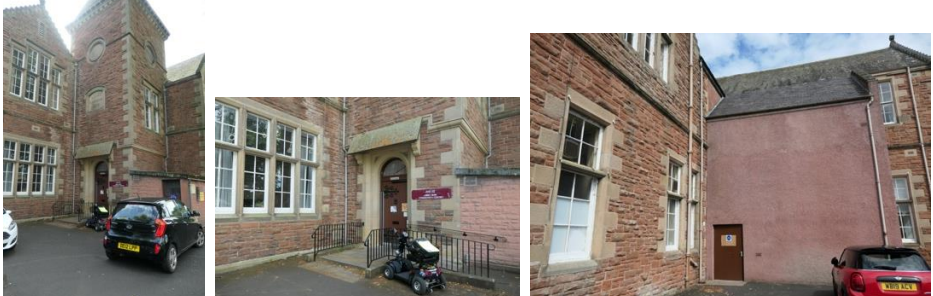
<b>Visual Audit 18 July 2023</b>		<b>Location:</b>	The Knowes Kelso	
<b>Abbey Row Community Centre</b>		<b>Facility Age:</b>	1873	
		<b>Ownership</b>	Scottish Borders Council	
		<b>Size:</b>	601m <sup>2</sup>	
		<b>Accessibility</b>		<b>Key Notes</b>
<b>Car Parking &amp; Public Transport</b>		There is a ramp for disabled access and automatic door opening.		The building is generally in a good condition for its age. Normal age-related deterioration, maintenance issues and poor energy efficiency. The heating was difficult to control with a central thermostat for the whole building situated in reception
There is parking within the curtilage of the property.				
<b>AUDIT TABLE</b> <b>Ratings</b> - A - Good condition / fit for purpose. B - Required moderate to significant investment C - question whether fit for purpose				
Facility Aspect	Current Condition	Operational Rating	Photographic Evidence	
Exterior fabric	Generally, in good condition with regular maintenance required around guttering, windows stonework, and the whole external fabric	<b>B</b>

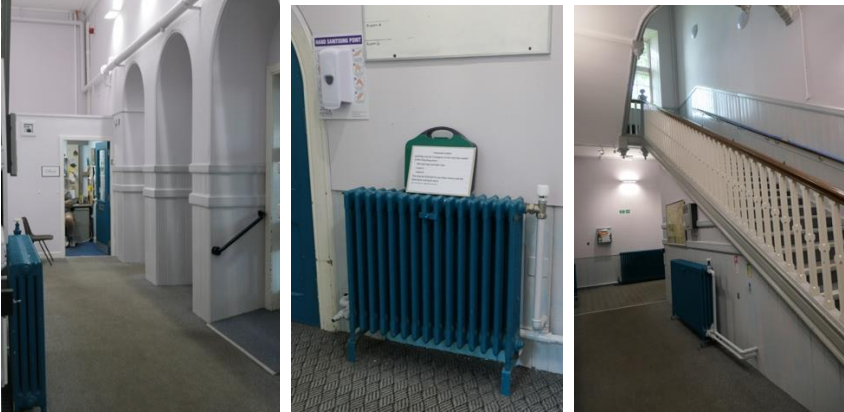
<p>Entrance hall</p>	<p>Generally in good condition for a converted building with multi use purpose. A lift was available for disabled access to the upper floor. At time of visit, there was a painting programme in place for the hallway. Heating is by old and inefficient radiators</p>	<p><b>B</b></p>

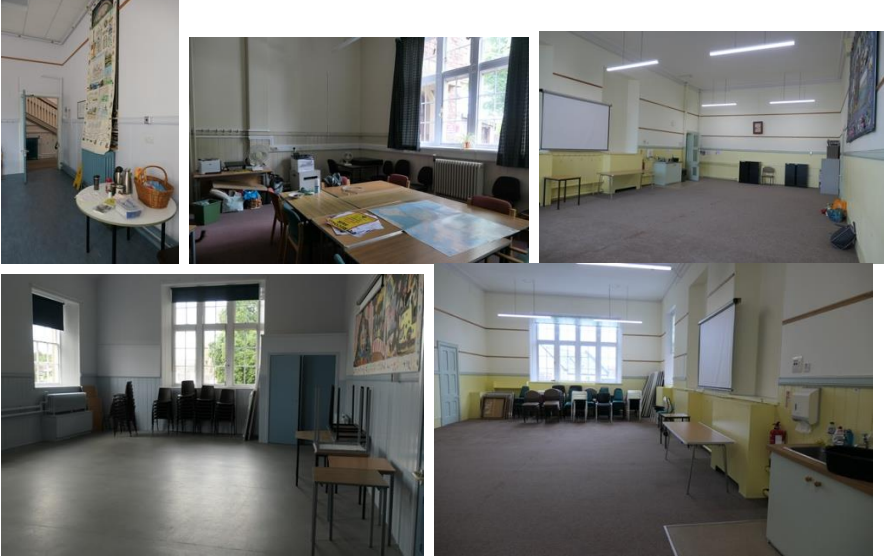
<p>Rooms</p>	<p>Generally in good condition but require regular maintenance and an updated heating system. Not flexible in terms of layout or size.</p>	<p><b>B</b></p>

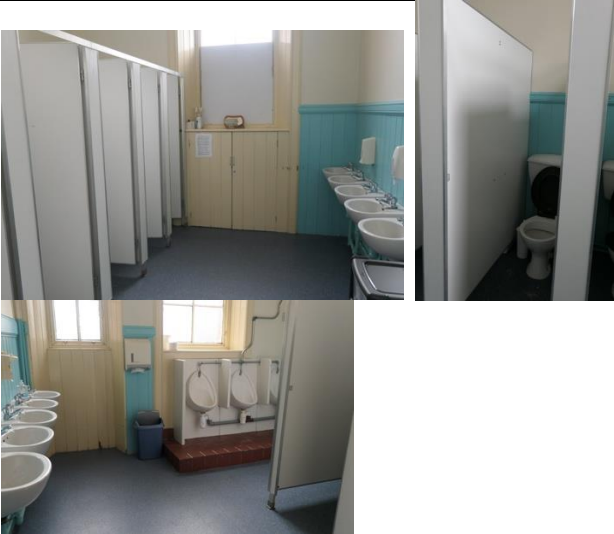
Toilets	Require upgrading to modern standards	C

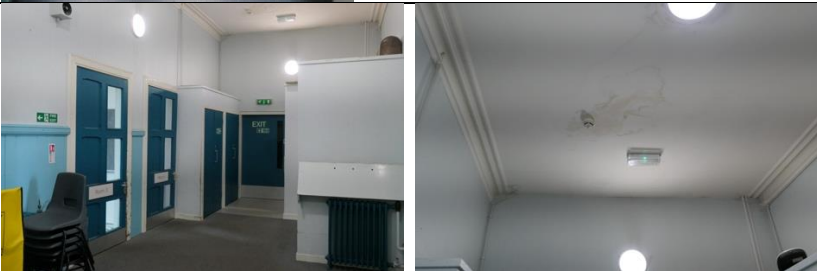
Upper hallway	In good condition for the age and type of building but showing signs of water ingress	B

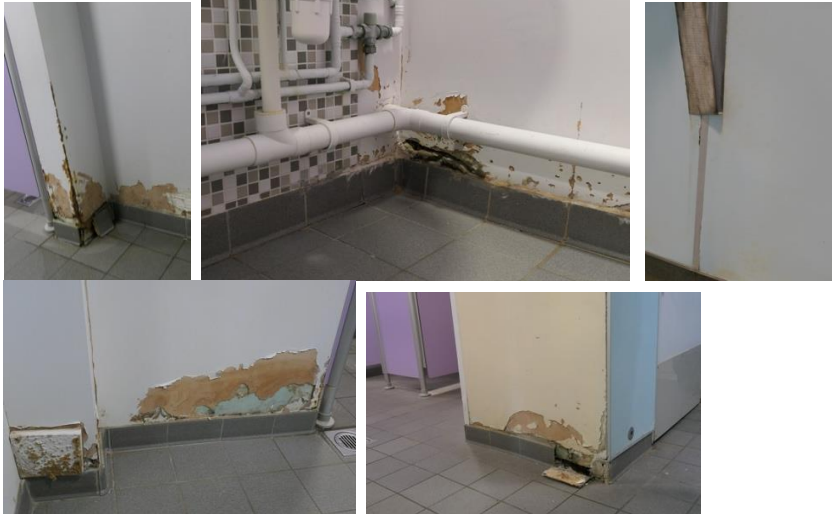
Changing area	These areas are in poor condition with an obvious lack of maintenance. A significant number of lockers were unusable as keys were broken, flaking paint work was in evidence in most cubicles, tiles missing or not fixed to the wall, a cubicle not in use to a more significant problem with a leak from the roof/waste. Wet wall taped with "gaffer" tape which was no longer adhesive to the board	<b>C</b>

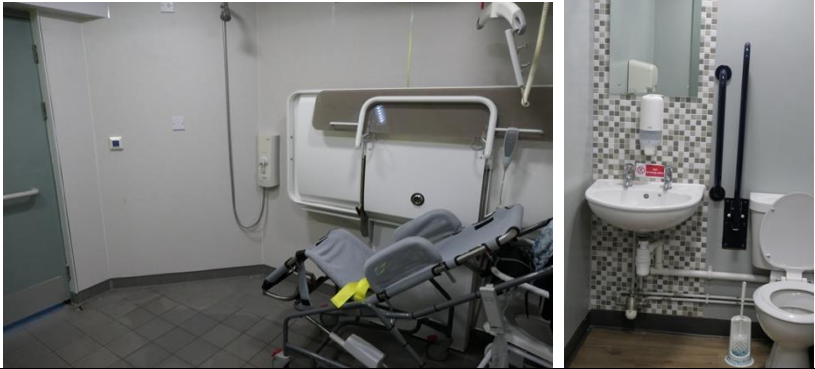
<p>Disabled toilet/changing.</p>	<p>The staff pointed out that the electric shower switch was in a location which may be hazardous</p>	<p>C</p>

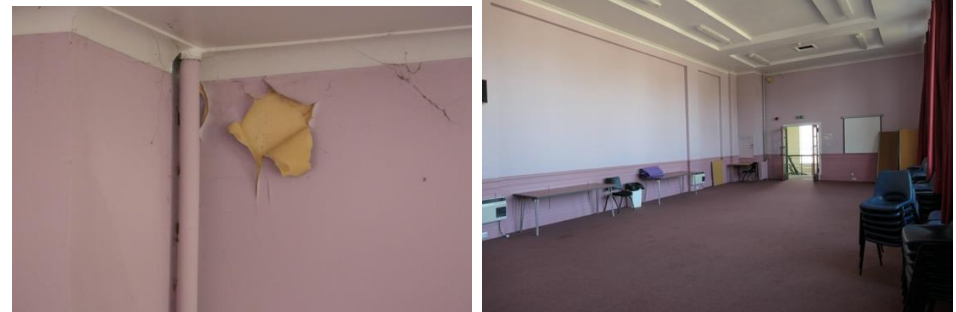
Upper floor rooms	In good condition for the age and type of building but showing signs of water ingress	B

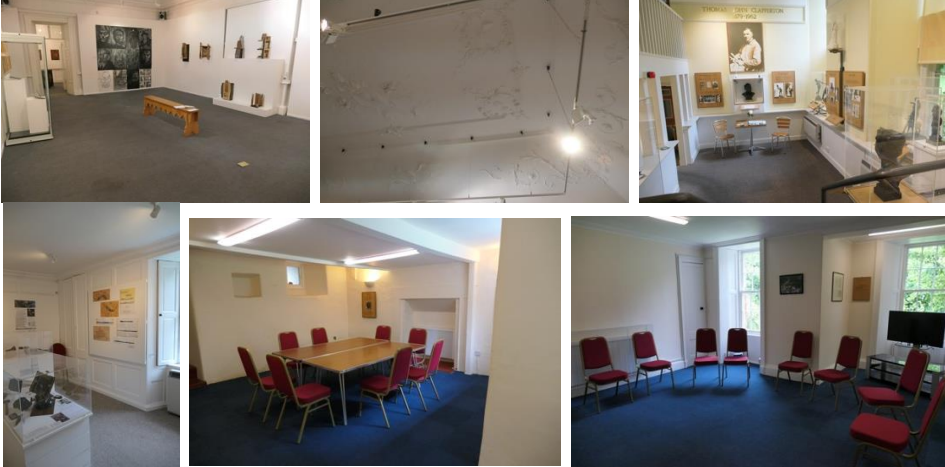
Rooms	Generally in good condition but require regular maintenance and an updated heating system. Not flexible in terms of layout or size and the lighting requires upgrading to contemporary museum standards. Previous water ingress on the front-facing wall and appears to be due to pointing defects.	<b>B</b>

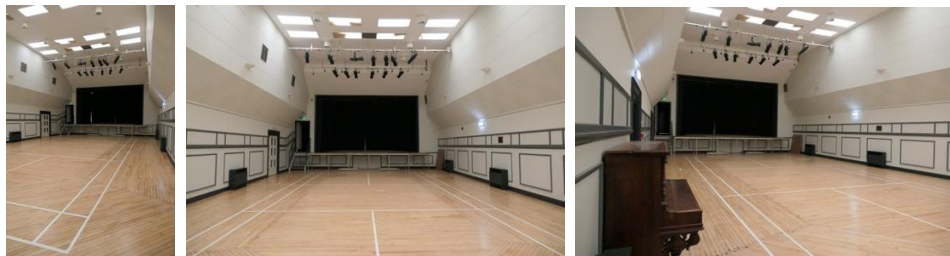
Hall	Recently refurbished Evidence of internal stonework maintenance required	<b>A</b>

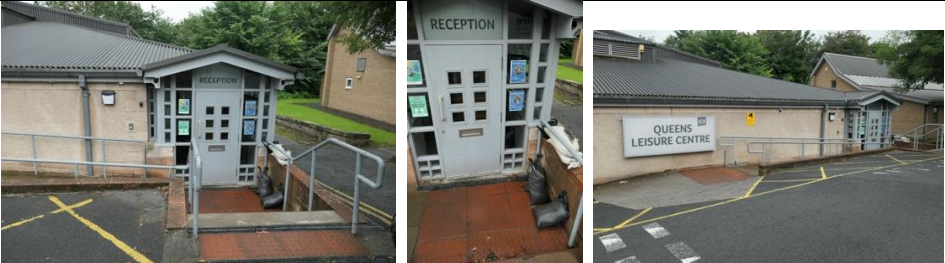
Exterior fabric	Evidence of the building requiring ongoing maintenance and flooding at the main entrance with sandbags required	B

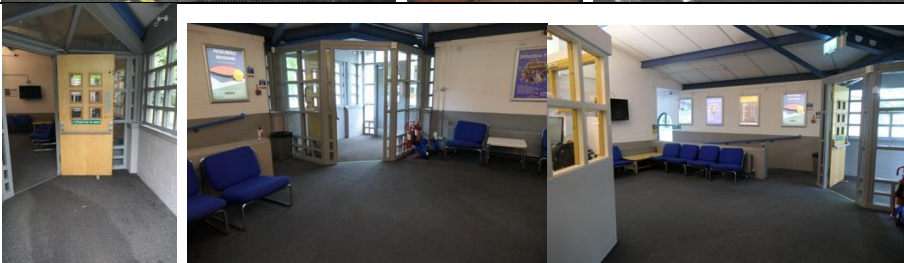
Reception	Generally in good condition but evidence of regular flooding across the entire reception area cause by water coming in the front door	B

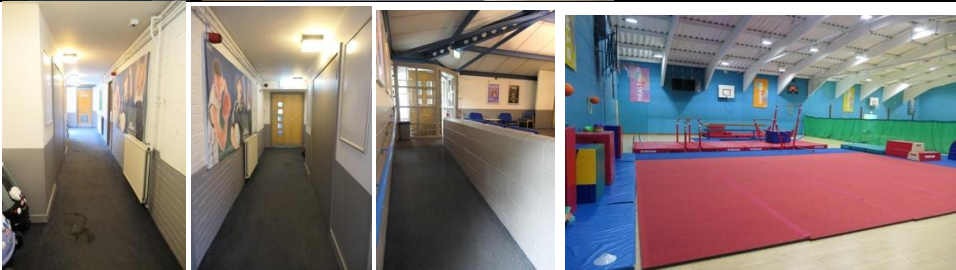
Corridors Main Hall and viewing area	Generally in good condition but the roof leaks in heavy rain	B

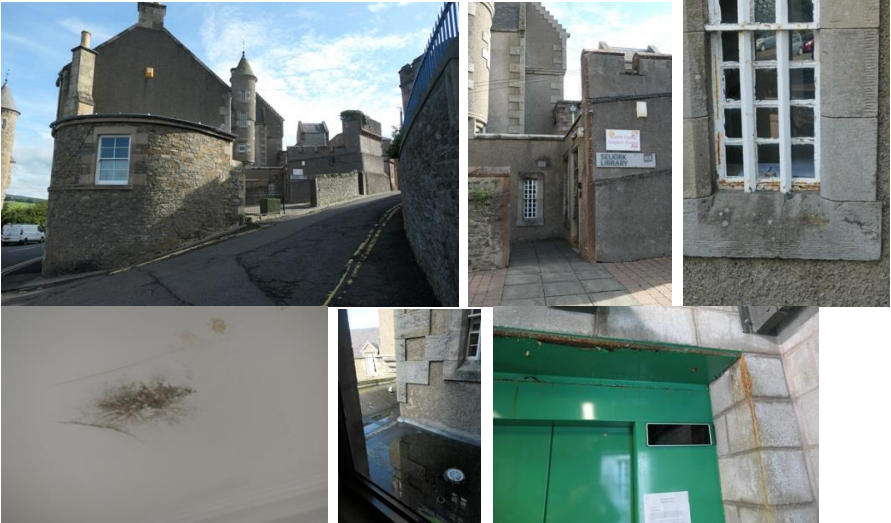
Facility Aspect	Current Condition	Operational Rating	Photographic Evidence
Exterior fabric	Ongoing maintenance required, particularly to the stonework and pointing. Evidence of internal water damage and ingress. There is standing water on the flat roof, possibly with blocked gutters and downpipes.	C

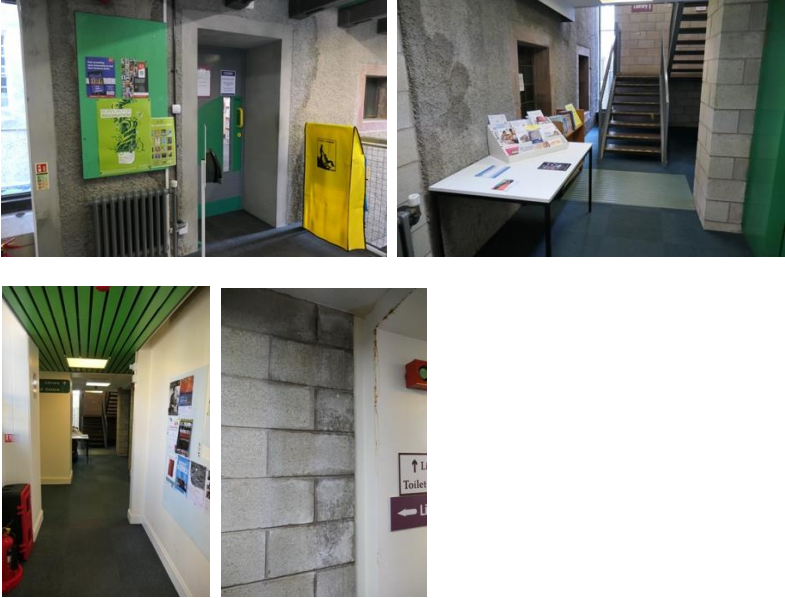
Reception Hallway	Generally in good condition but with evidence of water ingress. From the lift into the extension, there is a significant smell of dampness.	B

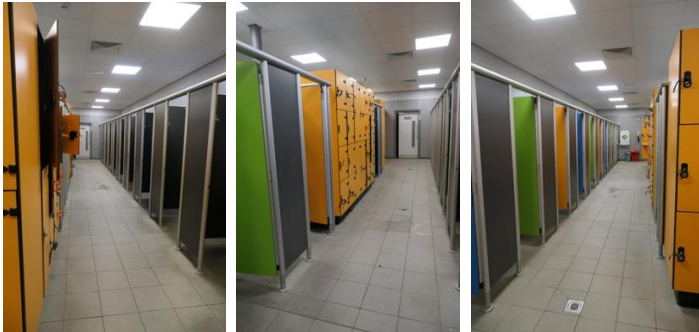
Toilets	Good condition	A	 
Pool	Good condition but with evidence of the wet wall in the shower area separating from the wall	A	 
Fitness Suite	Good condition	A
