23686-03-report-gf

CONVERSION of AGRICULTURAL BUILDING to form DWELLING HOUSE at BLUE HOUSE, RESTON.

Following instruction to proceed we confirm carrying out a visual condition survey of the existing agricultural building located at the above site known as Blue House, Reston. We visited the site on Tuesday 4th July 2023 and the weather was overcast but dry at the time of the survey.

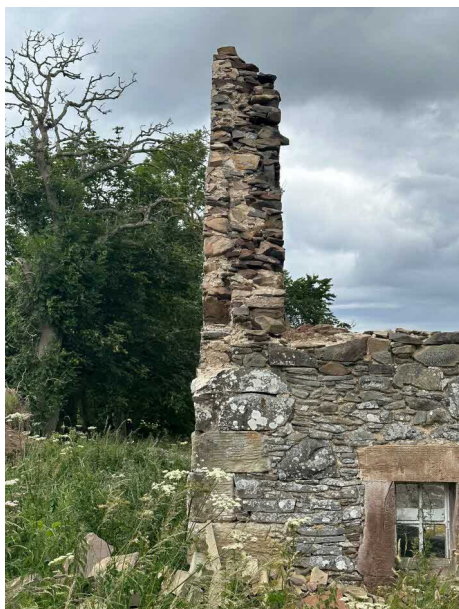
Photograph 001

This can be considered a gable elevation of the existing building with the stone extending to an apex indicating the original building had a pitched roof. The roof is not in place currently, so its form of construction is unknown, but the exposed stone gable retains a clear form and triangular shape. The gable coping stones are missing, and the existing wall head is open and subject to water ingress as the southwest elevation. There is currently a small door opening formed within the elevation and this wall is also plumb and vertical (see photograph 001).

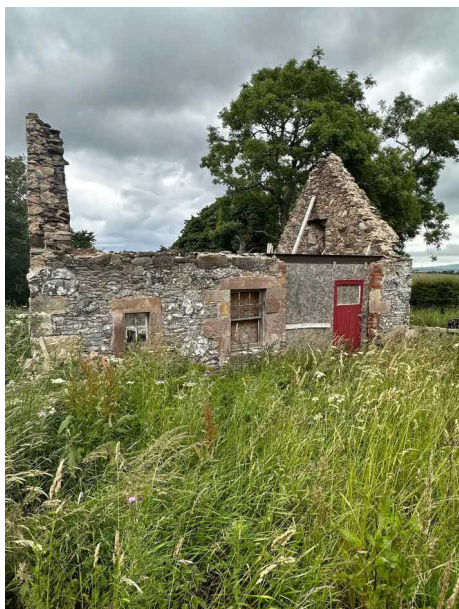
Photograph 002

This can be considered the prominent elevation of the existing building which has a large door opening and 2 window openings located within it (see photograph 002 and 006). The window openings have stone quoins on both sides with a stone lintel and sill above and below the opening. The large door opening has a steel beam acting as the lintel over the opening and has been infilled with a timber stud wall clad with OSB to close the building off. The masonry wall is formed to a height of approximately 2.4m currently and the wall is plumb and vertical. The exposed wall head is open to water ingress and is causing the mortar to erode and the smaller stones forming the wall to loosen.

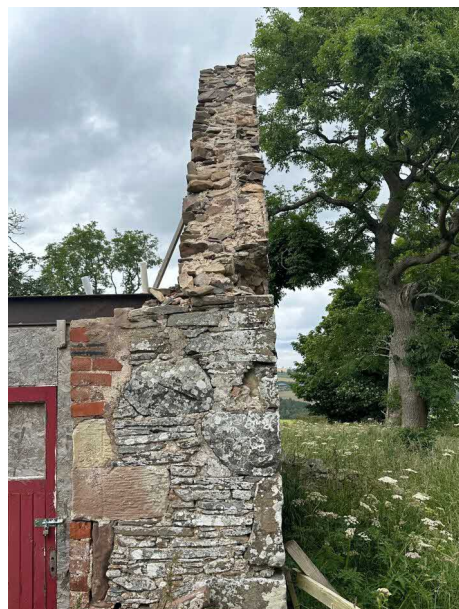
Photograph 003

This can be considered a gable elevation of the existing building with the stone extending to an apex and retains a clear form and triangular shape. The gable coping stones are missing, and the existing wall head is open and subject to water ingress as the other elevations. There is currently a window opening formed in the upper section of the wall and it is plumb and vertical (see photographs 003 and 004).

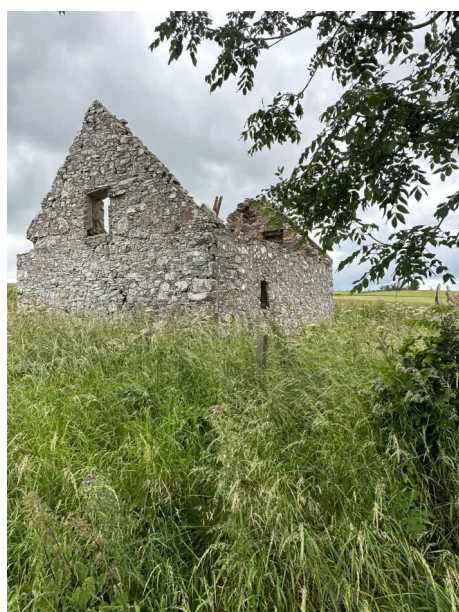
Photograph 009

This can be considered the rear elevation of the existing building (see photograph 009) and is built to a height of approximately 2.5m and the wall is plumb and vertical. There is a very small opening in the wall which does not have quoin stones or stone lintel and sill so can be considered an addition rather

than original. The exposed wall head is open to water ingress and is causing the mortar to erode and the smaller stones forming the wall to loosen.
