Linthill Walled Garden, Lilliesleaf
Architectural Commentary
10380-CSY-Z1-XX-RP-(21)-001

1.0 INTRODUCTON

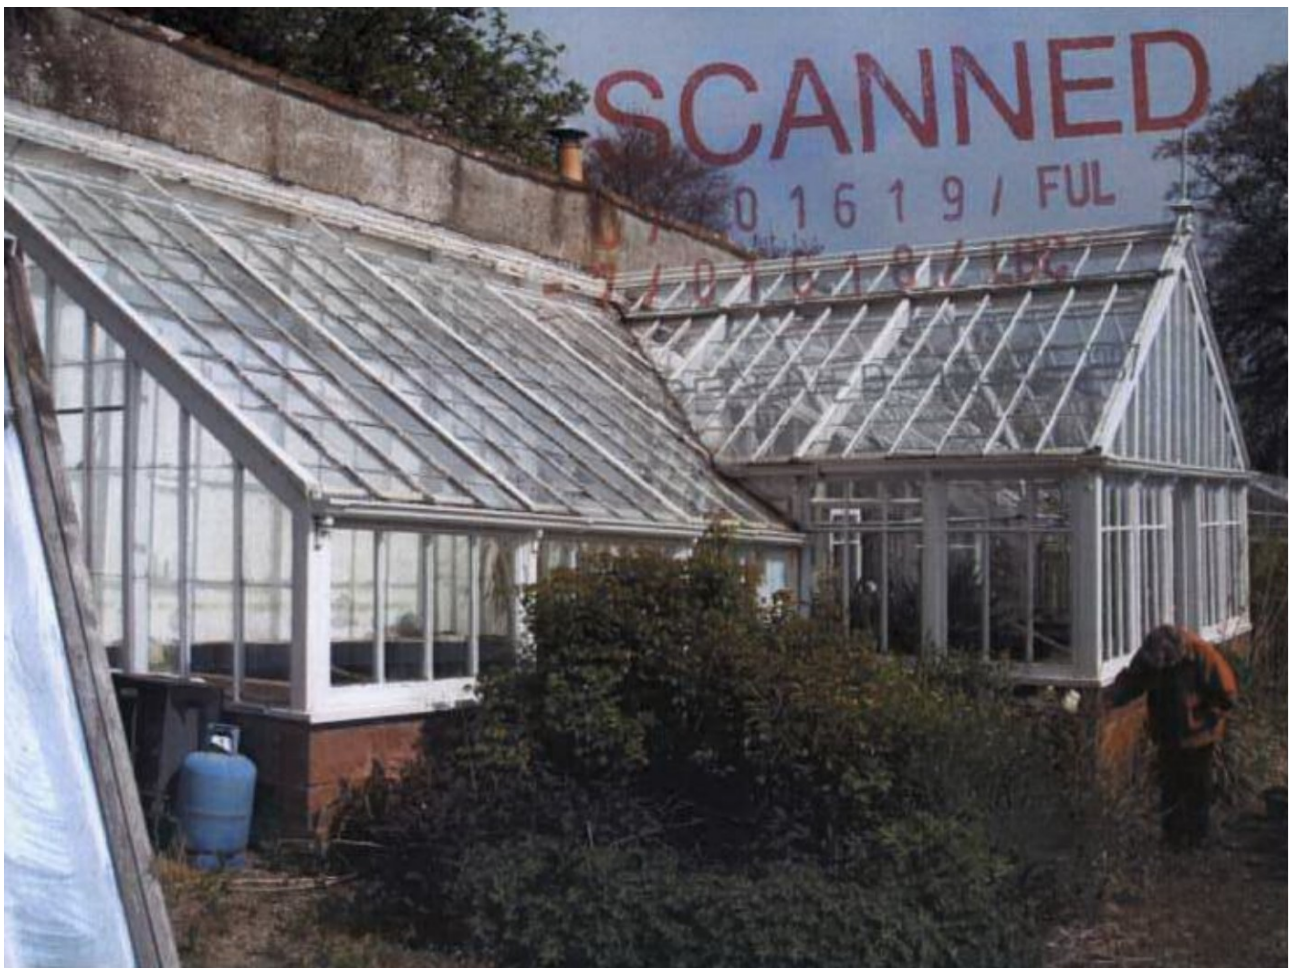
An image of the original glass house, prior to development, is shown in Fig. 02. Constructed in a painted, timber frame on a brick and red ashlar plinth, the lean-to construction appears to be ventilated at the top with either clips or lead t-sections holding each of the glass panes in place. Whilst much of the detailing around the eaves and fascia is essentially utilitarian, a prominent finial can be seen on the far gable.

Fig.02: Original 19th century glasshouse

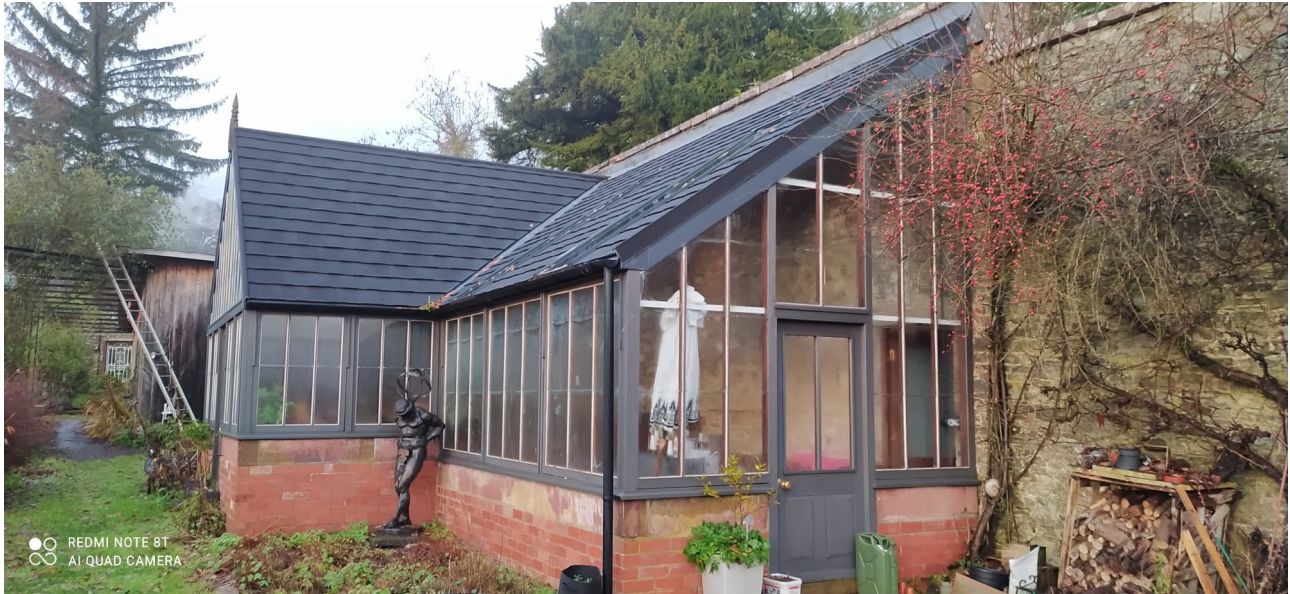
Fig 03. Reconstructed Glass House, circa 2019

To the appellant's credit, the existing base course appears to have been reconstructed using salvaged material, where possible. The red ashlar is legible, as are the presence of some historic bricks.

The detailing of the new vertical glazing is consistent with the historic glass house. As can be observed by comparing Figures 02 and 03, the utilitarian, structural joinery details, as would be expected of a building of this nature, such as corner posts and cills, have been largely replicated successfully. Furthermore, a clear effort has been made by the appellant to re-create the slim-profile mullions that give the original elevations such an elegant, vertical emphasis. These hold thin, single sheets of glass that are jointed horizontally using a similar traditional clip/ lead T-section detail as can be seen on the original.

The current roofing material and associated flashings, verges and fascias are formed from felt sheet and upvc respectively. These materials are typically not reflective of the aesthetic quality required when working with a listed building such as Linthill Walled Garden.

With hindsight, a compromise may be potentially sought whereby a more appropriate, high quality material, such as natural slate with lead flashings, is implemented to the solid roof. This approach, as is willing to be adopted by the appellant, could potentially retain the legibility of the glass house, as desired by the conservation officer, whilst also achieving the levels of thermal comfort and maintenance considerations desired by the appellant.
