Arboricultural Impact Assessment

For Dingleton

September 2023

By Toby Wingham

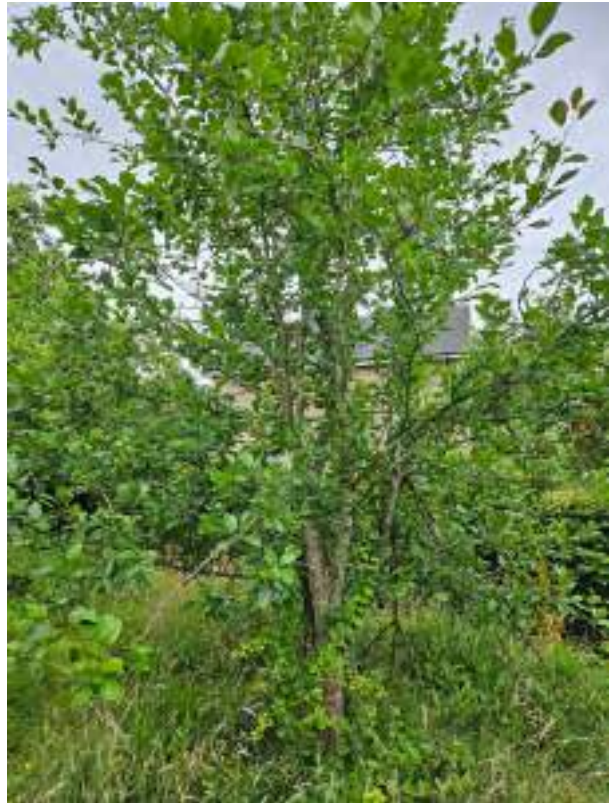
Apple Tree ID #5
6 Dingleton Road

Tree Details	
Latin Name:	Malus domestica
Tag Number:	2507
Stem Diameter [mm]:	151.66
Priority:	
Comments:	Large pruning wound at 0.5m on North of tree with around 100mm diameter. Minor crown diaback. Crossing branches.
Recommendations:

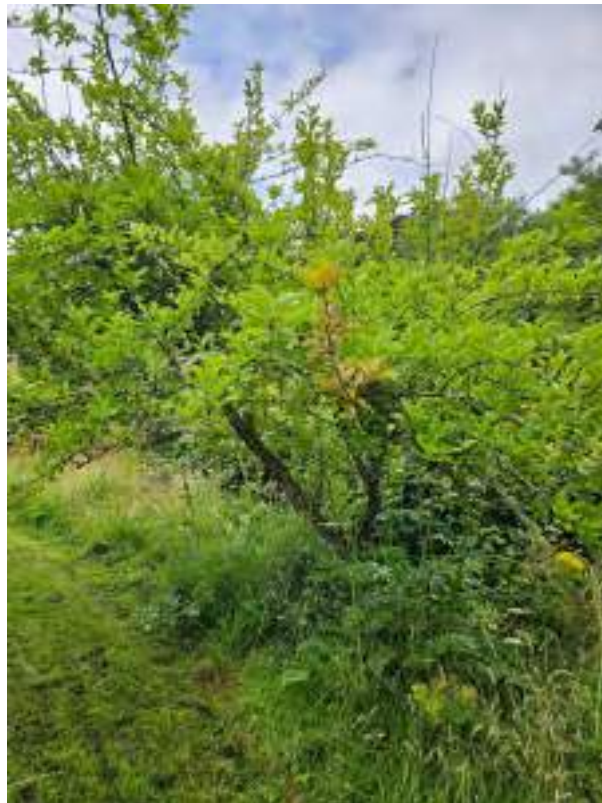
Apple Tree ID #7
6 Dingleton Road

Tree Details	
Latin Name:	Malus domestica
Tag Number:	2505
Stem Diameter [mm]:	151.66
Priority:	
Comments:	Crossing branches. Decay at base with length of 15cm and width of 8cm. Pruning wounds.
Recommendations:

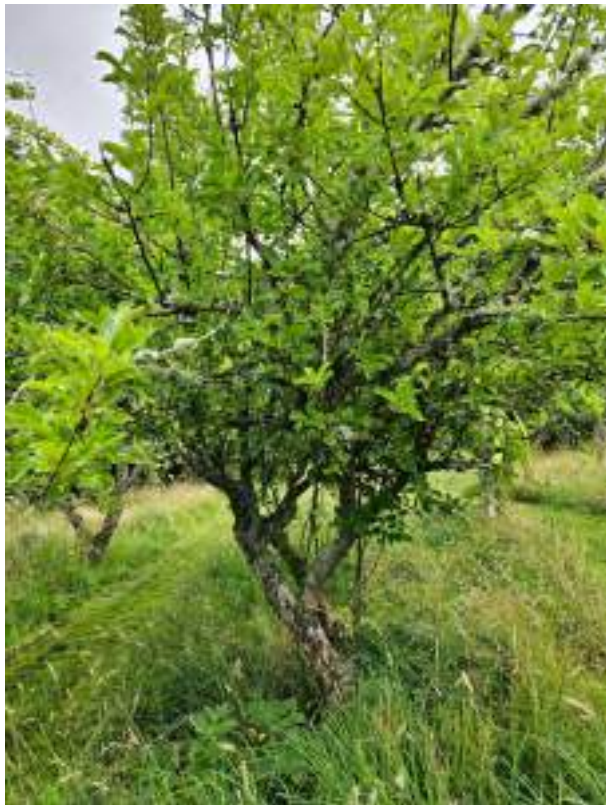
Apple Tree ID #8
6 Dingleton Road

Latin Name:	Malus domestica
Tag Number:	2504
Stem Diameter [mm]:	219.32
Priority:	
Comments:	Multi stem union at 0.5m. Large pruning wound at union with diameter of around 100mm. Minor deadwood.
Recommendations:

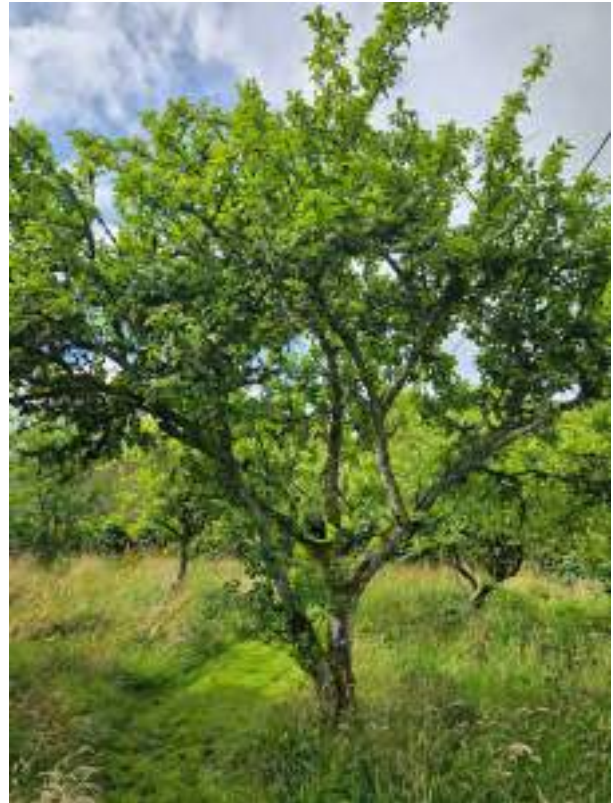
Apple Tree ID #12
6 Dingleton Road

Tree Details	
Latin Name:	Malus domestica
Tag Number:	1299
Stem Diameter [mm]:	220
Priority:	
Comments:	Two large pruning wounds on East Side at 0.5m with diameter of around 100mm. Epicormic growth from wounds.
Recommendations:

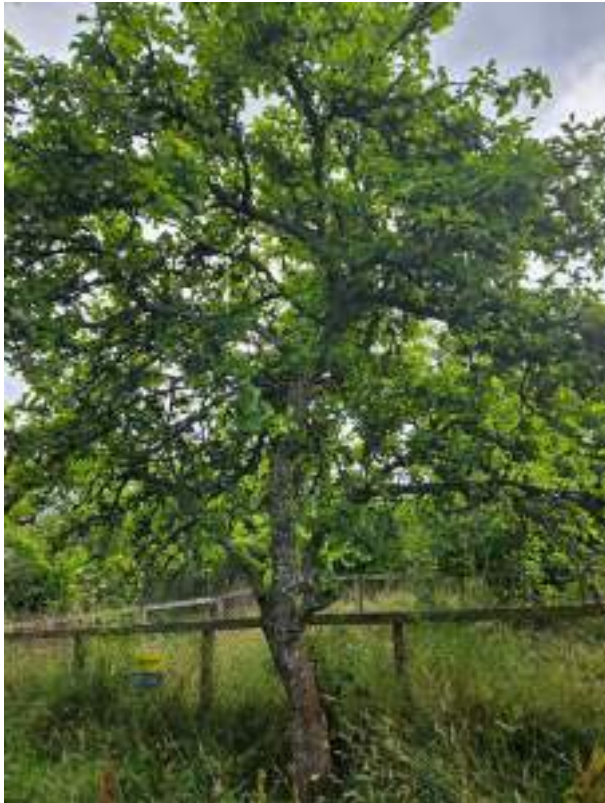
Apple Tree ID #13
6 Dingleton Road

Latin Name:	Malus domestica
Tag Number:	1279
Stem Diameter [mm]:	160
Priority:	
Comments:	Multiple large pruning wounds at base with diameter of around 80mm. Epirocmr growth at base and coming from wounds. Minor deadwood.
Recommendations:

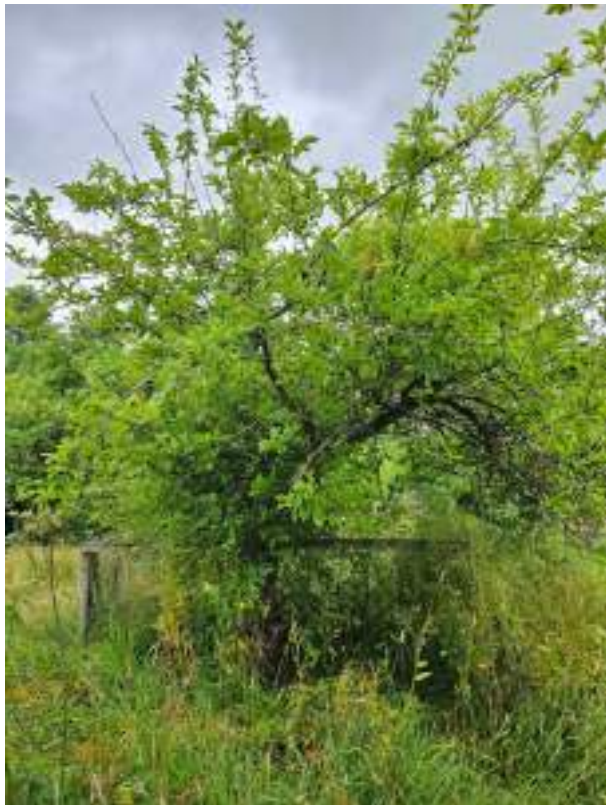
Apple Tree ID #14
6 Dingleton Road

Tree Details	
Latin Name:	Malus domestica
Tag Number:	1283
Stem Diameter [mm]:	180
Priority:	
Comments:	Historic pruning with wounds over 50mm diameter. Minor deadwood. Slight lean to north.
Recommendations:

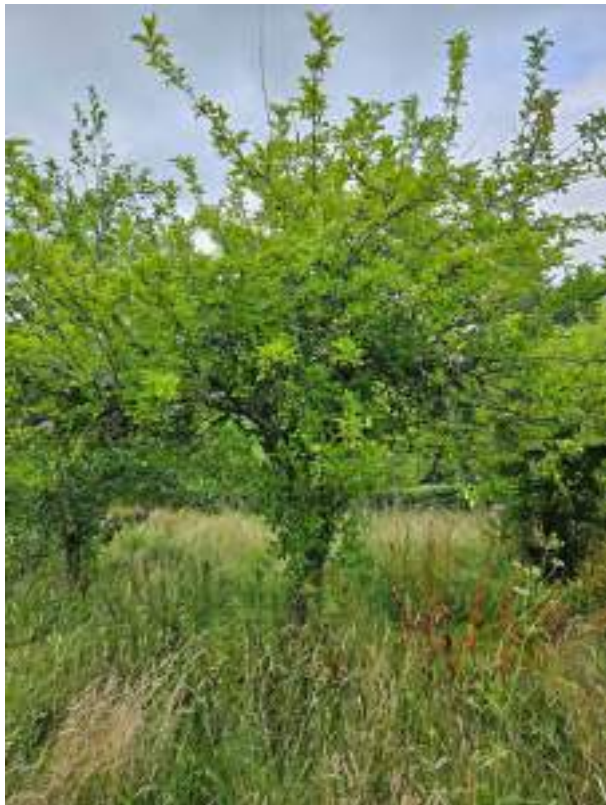
Apple Tree ID #15
6 Dingleton Road

Tree Details	
Latin Name:	Malus domestica
Tag Number:	1284
Stem Diameter [mm]:	178.89
Priority:	
Comments:	Minor deadwood. Historic pruning wounds. Decay on sub stem to east at 1m with aperture of 50mm.
Recommendations:

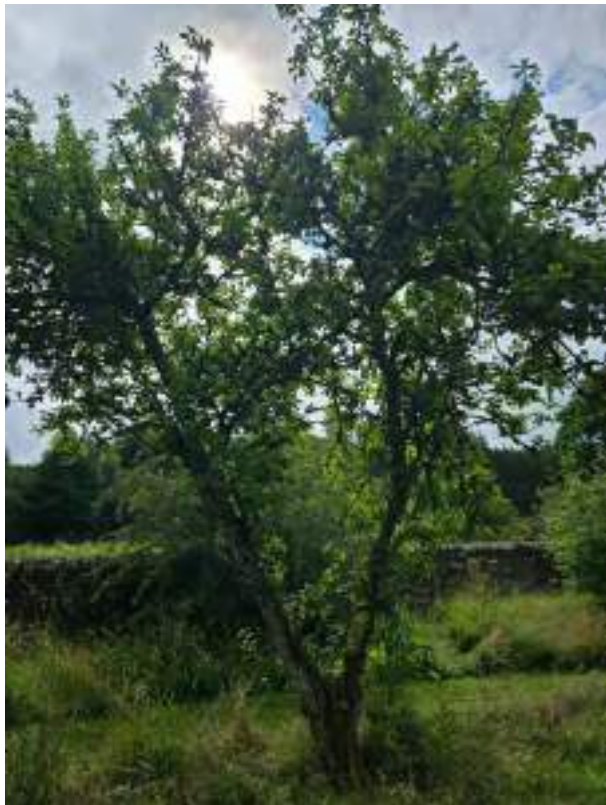
Apple Tree ID #18
6 Dingleton Road

Tree Details	
Latin Name:	Malus domestica
Tag Number:	2513
Stem Diameter [mm]:	180
Priority:	
Comments:	Historic pruning wounds. Small self seeded elder growing at base.
Recommendations:

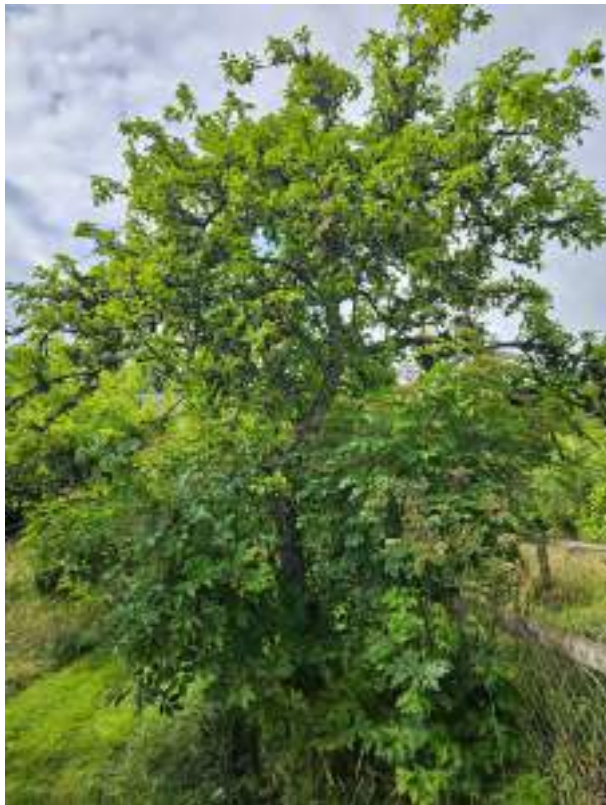
Apple Tree ID #19
6 Dingleton Road

Tree Details	
Latin Name:	Malus domestica
Tag Number:	Unobtainable
Stem Diameter [mm]:	100
Priority:	
Comments:	Crossing branches. Historic pruning cuts made.
Recommendations:

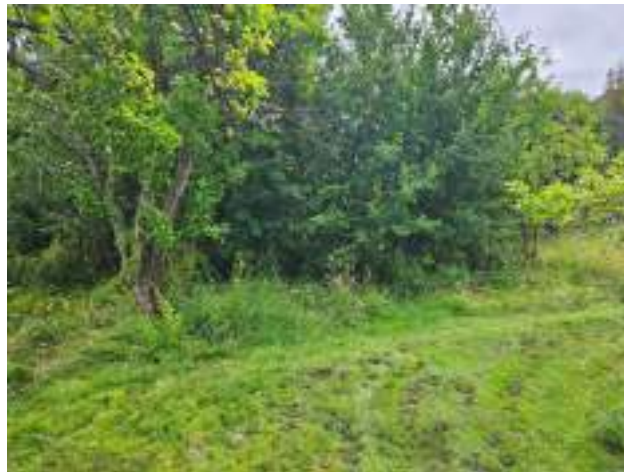
Apple Tree ID #23

Sapwood is exposed on sub stem to south of tree. Historic pruning cuts made. Multi stem union at 0.5m. Minor deadwood. Lesion on sub stem at 4m on East of tree towards thr centre. Decay at base.

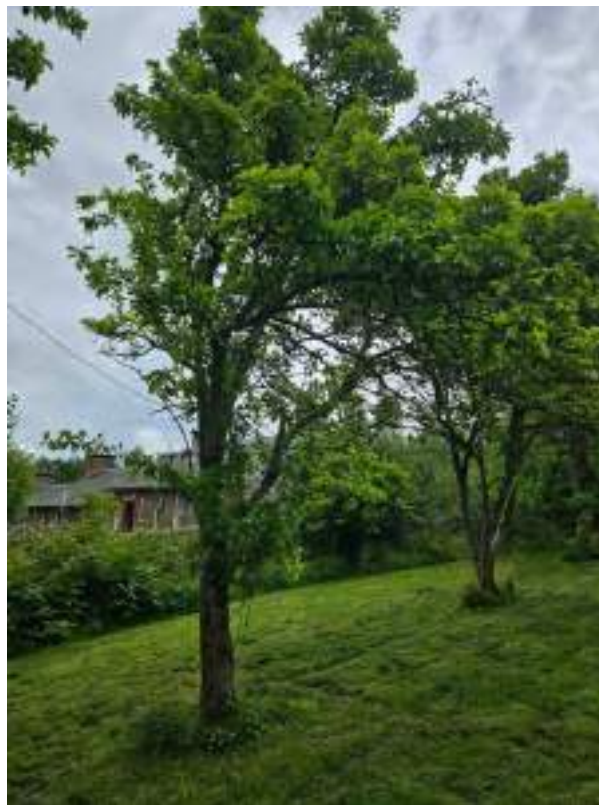
Apple Tree ID #28
5 Dingleton Road

Tree Details	
Latin Name:	Malus domestica
Tag Number:	2795
Stem Diameter [mm]:	140.71
Priority:	
Comments:	Epicormic growth present on some branches. Historic pruning cuts. Minor deadwood. Adjacent to telephone pole and neighbouring garden.
Recommendations:

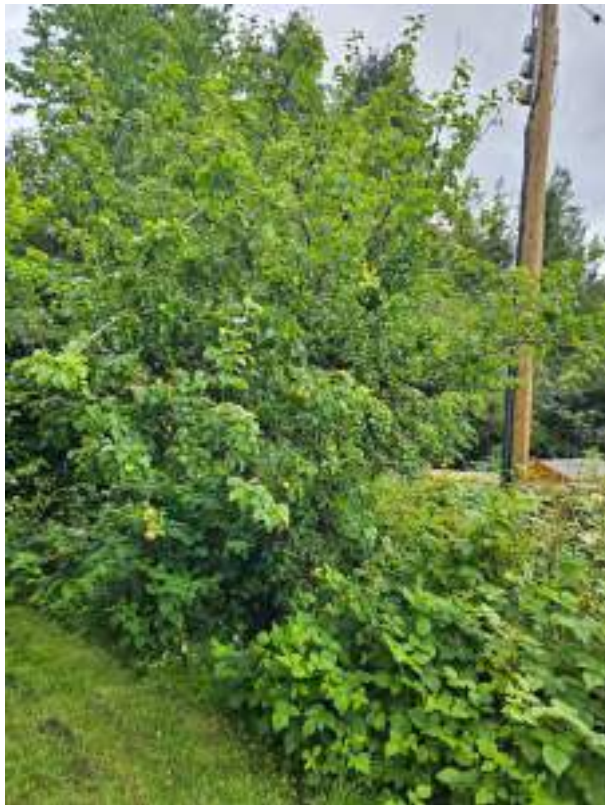
Apple Tree ID #29
5 Dingleton Road

Tree Details	
Latin Name:	Malus domestica
Tag Number:	2794
Stem Diameter [mm]:	290.86
Priority:	
Comments:	Compressive union at 1.5m. Minor deadwood. Epicormic growth from wounds at base. Historic pruning wounds. Hogweed at base.
Recommendations:
