# **Breeding Bird Survey and Protection Plan – Folly Cottage, by Town Yetholm – August 2019**

**Title:** Breeding Bird Survey – Folly Cottage, by Town Yetholm – August 2019

**Author:** Brian Minshull

**Date:** 5<sup>th</sup> September 2019

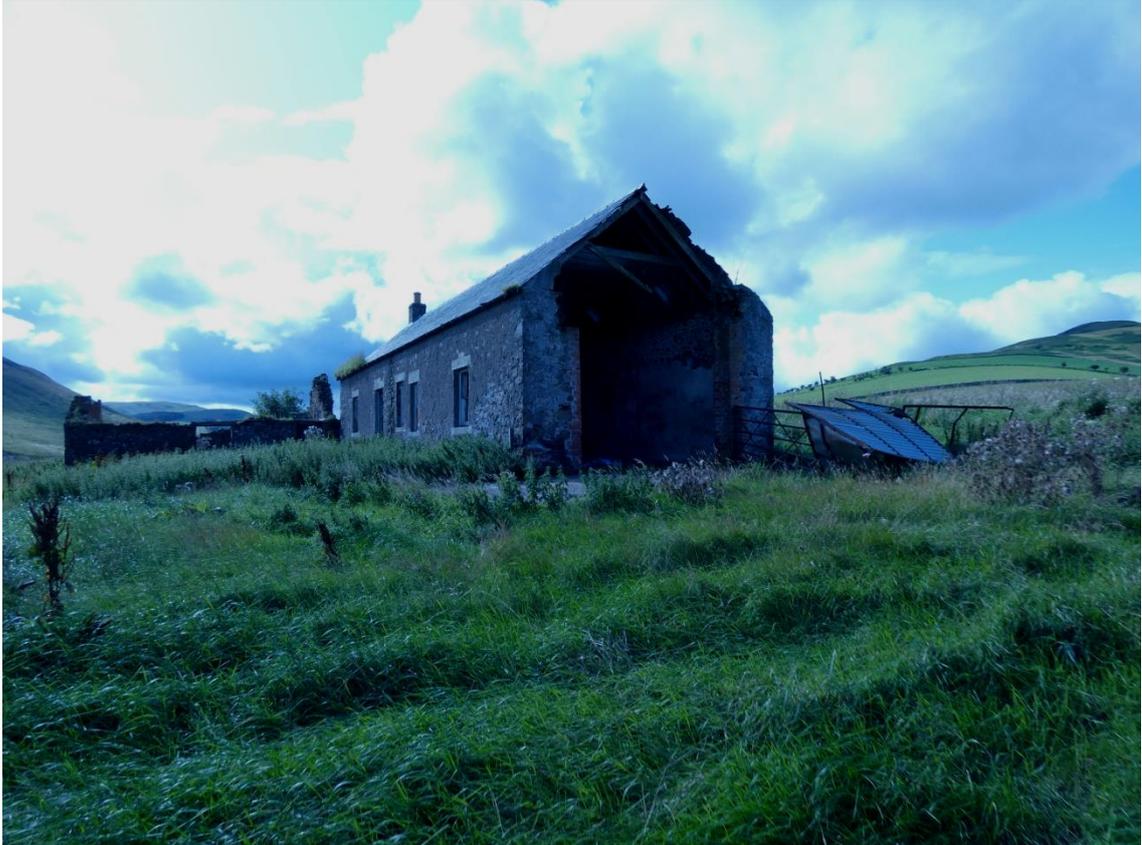
Although largely intact, the entire north-western gable end is missing, presumably having been removed to create an agricultural storage area (for example, the building was previously used for storage of straw bales, *etc.*) and a shelter for sheep. Conversely, the roof and other walls of the building are still functional. It has had its first floor, and all interior fittings and linings, removed. A new concrete floor slab has been laid. The roof is in poor condition, with rainwater goods missing and timberwork damaged by rot, *etc.* Existing windows and door openings have been blocked.

The building is structurally unsound as a result of the collapsed and / or removed gable end. For example, the remaining standing structure includes numerous broken or rotten roof timbers. Internally, as suggested, the building is open to the roof, exposing a collar beamed roof void which is lined with wooden sarking.

**Plate 3.1a, View of the north-western elevation of Folly Cottage (showing the gable end that has been removed).**

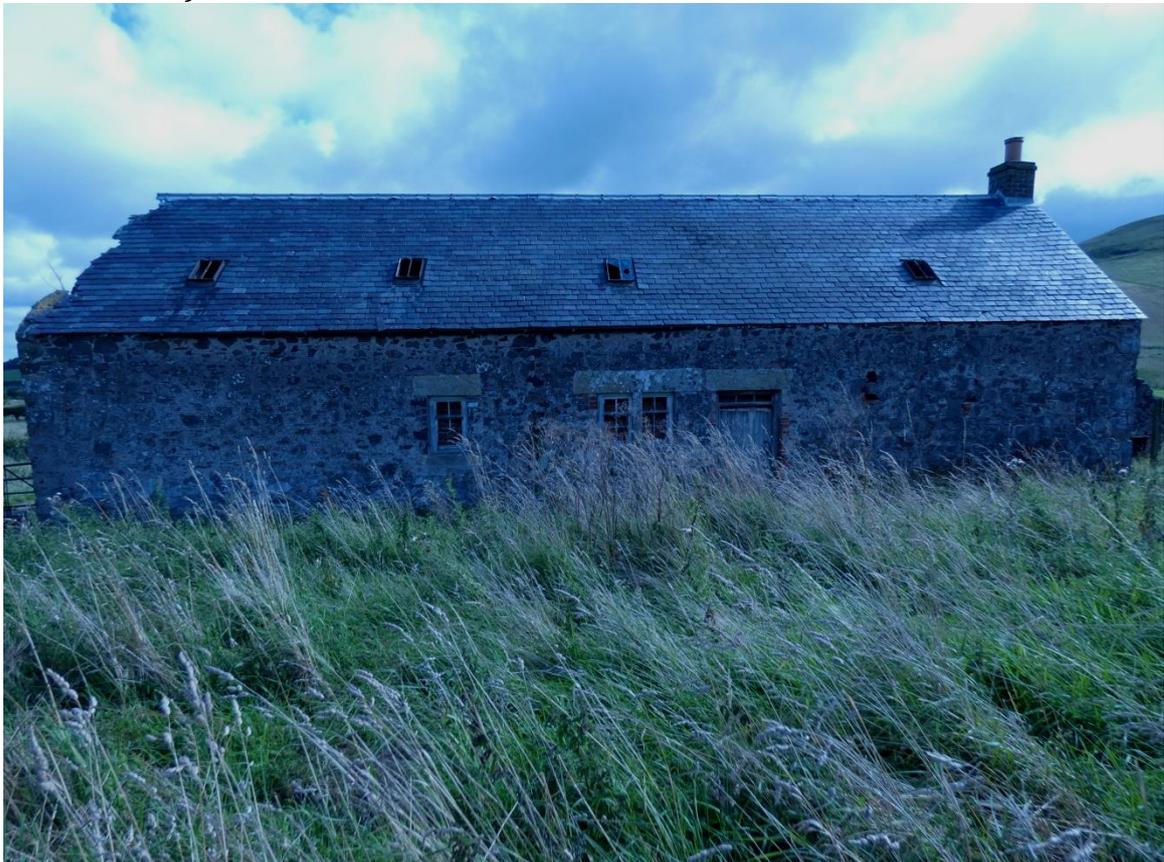
The skylights on the south-western aspect of the roof are largely intact, and the original windows and doors of the cottage have been sealed with red brick. As such, the open gable end is the only access for barn owl into the building.

**Plate 3.1b, View of the south-west elevation of Folly Cottage and the largely intact roof, etc..**

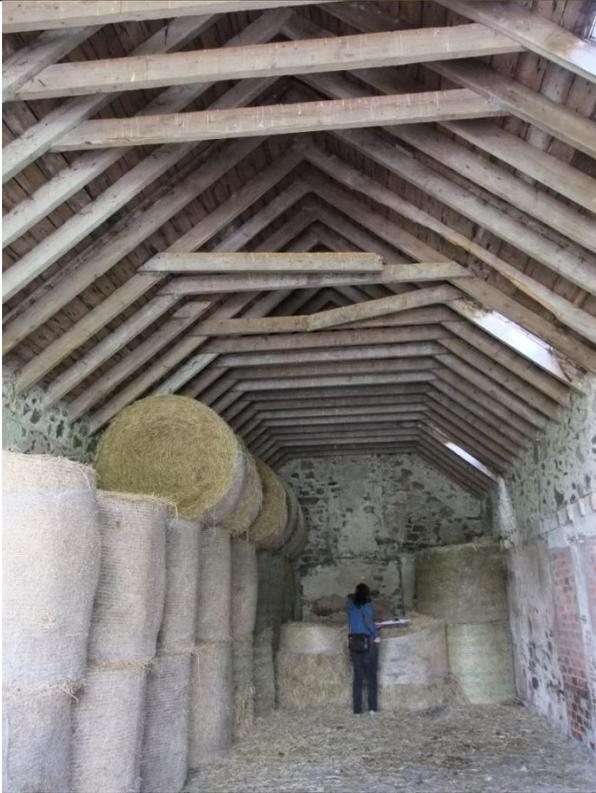
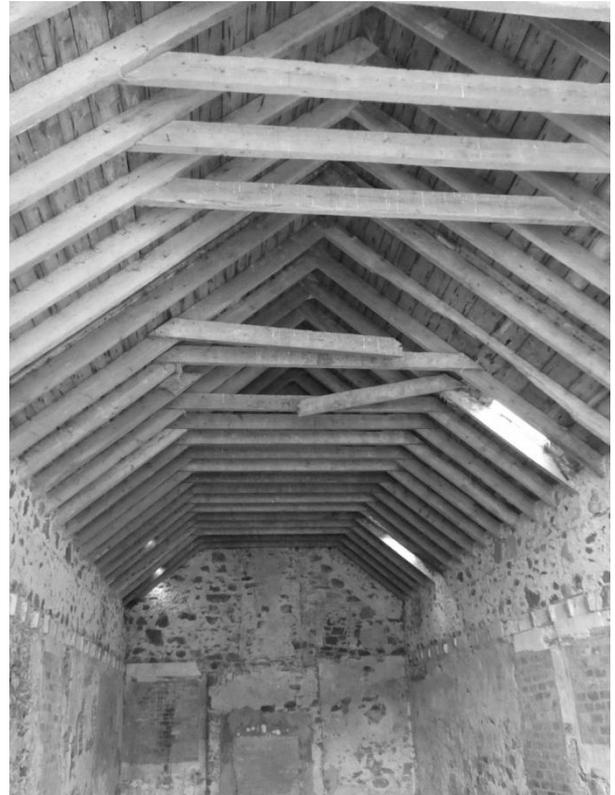
**Plate 3.2a and b, View of the straw bales which were stored in the main building at the time of the previous site visit in May 2013 (the barn owl nest site was to the left side of the building between the bales and a view of the same at the time of the recent site visit in August 2019.**

No evidence of barn owl was located<sup>3,4</sup>. This was not surprising, as since the successful breeding attempt in 2013 both the barn owl nest-box and the straw bales behind which the nest was located had been removed in order to prevent further such breeding attempts.

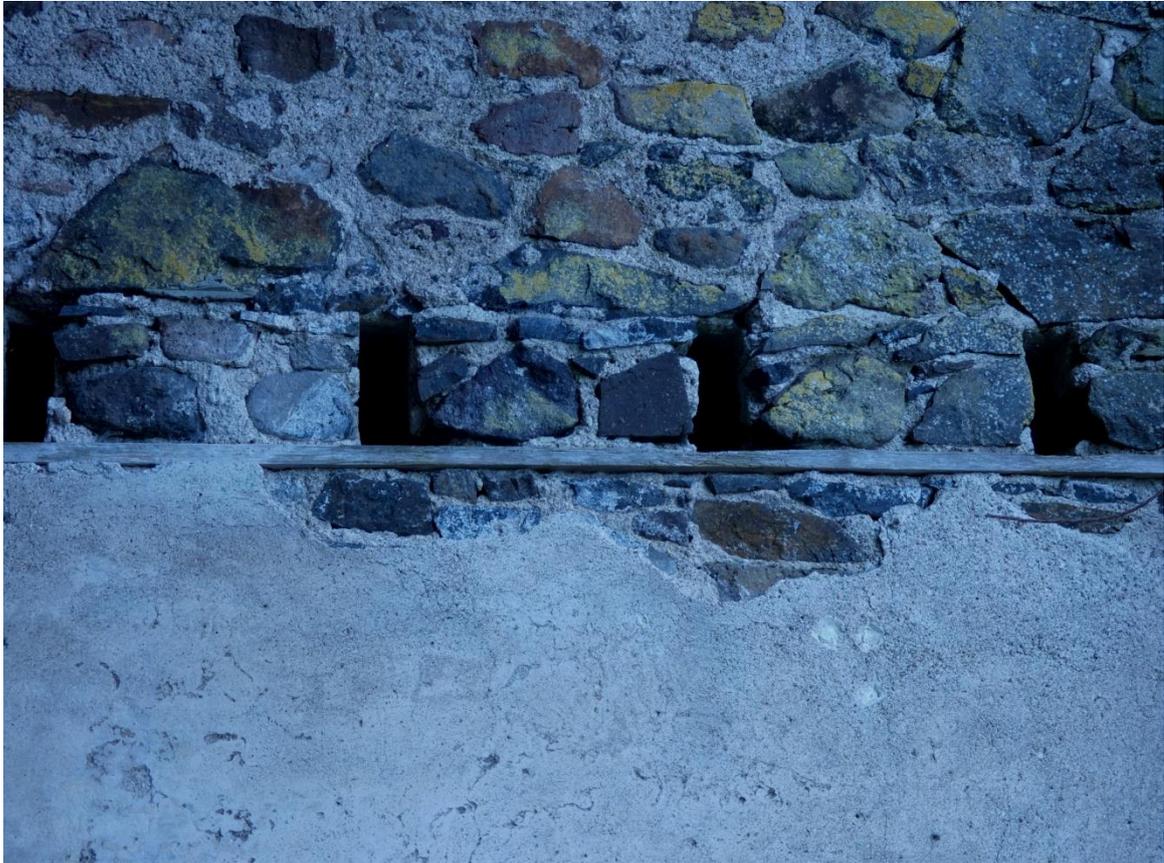
These were undoubtedly breeding in the floor beam holes (see Plate 3.2c). For example, recently hatched eggshells were seen on ground nearby (see Plate 3.2d).

Plate 3.2c, The floor beam holes used as nesting cavities by feral pigeons.

**As such, the recommended mitigation of the (breeding bird) species protection plan is to complete the demolition of the building in the mid-winter period, when even feral pigeons are unlikely to be breeding in the Scottish Borders.**

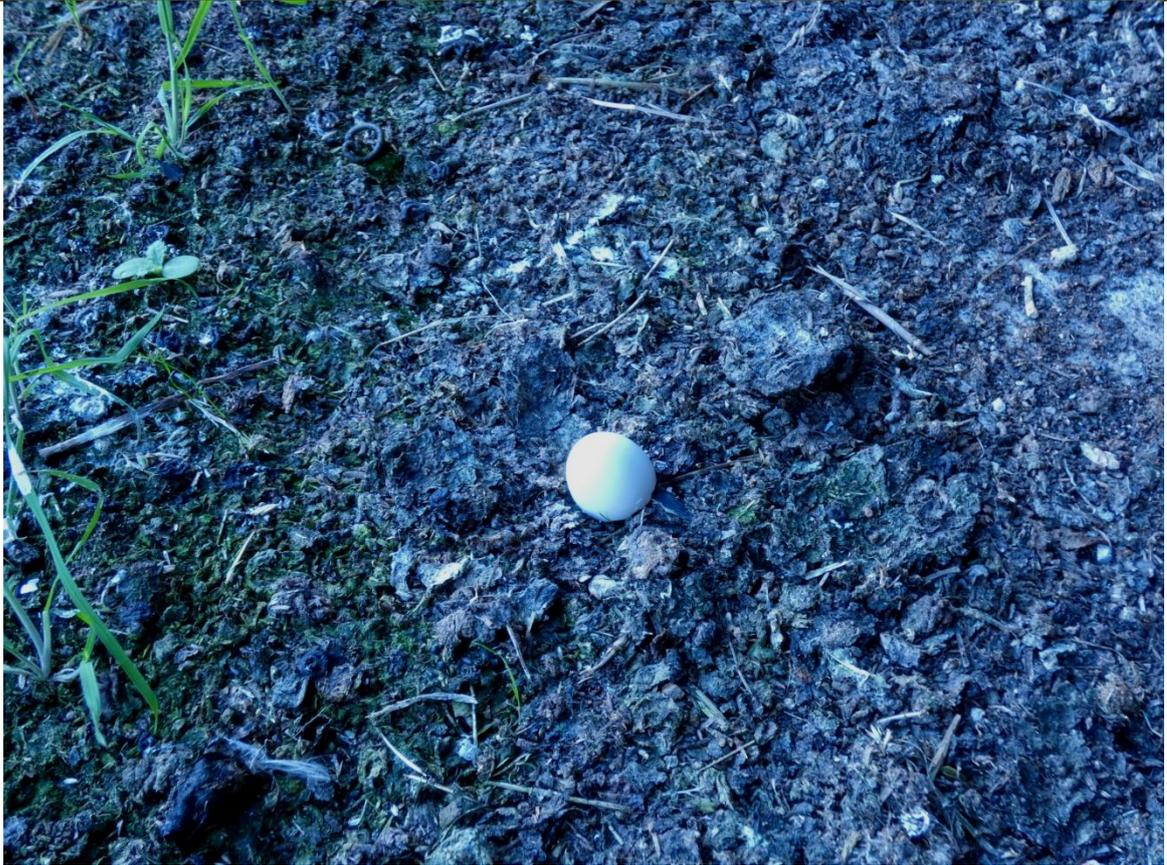
Plate 3.2d, A freshly hatched feral pigeon egg amongst the pigeon dropping debris that litters the floor of Folly Cottage.

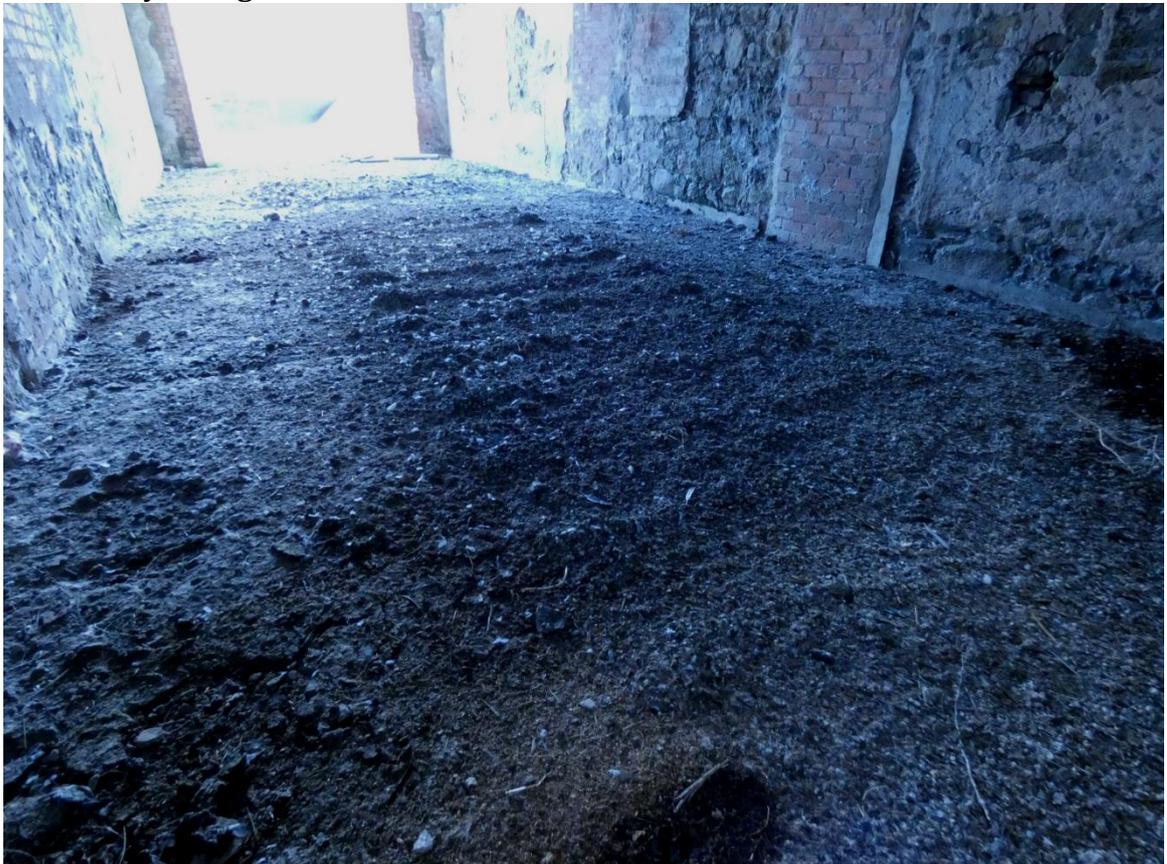
Further, they were obviously roosting in the roof beams. Several centimetres of droppings, feathers, *etc.*, were very evident beneath the central roof beams (see Plate 3.2e).

Plate 3.2e, View of the floor of Folly Cottage, showing the accumulated pigeon droppings, etc., beneath the roof beams.

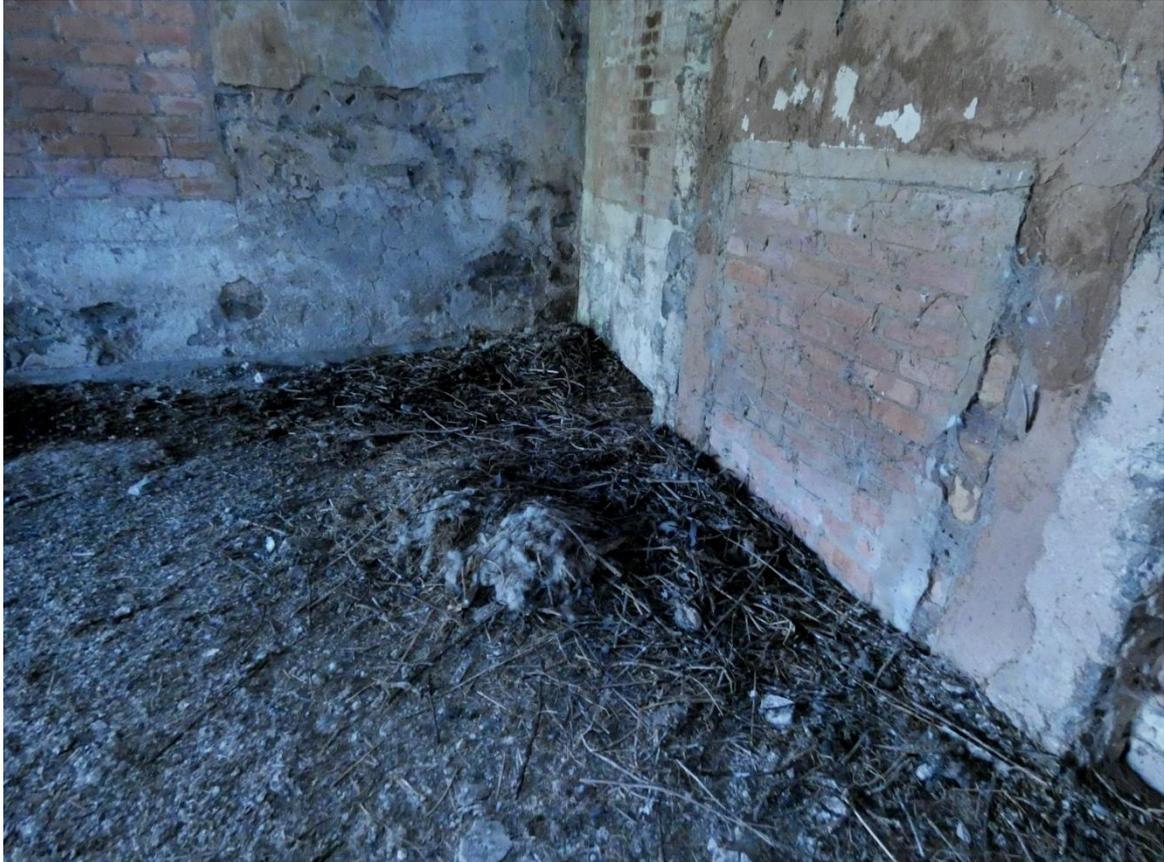
Beyond this there were the fallen remains of a jackdaw (*Corvus monedula*) nest at the far end of the building (see Plate 3.2f).

Plate 3.2f, The remains of a fallen jackdaw nest at the far end of the building.
