Bonchester Bridge
Flood Risk Assessment

1.1.1 This Flood Risk Assessment has been prepared by Allen Creedy MRTPI FIEMA to assess the flood risk associated with the proposed development on land to the northwest of Town O' Rule Farmhouse, near Bonchester Bridge in the Scottish Borders.

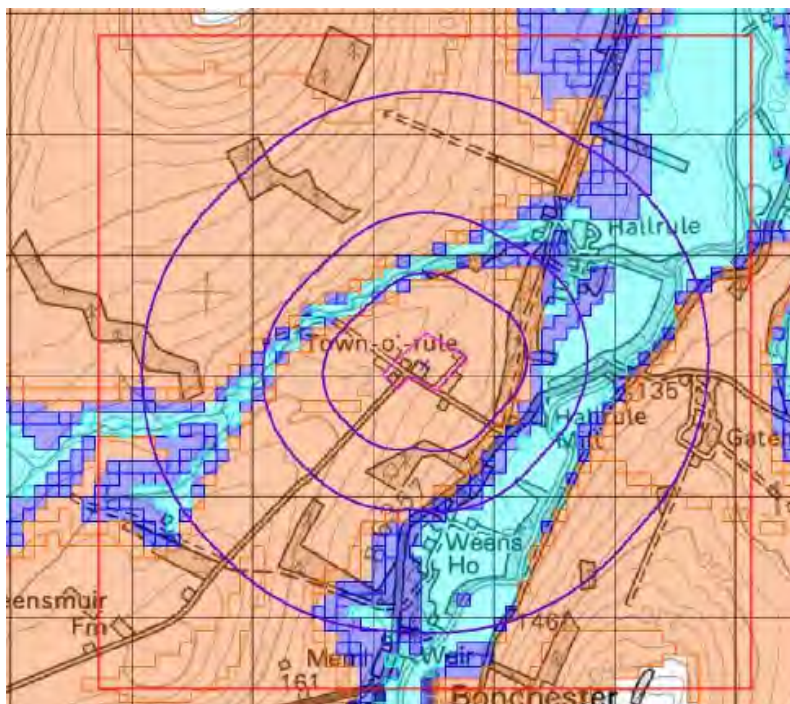
Figure 2.2 Extract from Envirocheck Groundwater Flooding Map

2.5.2 Envirocheck records confirm that the site is in an area where there is limited potential for groundwater flooding to occur.

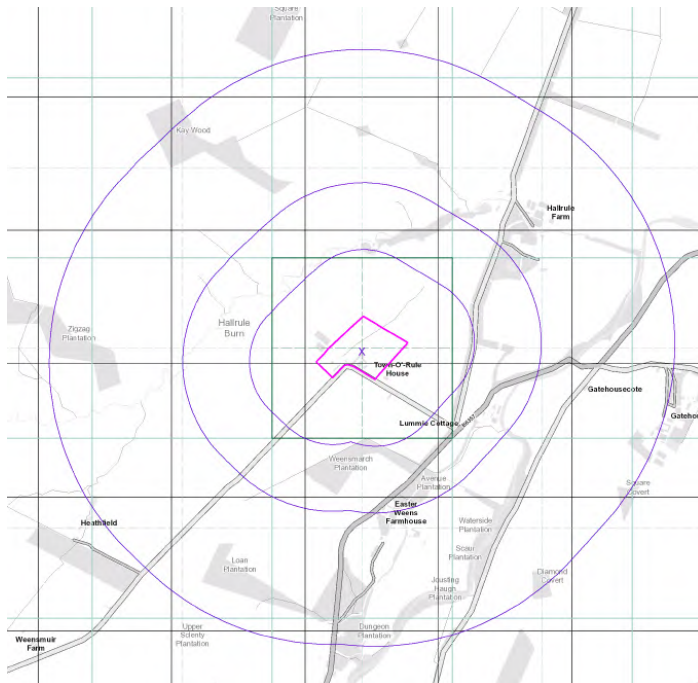
Figure 2.3 Extract from Envirocheck Surface Water Flooding Map

2.6.2 Envirocheck records confirm that the site is not at risk from surface water (pluvial) flooding.

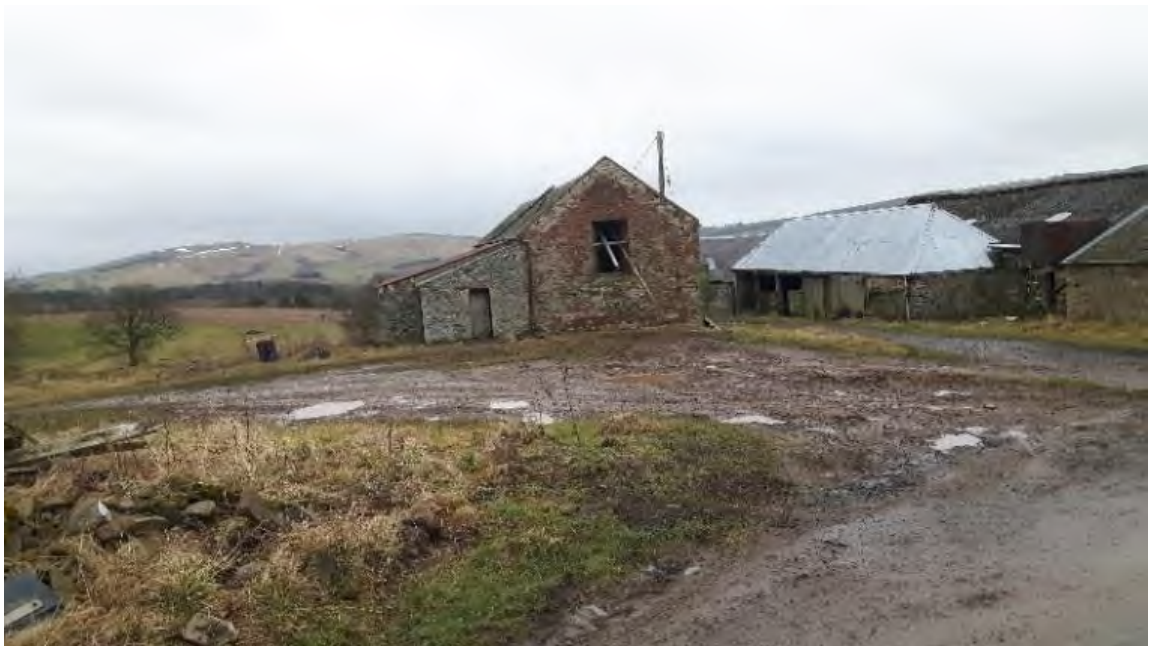
Figure 3.1 Topography of existing site as observed from access road on 16.03.2018

3.2.1 The site covers a section of land which includes a terrace at a higher level (which covers the site of an existing open-sided, L-shaped timber structure and stone outbuilding) that slopes steeply down to the northwest, towards the small stream which runs parallel to the site and flows in a northerly direction. The site levels fall from 186.83mAOD at the site access, down to 181.48mAOD beyond the terrace upon which the proposed dwelling would be constructed. The rest of the site is relatively even with small hummocks and undulations.

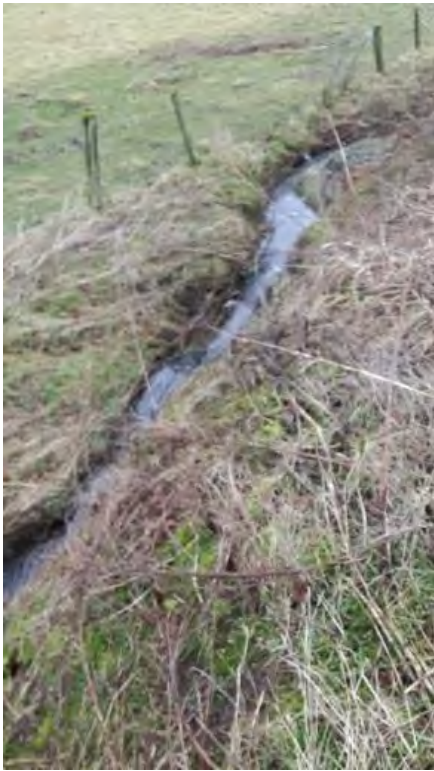
Figure 3.2 Nearest watercourse as observed on 16.03.2018

3.3.1 The nearest watercourse, a small stream, is located approximately 35 metres to the west of the site of the proposed dwelling. The stream flows in a northerly direction and the topography of the site (where the development site sits at a higher level than the stream) means that there is no risk of the stream overflowing and presenting a flood risk to the proposed dwelling.

3.3.2 The site walkover on Friday 16th of March was undertaken during rainy, wet and cold conditions where it would be expected that any drainage and/ or flood risk issues would become more obvious. However, no risk of flooding or drainage issues were observed.

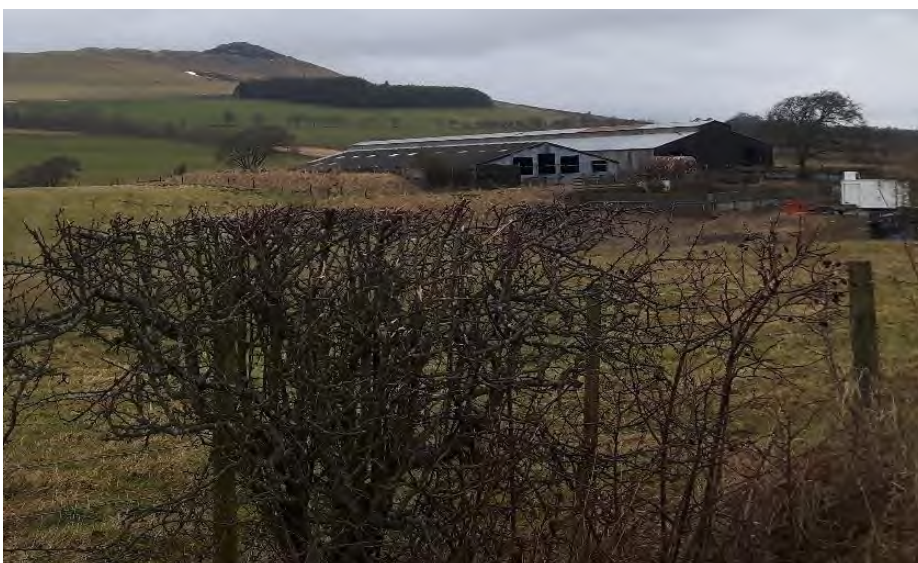
- 3.4.1 The site and surroundings consist of land which is used largely for agricultural purposes. The site is located to the east of a small stream and land use consists of existing buildings and hardstanding with a greenfield area. There are residential dwellings to the east of the site. There are agricultural buildings, including two large sheds located to the west of the site.

Figure 3.3 Agricultural buildings to the west of the site as observed on 16.03.2018

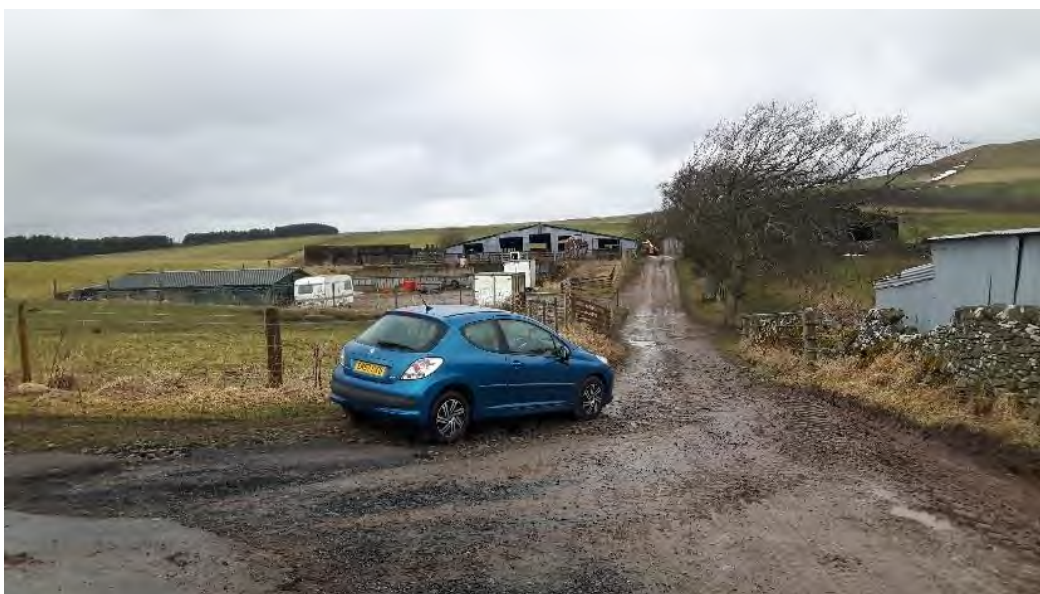
Figure 3.4 Site access as observed on 16.03.2018

3.6.1 Access to the site is gained from the D63. There is an existing agricultural track adjacent to the site which provides access to the agricultural buildings to the west. The track is not at risk from fluvial flooding due to the difference in elevation between the access and the watercourse. No evidence of surface water (pluvial) flooding was observed during the site walkover, which was undertaken in rainy conditions.
