Bonchester Bridge

Contaminated Land Preliminary Risk Assessment

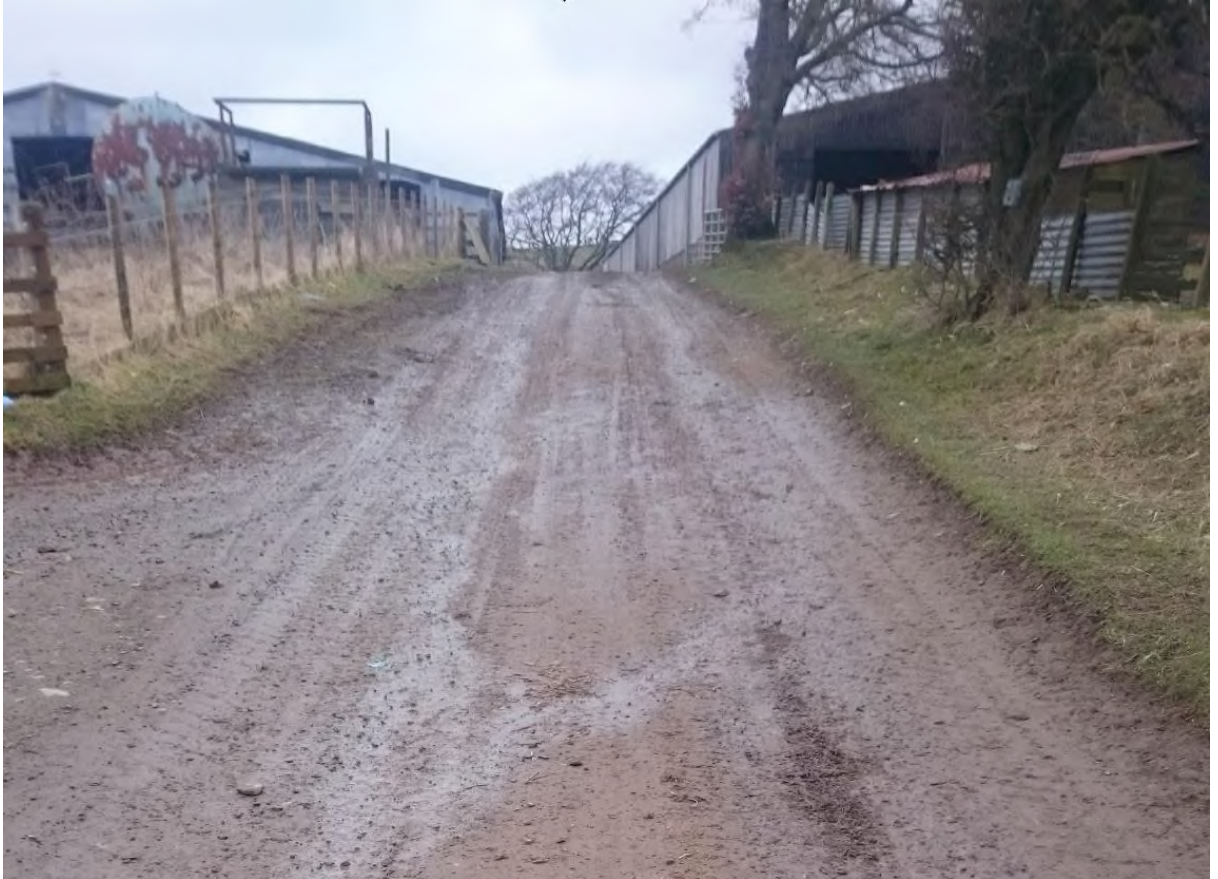
7.1 Photograph 1

2.3.2 The access track onto the site (Photograph 1) splits into three roads with one option leading to the proposed development site north east of the track. This area predominantly comprises of bare earth (Photograph 2) likely due to the use of the track by agricultural vehicles accessing into/ egressing from the site. The stone cottage, which will be retained, refurbished and converted as part of the proposed development, currently has a single-storey extension which is constructed of a mixture of stone and corrugated metal sheets (Photograph 3). The extension is in a state of disrepair, with numerous broken doors and windows observed. The extension is proposed to be demolished as part of the proposed development. Existing and proposed site plans are included at Figures 2.1 and 2.2, respectively. Various agricultural buildings and residential properties are located to the east of the site (Photograph 4). At the time of the site walkover, many of the agricultural buildings were either empty or were being used to store agricultural paraphernalia. To the

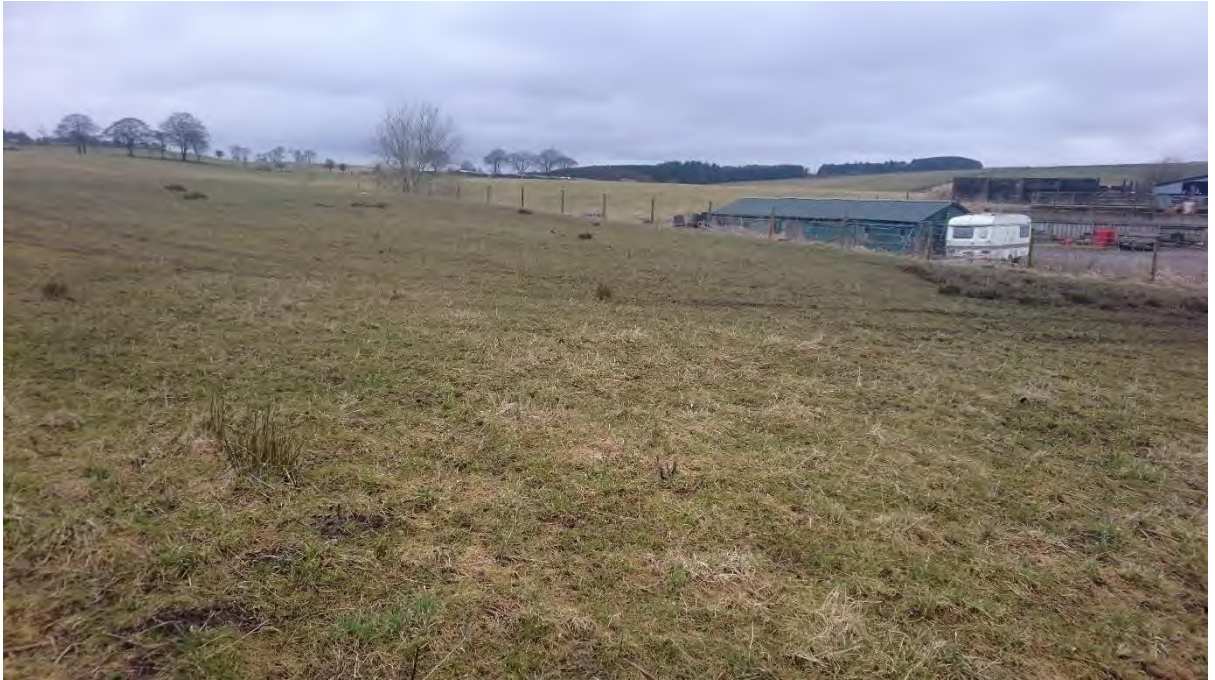
7.9 Photograph 9

2.3.3 To the southwest of the site is an agricultural field associated with Town O' Rule farm (Photograph 9). The wider surrounding landscape is a mix of agricultural land and woodland plantations with a small group of residential properties located to the east of the site.
