Black Barn, Eckford  
Preliminary Ecological Assessment (PEA)  
*For Ferguson Planning*

6<sup>th</sup> May 2021

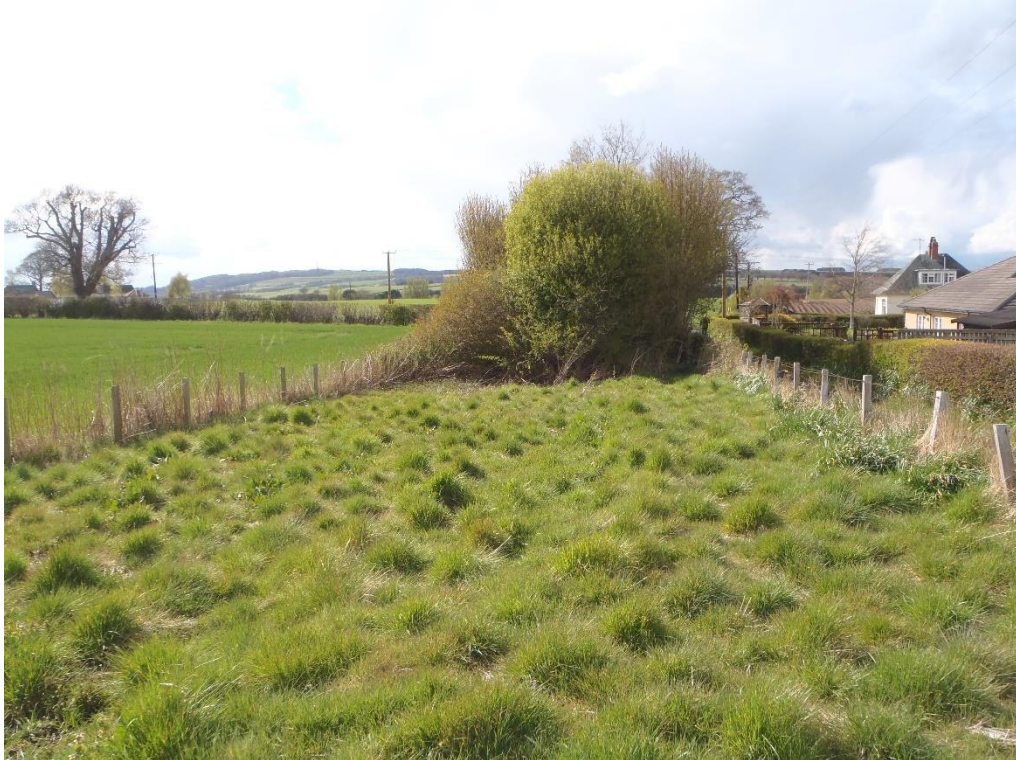
At the east of the site entrance there is an area of semi-improved neutral grassland with species present including cock's-foot grass *Dactylis glomerata*, willowherb, broadleaved dock *Rumex obtusifolius*, white dead-nettle *Lamium album*, garlic mustard *Alliaria petiolata* and lesser celandine *Ranunculus ficaria*. It is understood that the grassland is mown throughout the summer months.

*Photograph 1: showing a view of the site entrance (looking west)*

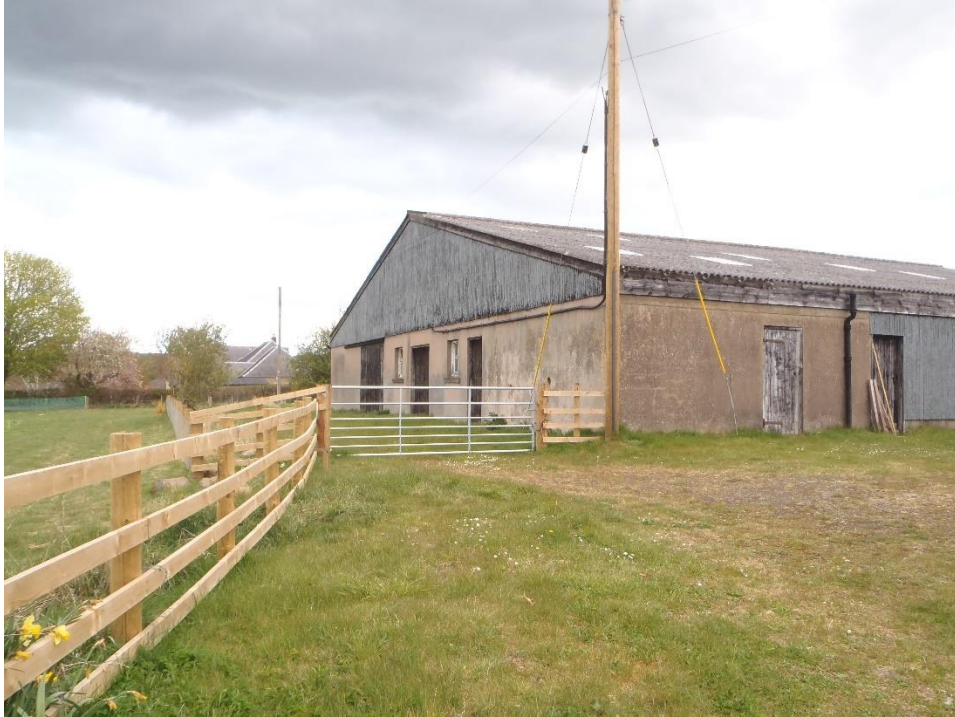
The main area of the site is dominated by Black Barn, a former agricultural barn that is now disused and in a poor condition with area of the roof having fallen in. The barn is surrounded by a strip of improved neutral grassland that is managed through mowing and was short at the time of the survey. Species present include daisy *Bellis perennis*, perennial rye-grass *Lolium perenne*, ribwort plantain *Plantago lanceolata*, dandelion *Taraxacum officinale* agg., yarrow *Achillea millefolium*, common nettle, garlic mustard, meadow foxtail *Alopecurus pratensis*, cock's-foot grass, white dead nettle and ragwort *Senecio jacobaea*.

*Photograph 2: showing a view of the site*

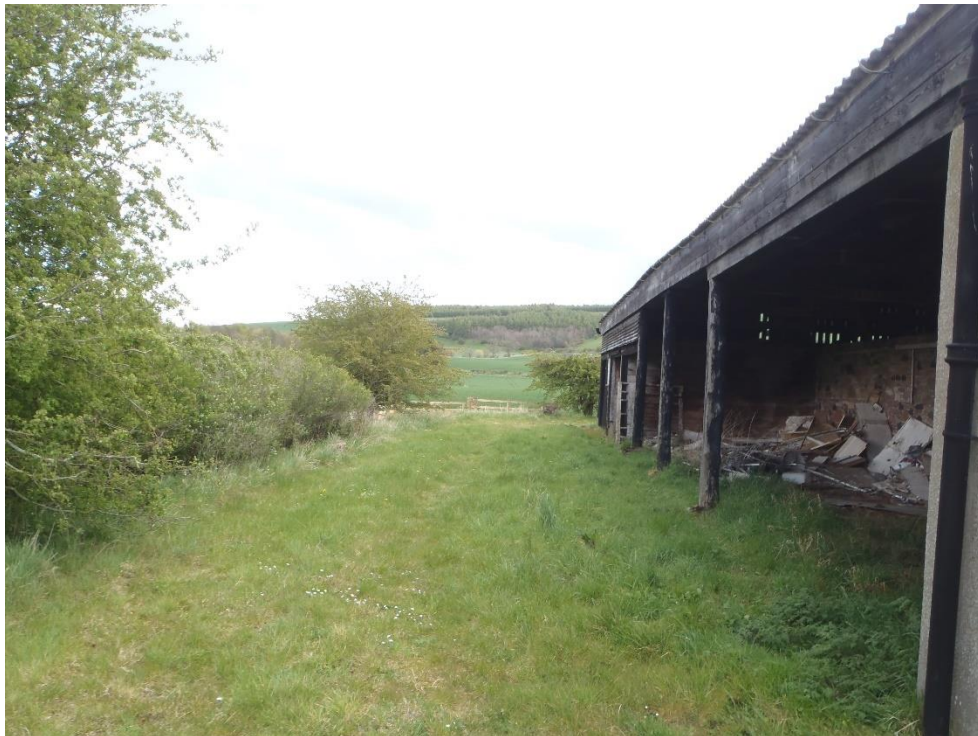
*Photograph 3: showing a view of the grassland around the barn*

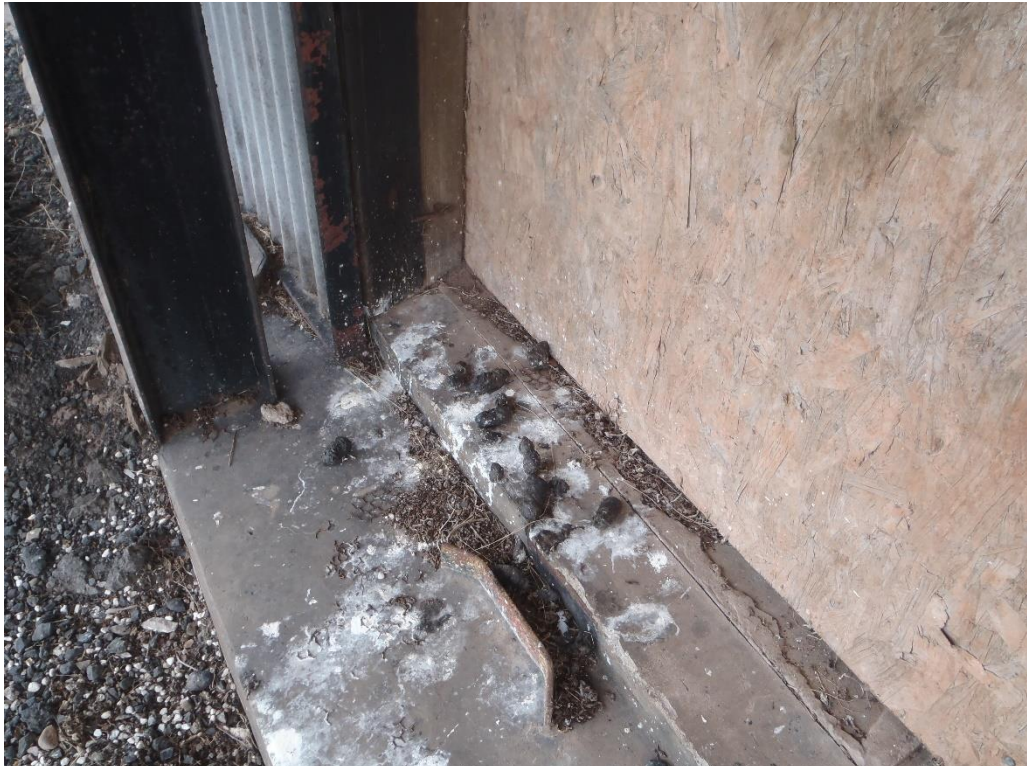
The barn present provides the most suitable habitat on site for nesting birds. Evidence of pigeon *Columba palumbus* was noted throughout the site and the internal surfaces of the barn were covered in guano. Several pigeon carcasses were found inside the barn. Barn owl *Tyto alba* pellets were found both inside and outside of the barn; however, no evidence of roosting or breeding barn owl was found during the survey.

*Photograph 4: Barn owl pellets identified on the east side of the barn*

- ☛ Barn owl nest boxes should be erected in suitable locations nearby in the landscape and fitted to trees or poles to provide nesting opportunities for barn owl post-construction. Alternatively, a barn owl nesting space could be incorporated as part of the building design.

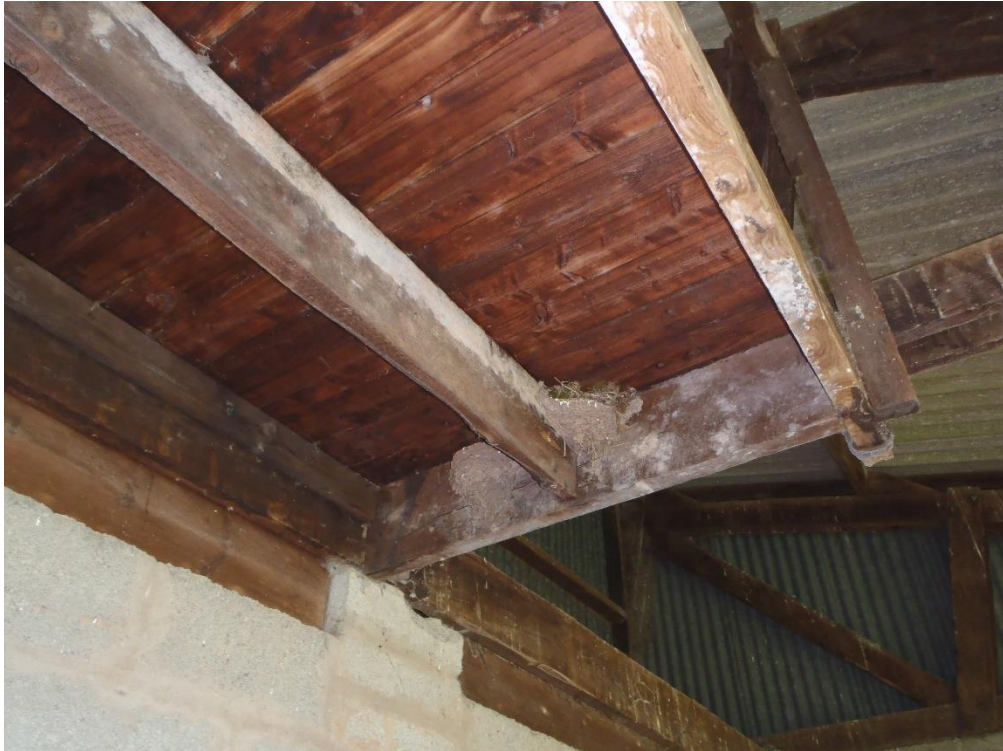
Swallow *Hirundo rustica* nests were also noted within the barn. These were not active at the time of the survey; however, swallows were

noted to be present foraging around the site and they are likely to build nests within the barn.

*Photograph 5: Showing a view of a swallow nest within the barn*

- ☛ Swift boxes should be incorporated into the structure of the new building as part of the design and layout considered.
- ☛ As part of the design and layout considered, bat boxes should be placed on or around the site boundaries if possible. This could

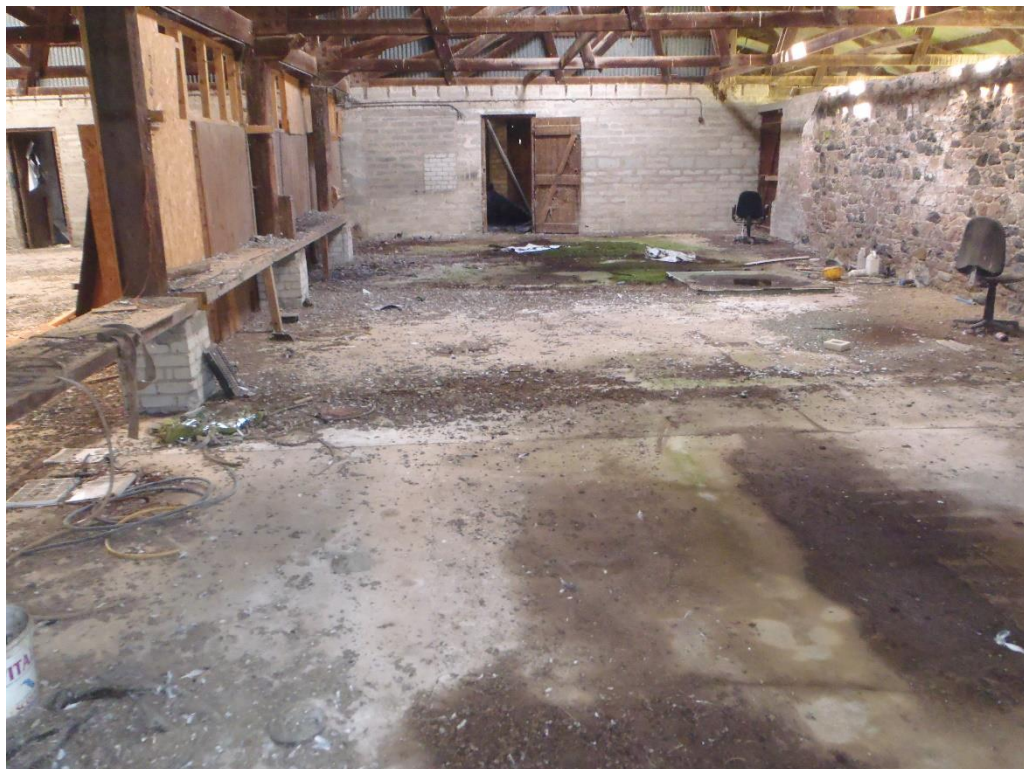
Black Barn dominates the site and is approximately 25m long by 25m wide, constructed from a timber frame. The walls are comprised of brick and corrugated metal sheets and the roof is pitched covered with corrugated cement sheets, some of which were noted to have fall into the building.

The barn was found to be in a poor condition and is exposed to the elements (i.e. wind and rain), through holes in the roof and an open side on the northern elevation reducing the suitability for roosting bats. Damp patches were noted on the floor where water enters the barn.

*Photograph 6: Showing a view inside the barn*

Internally the surfaces were found to be covered with pigeon guano that was dense in places. The timbers present within the barn were also noted to be damp with algae present in places.

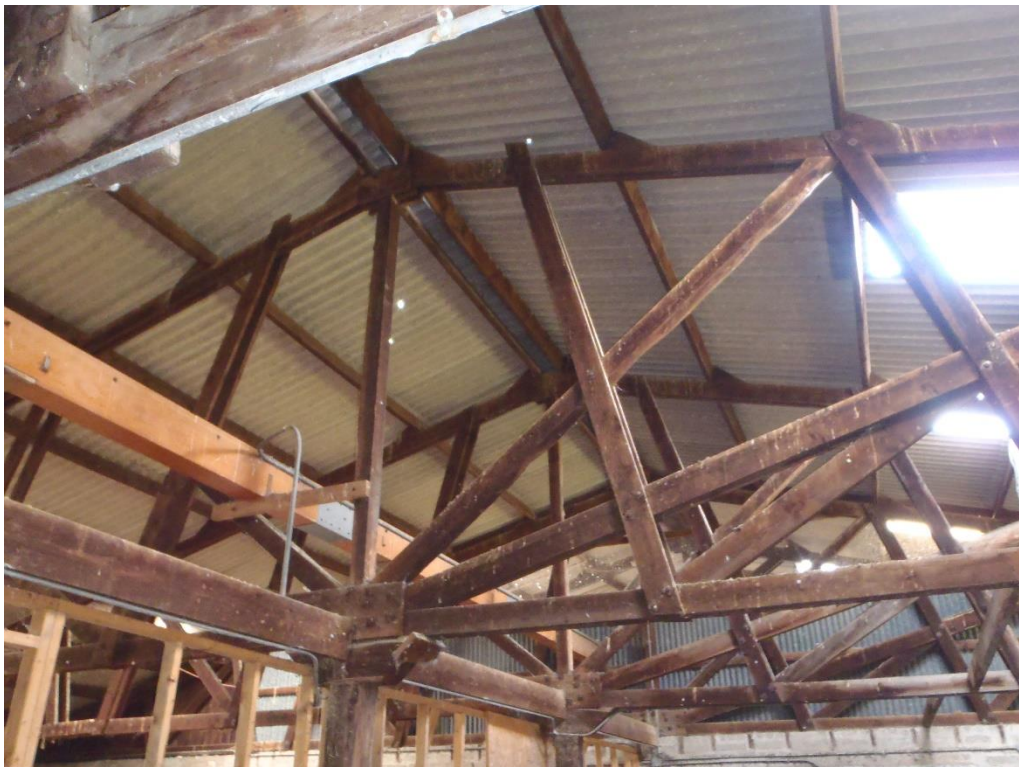
The roof structure of the barn provides few opportunities for roosting bats and suitable areas were noted to be covered in pigeon guano that would deter bats from roosting. Dense cobwebs were noted in places and the timbers were found to be wet from water ingress into the building.

*Photograph 7: Showing a view the barn roof*

No evidence of bat activity was found and the barn is not considered to be suitable for roosting bats. It is therefore assessed as providing Negligible Roost Potential for bat species.
