**Proposed New Patio Window Opening to the Former Westruther Parish Church, Westruther, TD3 6NS, Scottish Borders for Mr. & Mrs. G. Wright.**  
**Design justification for the formation of new patio doors in the south elevation.**

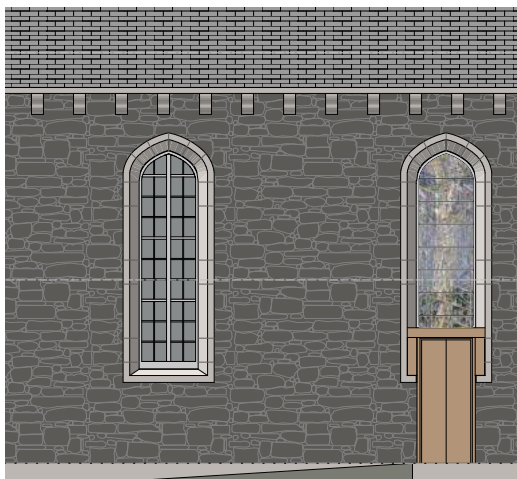
2 Existing Plan & Elevation in location of Proposed alterations.

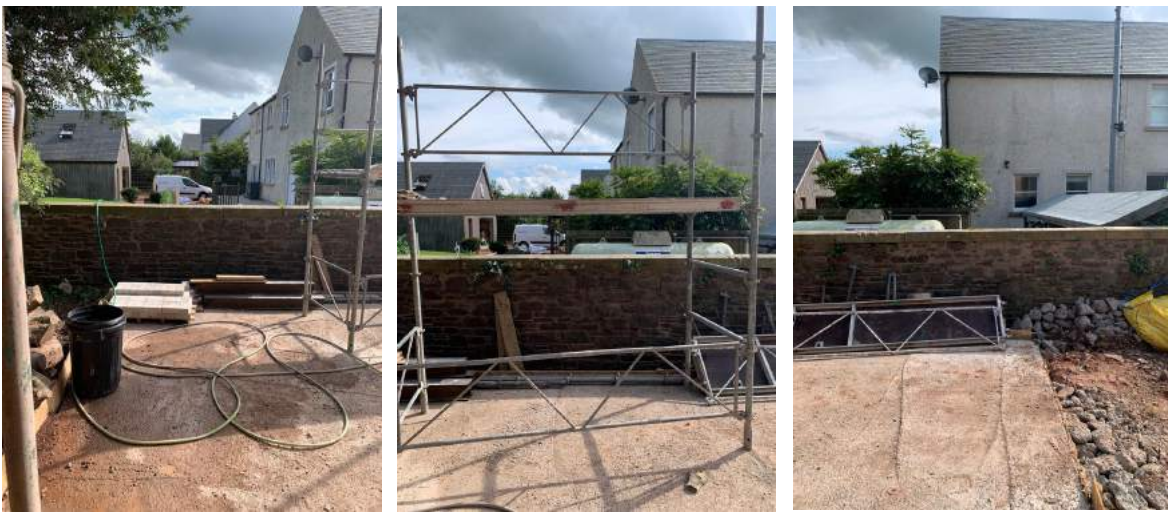
Aspect from the proposed patio to the boundary is restricted by an existing stone wall. Beyond the wall is a LPG gas tank to which the neighbour has created a fence and planting screen from his property to this installation. There is therefore no overlooking from the patio to the neighbour's garden due to the existing screening. A further fence is proposed to raise the boundary screen to 1.8m through a timber boarded fence within the applicant's property to reinforce the screening.

*4 Obstructed views from left-, centre- and right-hand sides of the proposed sliding door position.*
