EXECUTIVE SUMMARY : The Arches - Hawick

HEADTEACHER INTERVIEWS: The Arches - Hawick

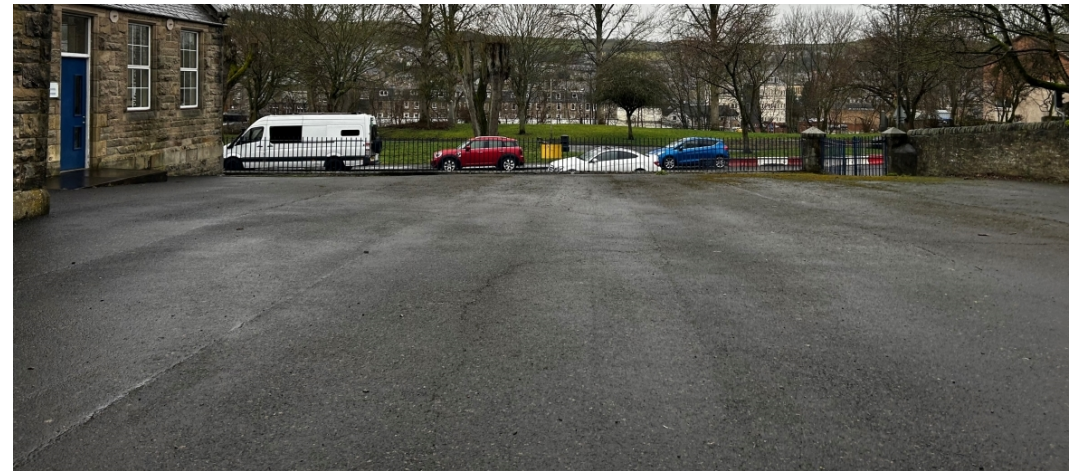
Playground

- There was a small tarmac playground to the front of the school.
5. **Does the school estate have the right balance of traditional and modern/flexible working spaces?**

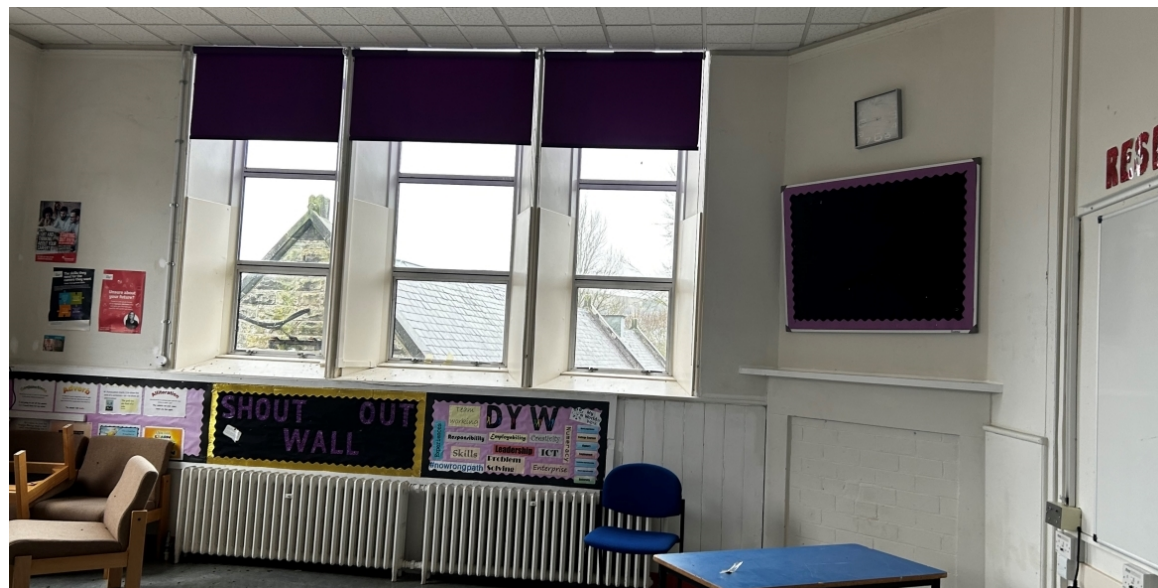
Classroom with new blinds

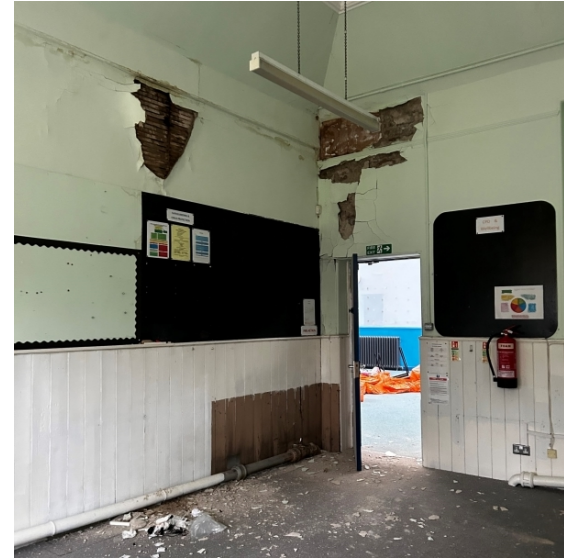
- The building has not been occupied for a number of years and a number of areas were observed to be in a poor state of repair.
- Particular issues with lathe plaster crumbling off the walls and ceilings in the rooms to the west of the building.

Classroom with crumbling lathe plaster walls

- The school was internally in a poor state of repair, particularly on the West side of the building, where areas of the ceiling and wall lathe plaster were badly crumbling.
