## FIELD PERFORMANCE REPORT

**BS EN 15330-1:2013 – Hockey & Football [Short Pile]**

**Field Reference:**                      **Jedburgh Grammar School**

**Report Number:**                      **17092/2663s**

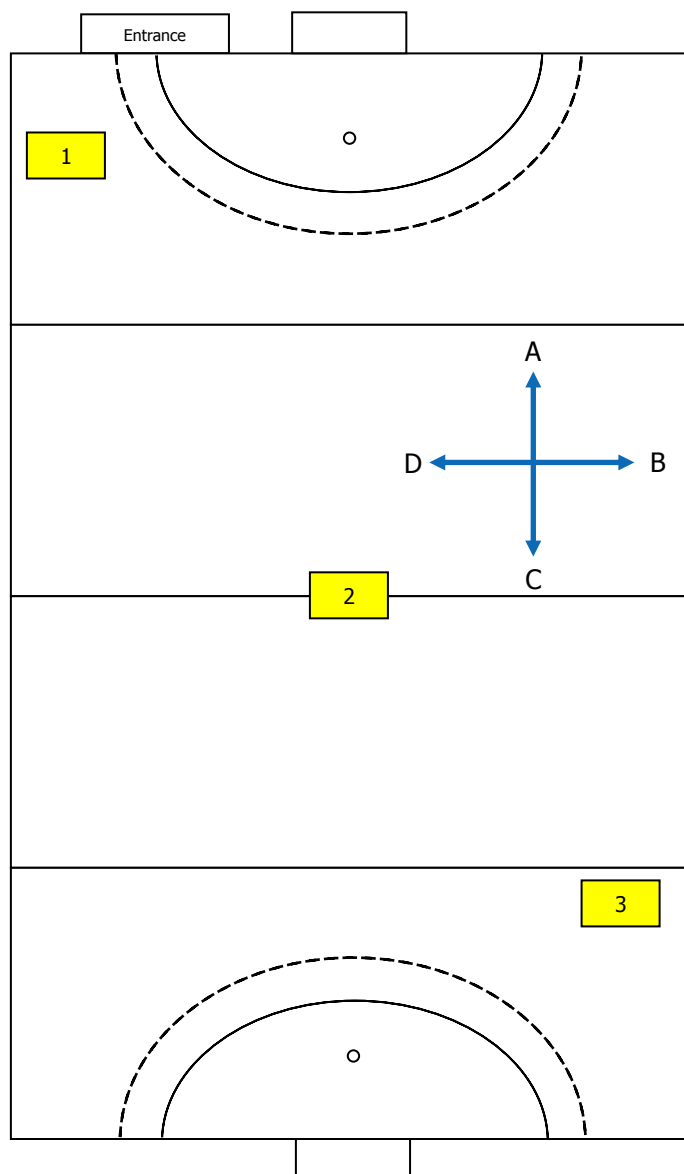
### TEST LOCATIONS

- 2.1 Testing was carried out at 3 locations across the pitch, as show in Appendix A.
- 2.2 The suit of testing was carried out in accordance with the requirements of BS EN 15330-1:2013 (Hockey & Football [Short Pile]) for the parameters examined as follows:
  - 2.2.1 Rotational Resistance – EN 15301-1:2007
  - 2.2.2 Shock Absorption – EN 14808:2005
  - 2.2.3 Vertical Deformation – EN 14809:2005
  - 2.2.4 Porosity – EN 12616:2013
  - 2.2.5 \*Surface Regularity and Dimensions – EN 13036-7:2003
