SPORT ENGLAND TYPE 1 MUGA TEST REPORT

Facility Reference	Kingsland Primary School
Facility Address:	Neidpath Road Peebles EH45 8NN
Report Number:	17092 / 2615s
Report Status:	FINAL
Issue Date:	17/05/2016
Client:	Scottish Borders Council Council Headquarters Newtown St Boswells TD6 0SA

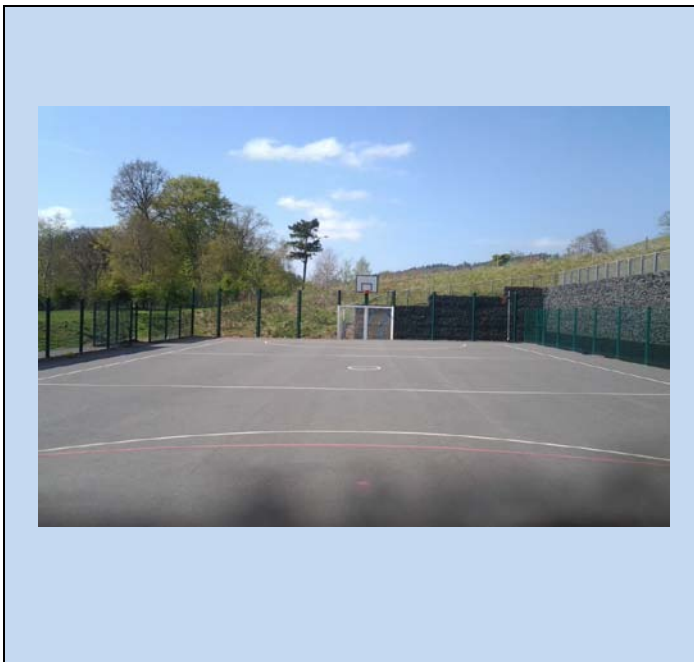
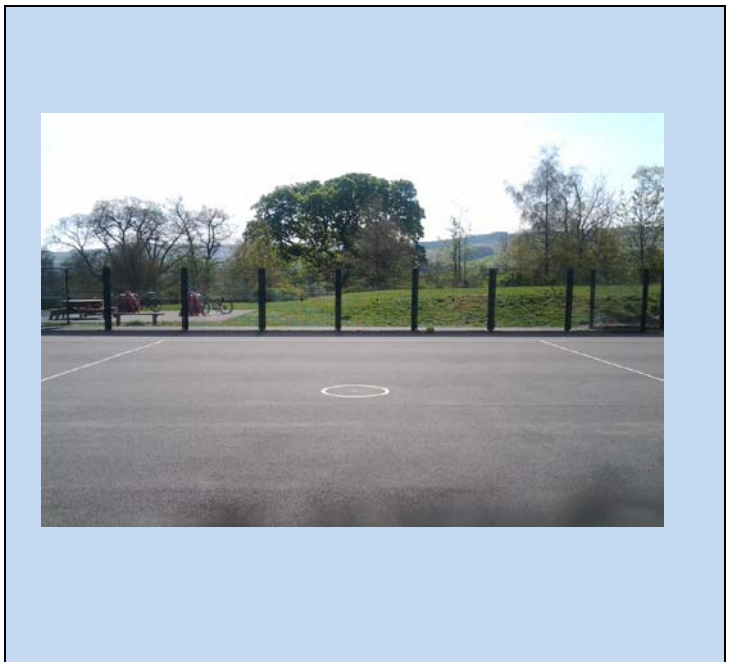
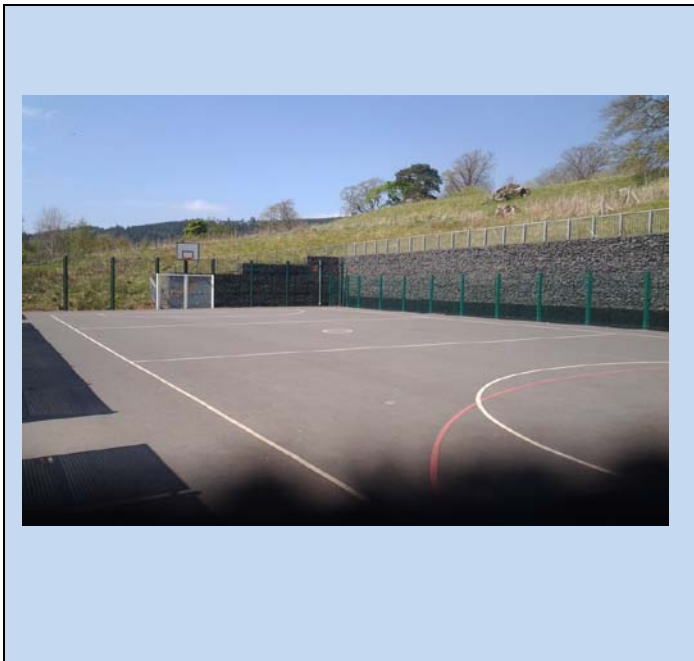
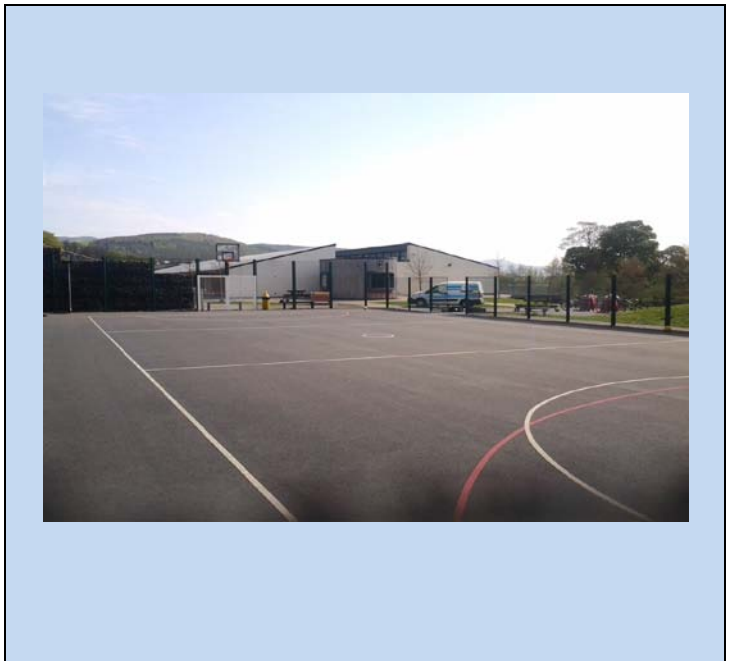
Site Photographs - Overview

Property	Condition
Visual Inspection	Aesthetics	Damage	No damage visible
		Colour	Non present
		Line Markings	In good condition
		Fencing	In good condition
		Goals, Equipment	Goals painted on fence, in good condition. Basketball nets in good condition, backboards in poor condition. Portable Netball nets also present, damage to netting
		Housekeeping (Litter etc)	Some litter/debris around edges of surface

This surface will require a proper maintenance regime. Maintenance of the surface combined with management of the users is vitally important to the surface longevity and continued performance. A robust maintenance schedule should be put in place in accordance with the surface manufacturers recommendations and taking into account the hours of use on the surface.
