SPORT ENGLAND TYPE 1 MUGA TEST REPORT

Facility Reference	Lauder Primary School
Facility Address:	Allanbank Gardens Lauder Berwickshire TD2 6AB
Report Number:	17092 / 2615s
Report Status:	FINAL
Issue Date:	17/05/2016
Client:	Scottish Borders Council Council Headquarters Newtown St Boswells TD6 0SA

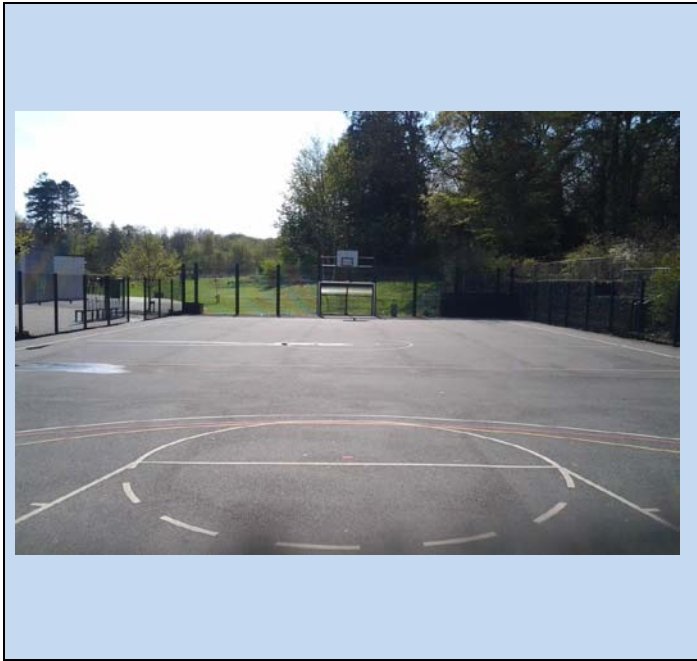
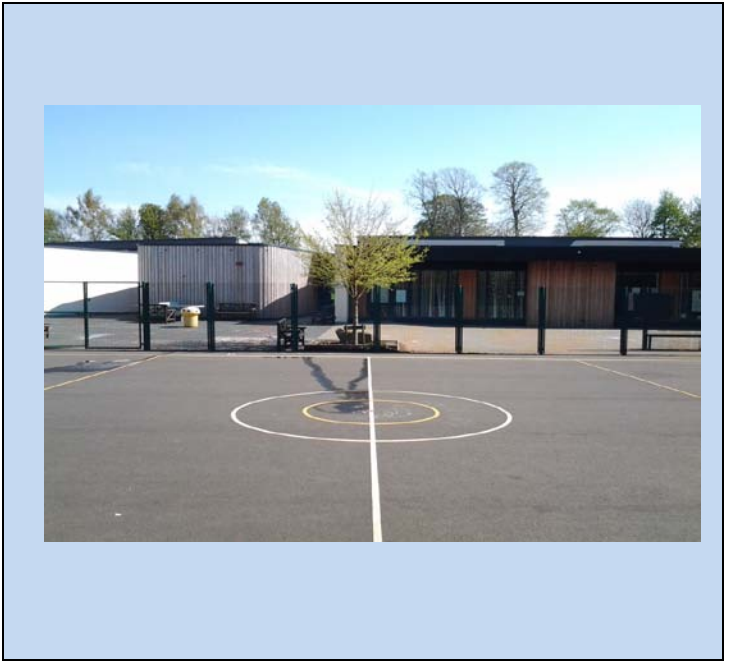
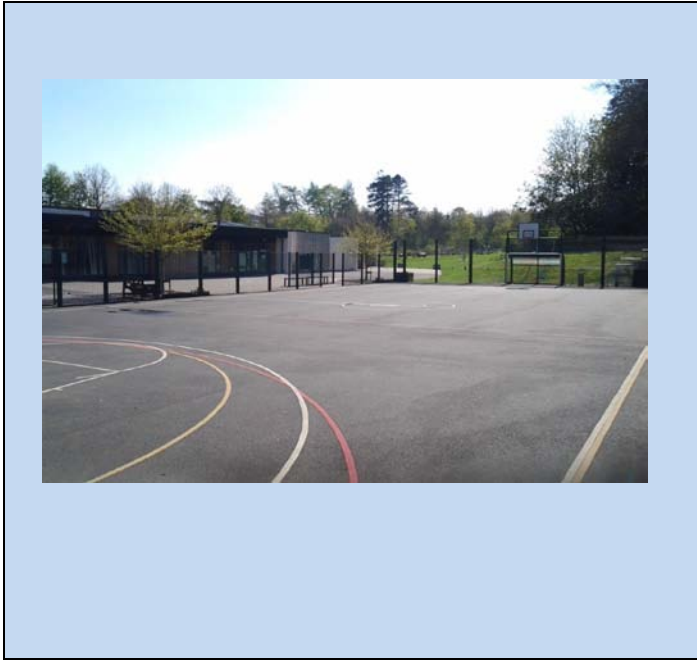
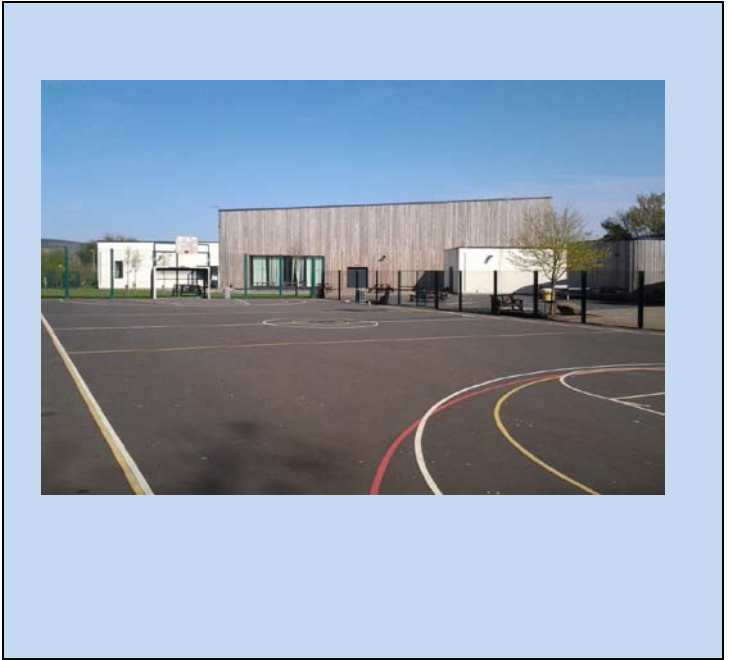
Site Photographs - Overview

Property	Condition
Visual Inspection	Aesthetics	Damage	No damage visible
		Colour	None present
		Line Markings	Line markings are showing signs of cracking and should be monitored
		Fencing	Fencing is in good condition
		Goals, Equipment	Equipment in good condition. Goals in good condition and no damage visible.
		Housekeeping (Litter etc)	Some debris and litter around edges
