Arboricultural Impact Assessment

For Dingleton

September 2023

By Toby Wingham

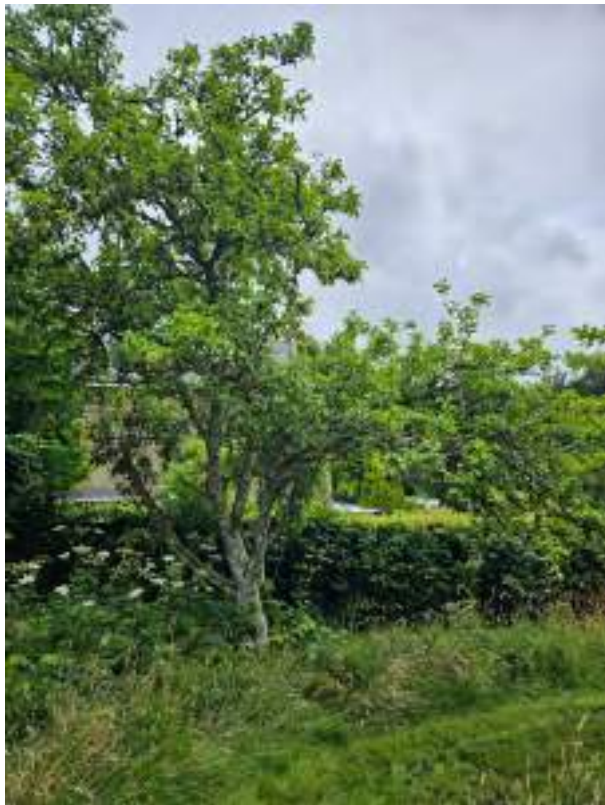
Wych Elm Tree ID #2

Tree Details	
Latin Name:	Malus domestica
Tag Number:	2509
Stem Diameter [mm]:	297.83
Priority:	
Comments:	Pruning wounds at around 80mm in diameter. Asymmetrical crown. Adjacent to neighbouring property. Slight lean to north.
Recommendations:

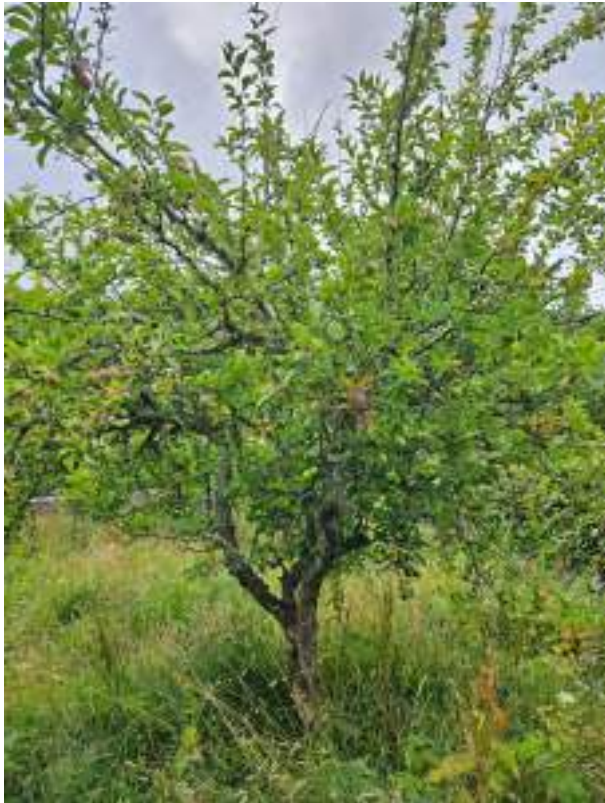
Apple Tree ID #6

Tree Details	
Latin Name:	Malus domestica
Tag Number:	2507
Stem Diameter [mm]:	151.66
Priority:	
Comments:	Large pruning wound at 0.5m on North of tree with around 100mm diameter. Minor crown diaback. Crossing branches.
Recommendations:

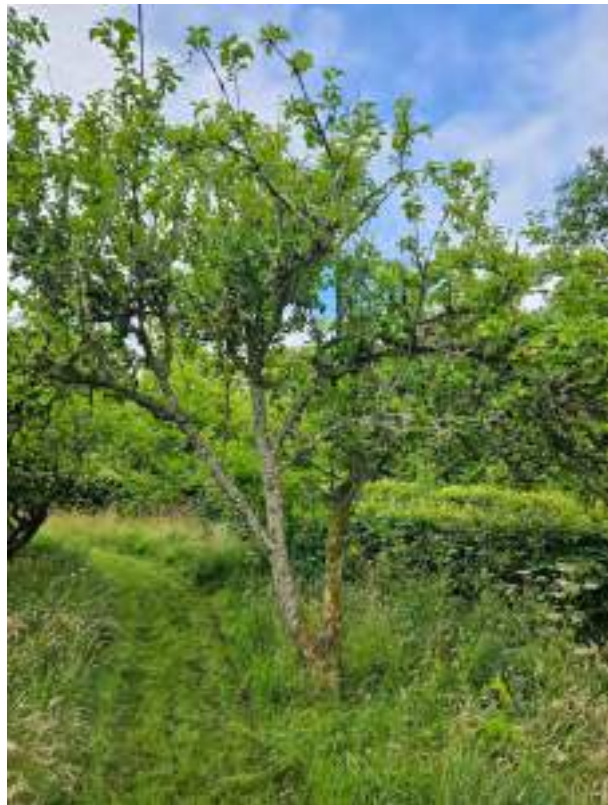
Apple Tree ID #9

Latin Name:	Malus domestica
Tag Number:	2504
Stem Diameter [mm]:	219.32
Priority:	
Comments:	Multi stem union at 0.5m. Large pruning wound at union with diameter of around 100mm. Minor deadwood.
Recommendations:

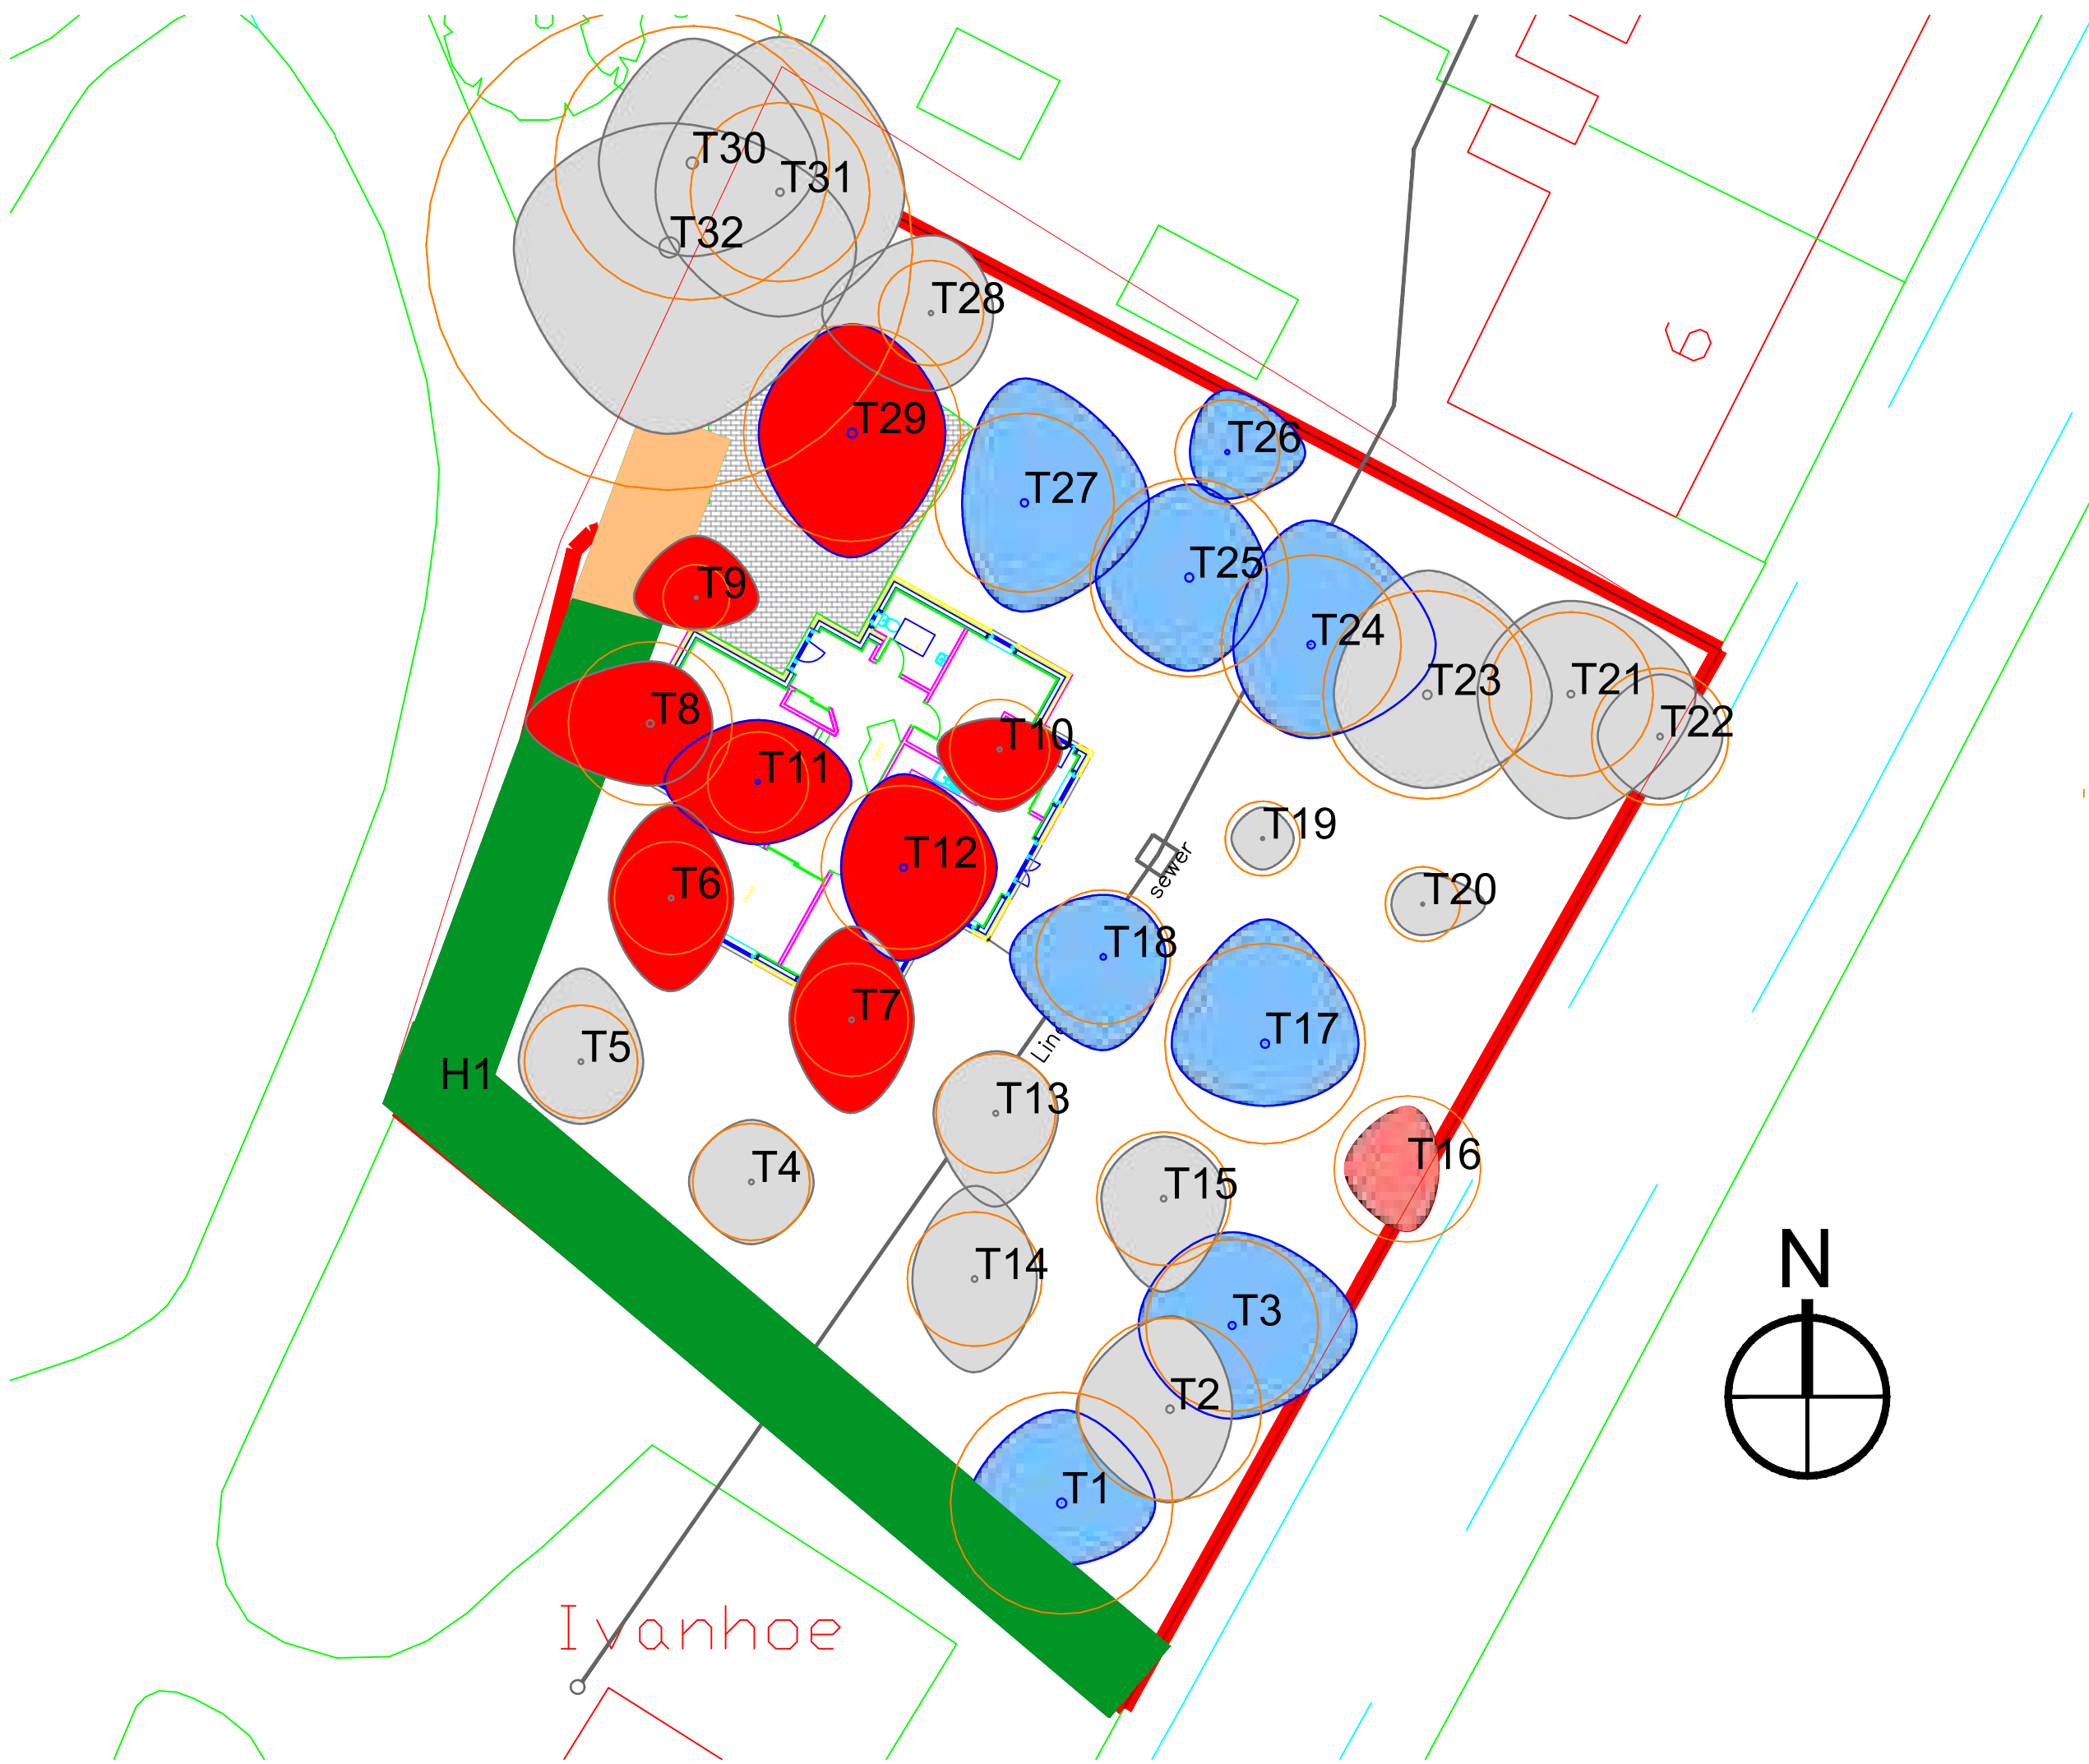
Site Dingleton		
Title Drawing 2: Recommended Tree Works		
Drawing No. 230929002	Scale 1:200@ A3	Date 29/09/2023
Drawn PMR	Checked PCL	Approved PMR

One tree, T16 requires removal as part of sound arboriculture due to its condition.
