# Annex Five

## Strategic Review of Sports, Leisure, Culture & Community: Building Audits

**Alan Jones Associates**

September 2023

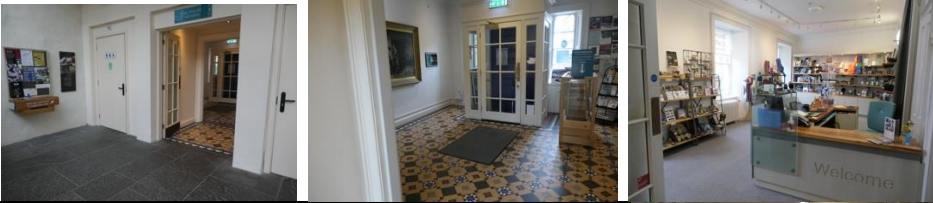
<p>Reception</p>	<p>In good condition for age and use as a reception for the museum.</p>	<p>A</p>

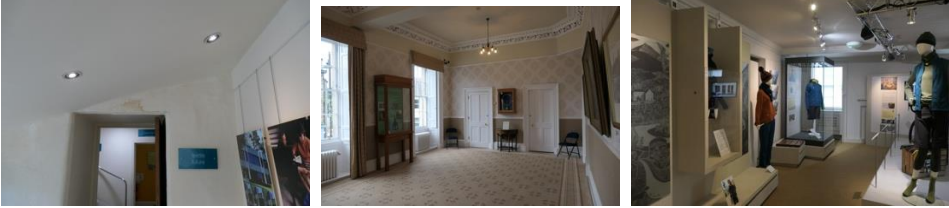
<p>Gallery/ display areas</p>	<p>Good condition but evidence of some water ingress</p>	<p>B</p>

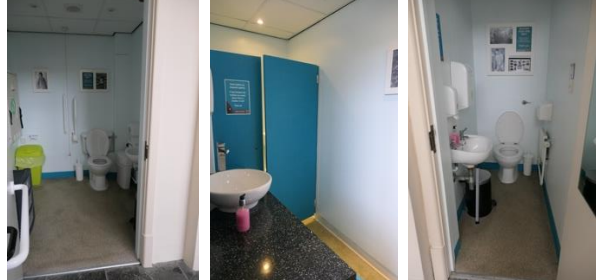
<p>Toilets</p>	<p>Good condition</p>	<p>A</p>

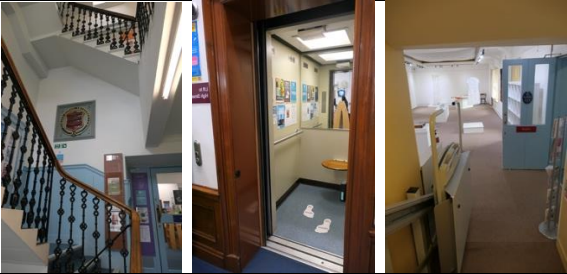
<p>Access</p>	<p>Access is difficult via steep staircase. The lift is accessed through the adjacent tourist information office which is not always open at the same time as the library and institute. The lift only gives access to the library floor and not the Institute Museum/gallery. There is a platform lift in the library to access a gallery space</p>	<p>C</p>

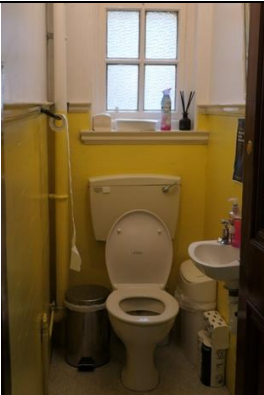
Toilets	Only toilet available is for staff and is occasionally used for members of the public	C

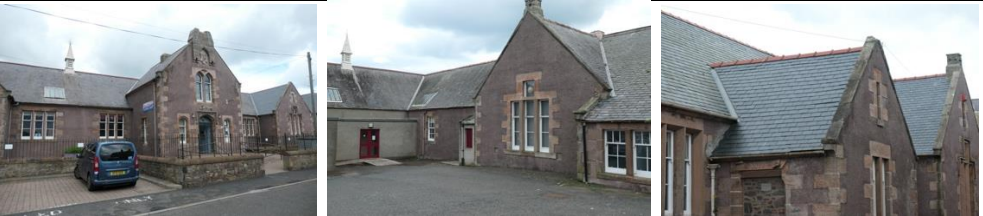
External fabric	The building is generally in good condition for its age with a portion of the roof looking as if it has been relatively recently re-roofed.	A

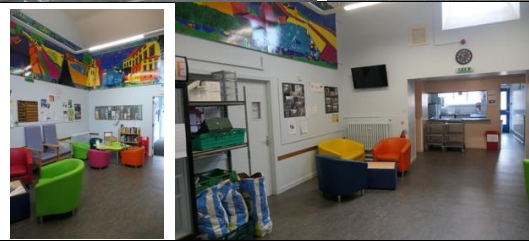
Reception area	The area is generally in good condition	A

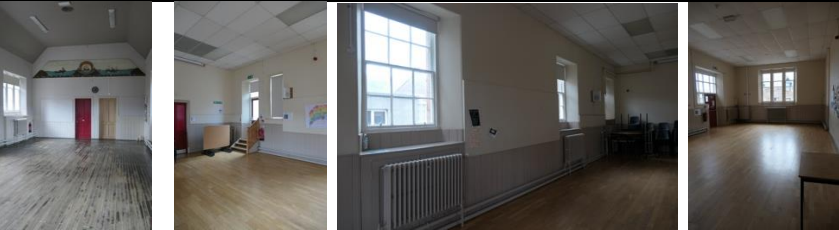
The main rooms/former classrooms	These are generally in good condition with evidence of recent refurbishment to some.	A

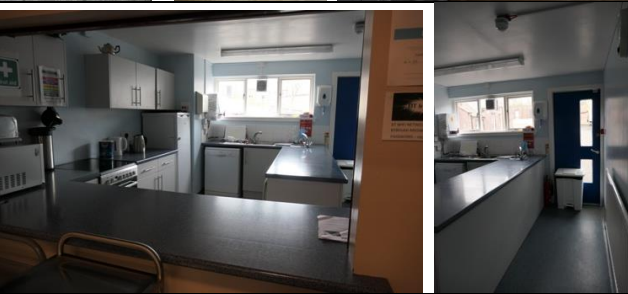
Kitchen area	The kitchen area is generally in good condition	A

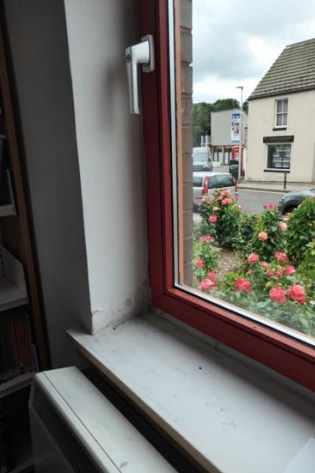
<p>Windows</p>	<p>Metal frame windows are not sealed to the internal wall in places which allows draughts to come in. In addition, the windows can't be opened in the summer when the library needs ventilated.</p>	<p>C</p>

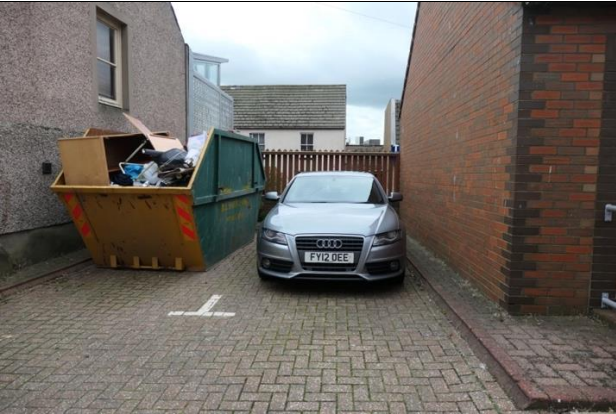
Rear of building	Dedicated staff parking is taken over by care home adjacent and a skip in one of the spaces	C

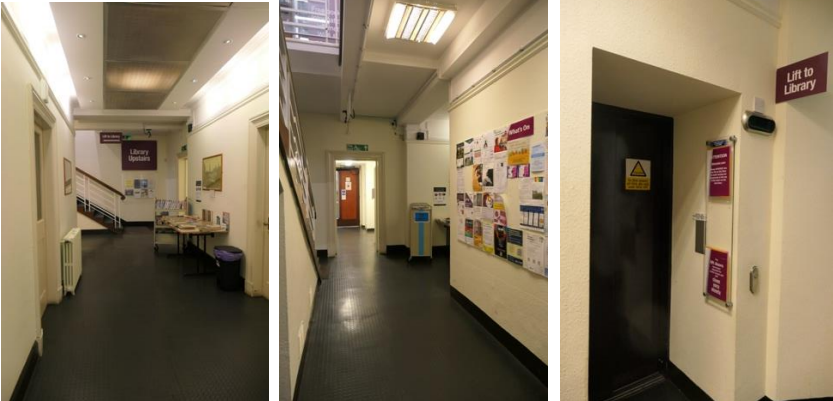
Entrance hall	Generally in good condition with a lift to the upper floor where the library hall is.	A

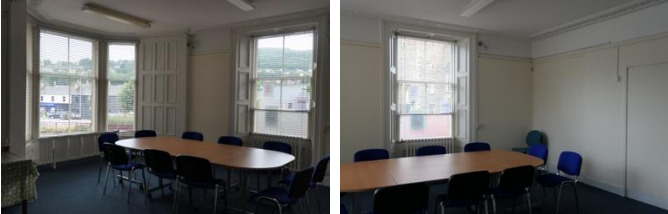
Ground Floor Room	Generally in good condition and well decorated	A

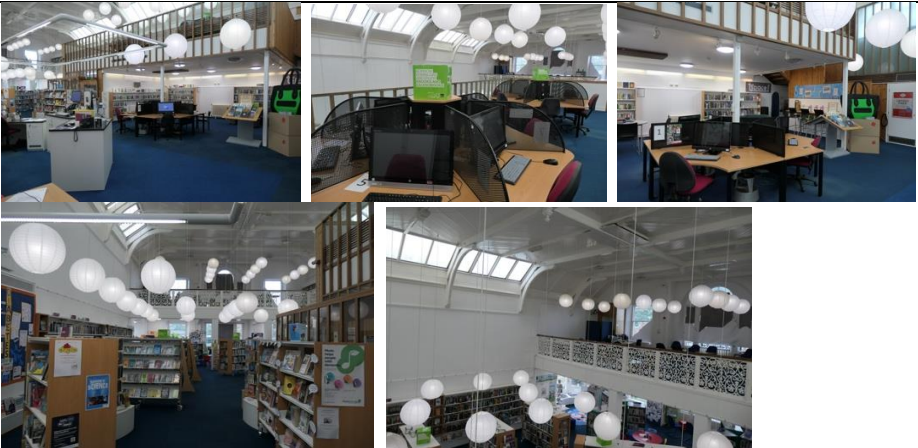
Main Library	In good condition and fit for purpose but there is no disabled access to the upper mezzanine floor where there are computers and reference books	A

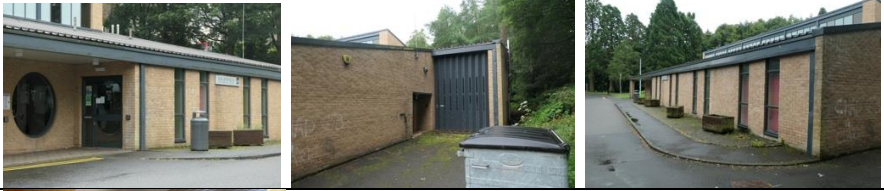
Facility Aspect	Current Condition	Operational Rating	Photographic Evidence
Exterior fabric	Evidence of requiring ongoing maintenance	<b>B</b>

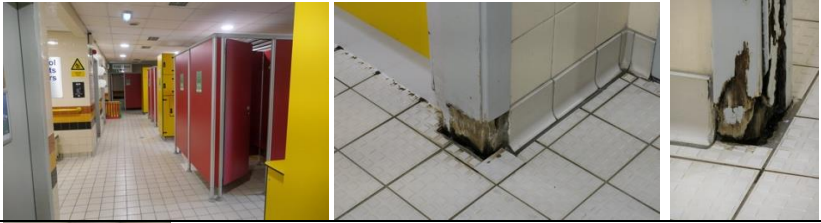
Changing Areas	Generally in good condition but there is evidence of wet rot around the changing areas	<b>B</b>

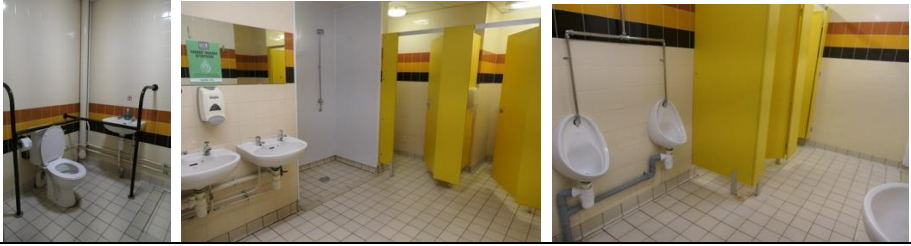
Toilets	Toilets are generally in good condition	<b>A</b>

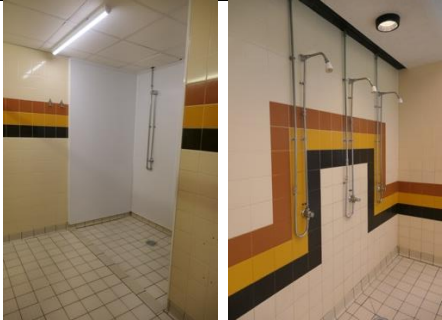
Shower Areas	Generally in good condition	A

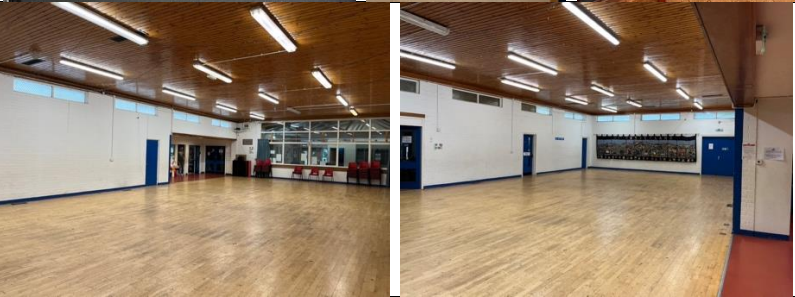
Main Hall	In good condition and fit for purpose	A

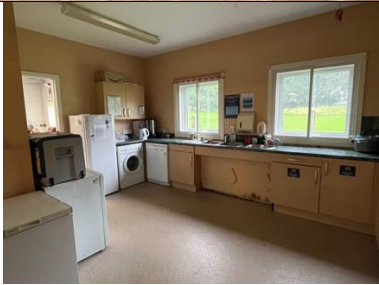
Kitchen	Requires some modernisation	B

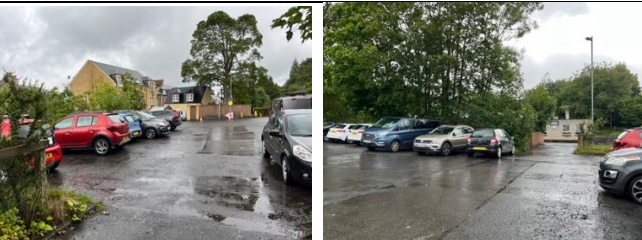
Parking	Within the grounds of the property	A

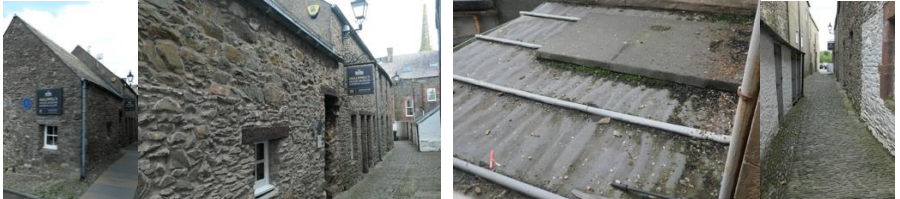
<b>Facility Aspect</b>	<b>Current Condition</b>	<b>Operational Rating</b>	<b>Photographic Evidence</b>	
Exterior fabric	Generally in good for its age condition with ongoing maintenance required	<b>B</b>

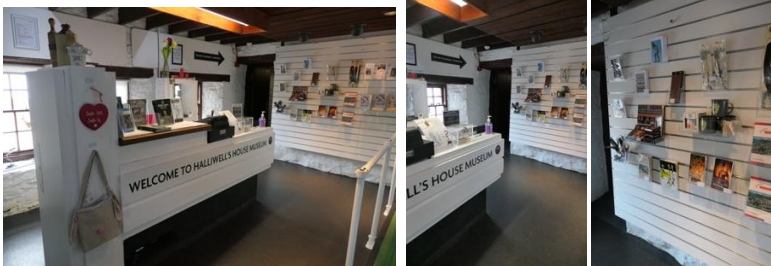
<p>Reception</p>	<p>In good condition for age and use as a reception for the museum but with limited retail/information space</p>	<p><b>B</b></p>

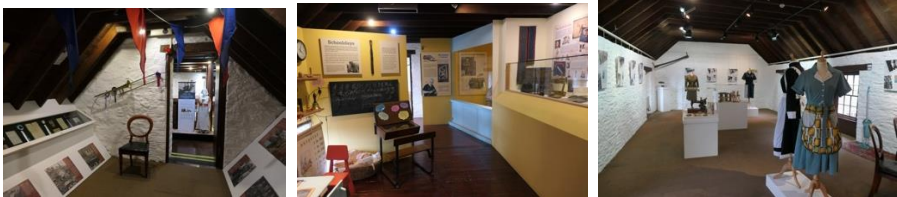
<p>Gallery/ display areas</p>	<p>Generally in good condition but with inadequate heating and lighting. Evidence of water ingress at a point in the Robson Gallery where there is likely to be a building join with another building.</p>	<p><b>B</b></p>

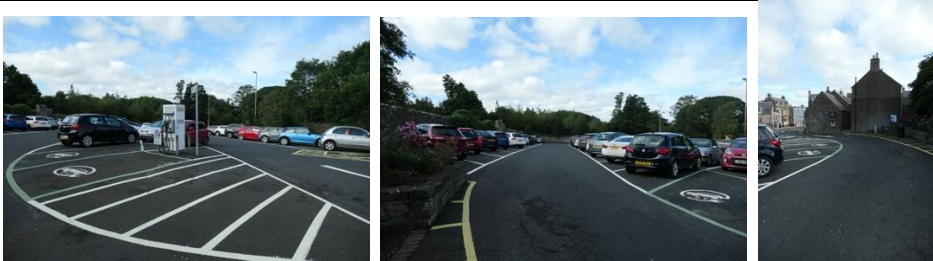
<p>Parking</p>	<p>Extensive parking in the adjacent public car park</p>	<p><b>A</b></p>

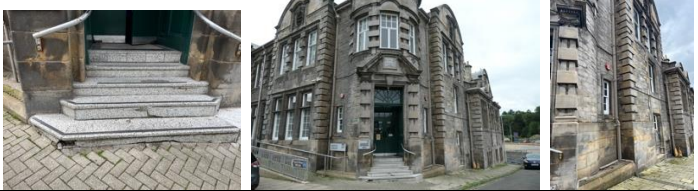
<b>Visual Audit 4 August 2023</b>		<b>Location:</b>	North Bridge Street, Hawick	
<b>Hawick Library</b>		<b>Facility Age:</b>	1904	
		<b>Ownership</b>	Scottish Borders Council	
		<b>Size:</b>	732m <sup>2</sup>	
		<b>Accessibility</b>		<b>Key Notes</b>
<b>Car Parking &amp; Public Transport</b>		There is disabled access to the side of the entrance		The building is generally in a good condition for its age. Normal age-related deterioration, maintenance issues Heating is said to be temperamental
On-street parking				
<b>AUDIT TABLE</b> <b>Ratings</b> - A - Good condition / fit for purpose. B - Required moderate to significant investment C - question whether fit for purpose				
Facility Aspect	Current Condition	Operational Rating	Photographic Evidence	
Exterior fabric	Stonework and entrance maintenance required	<b>B</b>

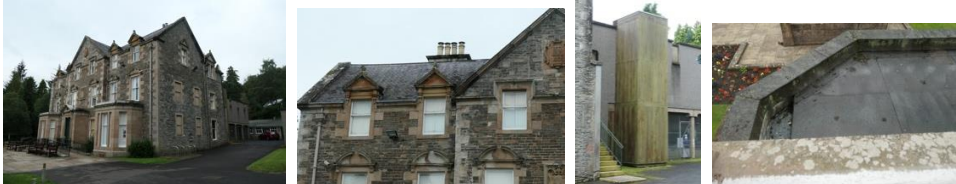
Facility Aspect	Current Condition	Operational Rating	Photographic Evidence
Exterior fabric	Stonework and roof maintenance required	<b>B</b>

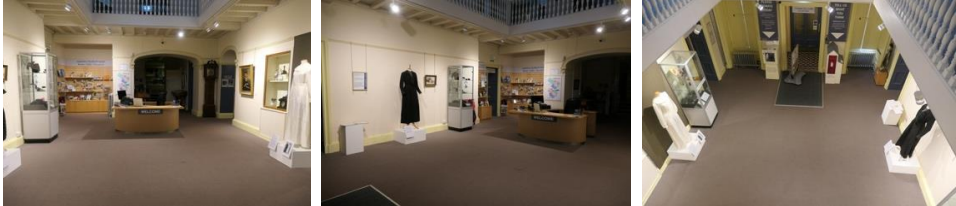
Reception	Good condition	<b>A</b>

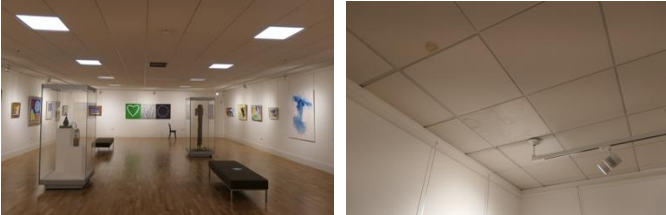
<p>Gallery</p>	<p>Good condition but evidence of water ingress on the ceiling tiles which appear to be caused by problems in the flat roof</p>	<p><b>B</b></p>

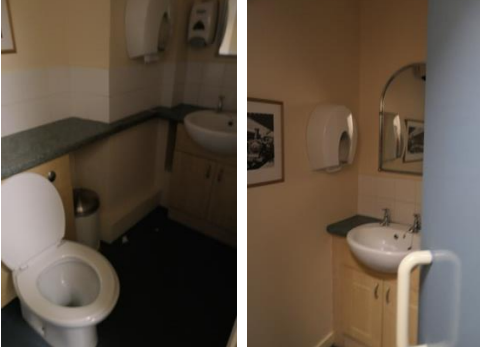
<p>Toilet</p>	<p>Good condition</p>	<p><b>A</b></p>

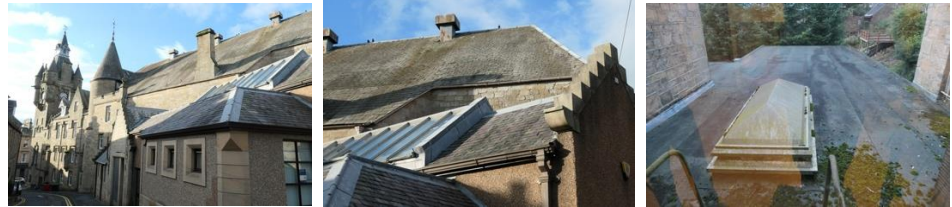
<b>Visual Audit 3 August 2023</b>		<b>Location:</b>	Cross Wynd, Hawick	
<b>Hawick Town Hall</b>		<b>Facility Age:</b>	1886	
		<b>Ownership</b>	Scottish Borders Council	
		<b>Size:</b>	1,140m <sup>2</sup>	
		<b>Accessibility</b>		<b>Key Notes</b>
<b>Car Parking &amp; Public Transport</b>		There is disabled access to the side and rear of the property		The building is generally in a good condition for its age. Normal age-related deterioration, maintenance issues
On-street parking				
<b>AUDIT TABLE</b> <b>Ratings - A - Good condition / fit for purpose.</b> B - Required moderate to significant investment C - question whether fit for purpose				
Facility Aspect	Current Condition	Operational Rating	Photographic Evidence	
Exterior fabric	Good condition with some vegetation evident on stonework	<b>B</b>

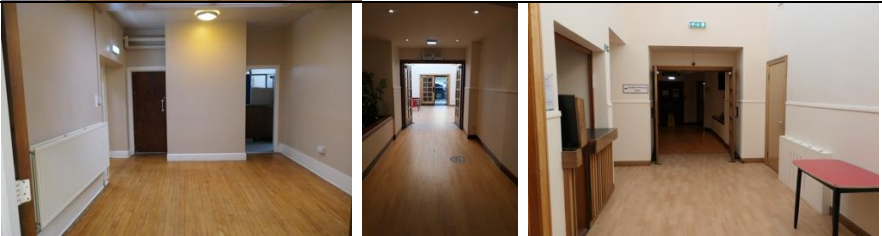
<p>Corridors</p>	<p>Good condition</p>	<p>A</p>

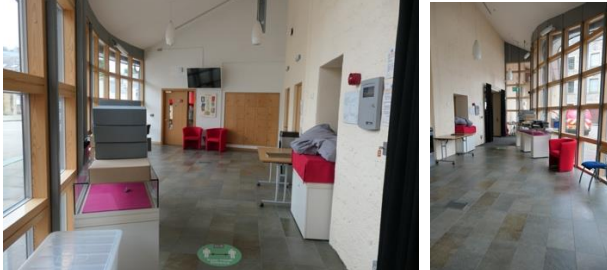
Reception (Heritage Hub)	Good condition	A

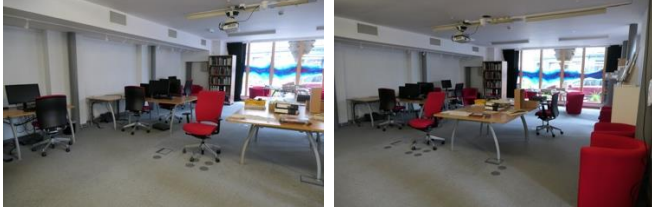
Hub workspace (Heritage Hub)	Good condition	A

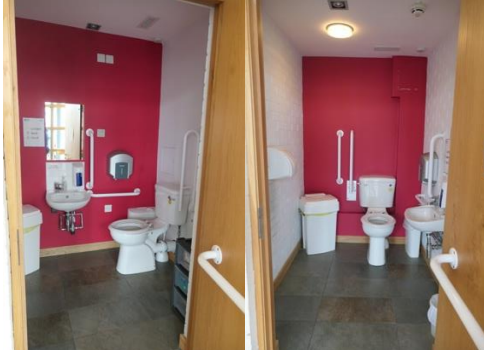
Toilets (Heritage Hub)	Good condition	A

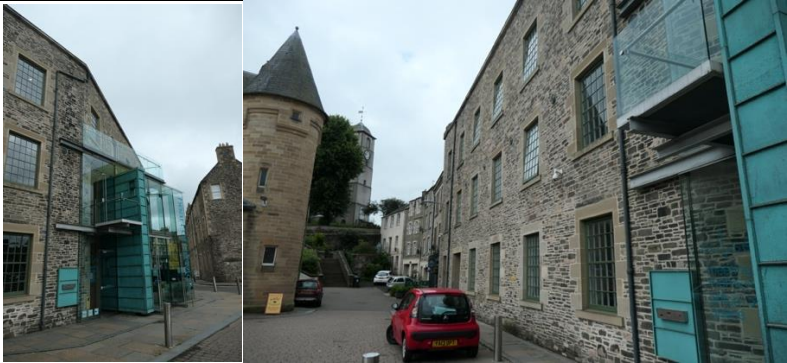
<p>Exterior fabric (Heart of Hawick)</p>	<p>Good condition</p>	<p>A</p>

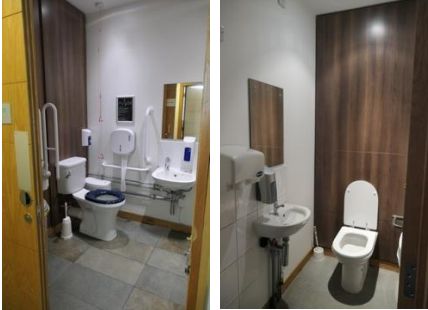
<p>Toilets (Heart of Hawick)</p>	<p>Good condition</p>	<p>A</p>

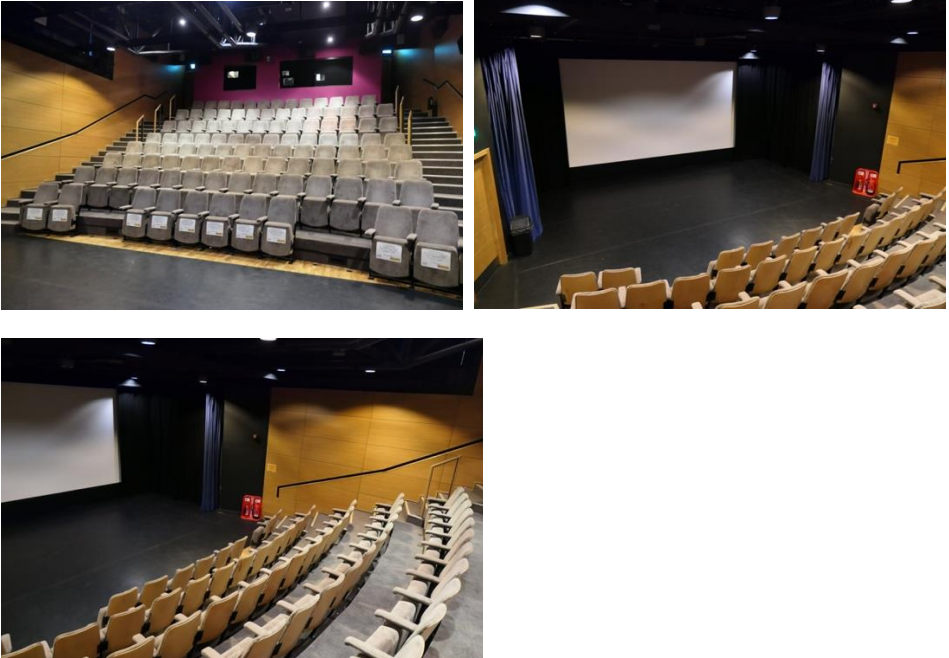
<p>Cinema (Heart of Hawick)</p>	<p>Good condition</p>	<p>A</p>

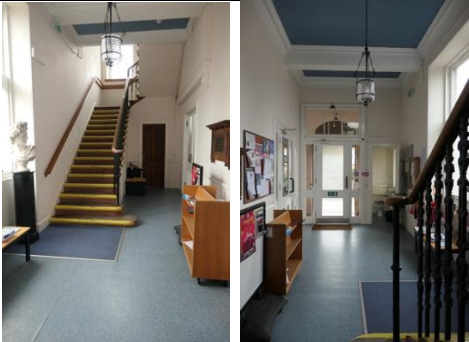
<p>Reception</p>	<p>In good condition, with access to the upper floor which does not form part of the library.</p>	<p><b>B</b></p>

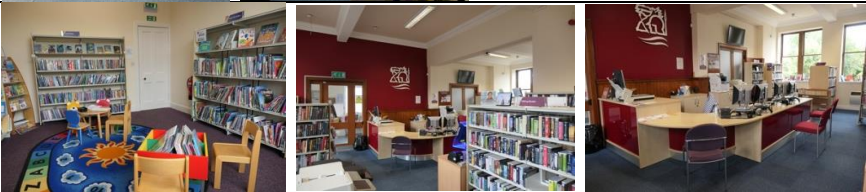
<p>Main library</p>	<p>Generally in good condition</p>	<p><b>B</b></p>

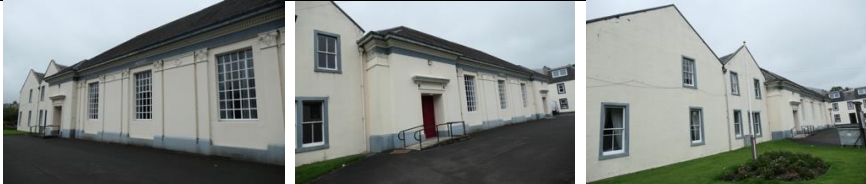
<b>Visual Audit 27 July 2023</b>		<b>Location:</b>	Leithen Road, Innerleithen	
<b>Innerleithen Memorial Hall</b>		<b>Facility Age:</b>	1922	
		<b>Ownership</b>	Scottish Borders Council	
		<b>Size:</b>	372m <sup>2</sup>	
		<b>Accessibility</b>		<b>Key Notes</b>
<b>Car Parking &amp; Public Transport</b>		There is only disabled access to the reception area and main hall.		The building is generally in a good condition for its age. Normal age-related deterioration, maintenance issues
There is parking on street and to the front of the building.				
<b>AUDIT TABLE</b> <b>Ratings - A - Good condition / fit for purpose.</b> B - Required moderate to significant investment C - question whether fit for purpose				
Facility Aspect	Current Condition	Operational Rating	Photographic Evidence	
Exterior fabric	Generally in good for its age condition with ongoing maintenance required	<b>B</b>

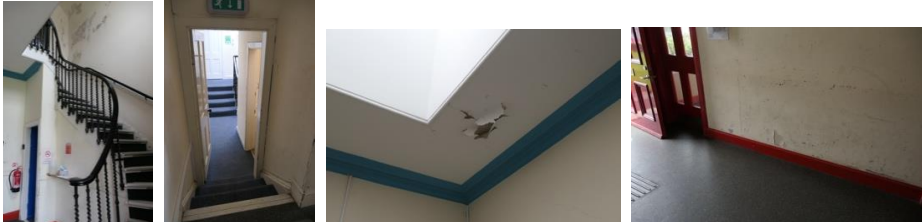
Hallways	There were two main stairwells which require upgrading and maintenance attention	<b>C</b>

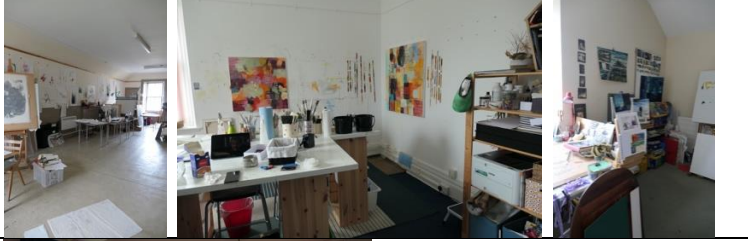
Rooms	General maintenance required in all rooms	B

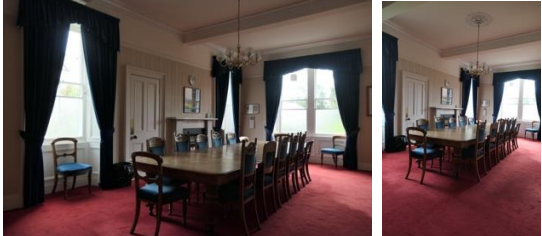
Chamber Room	In good condition as a meeting room	A

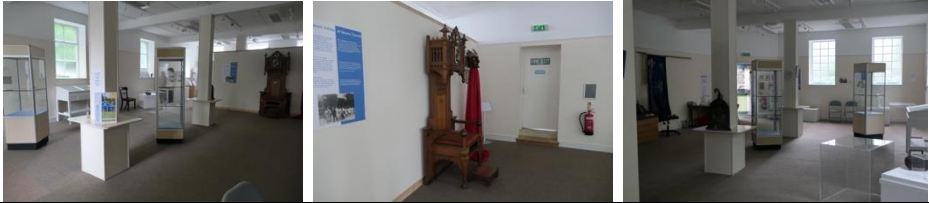
Main hall/gallery	In fair condition for age but inadequate heating and lighting for a gallery space.	C

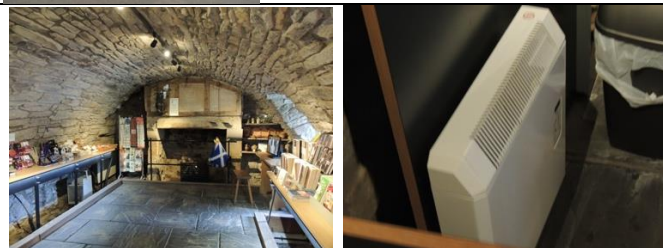
Reception	In good condition for age and use as a reception for the museum. Very inadequate heating with very low temperatures at the end of the season	<b>B</b>

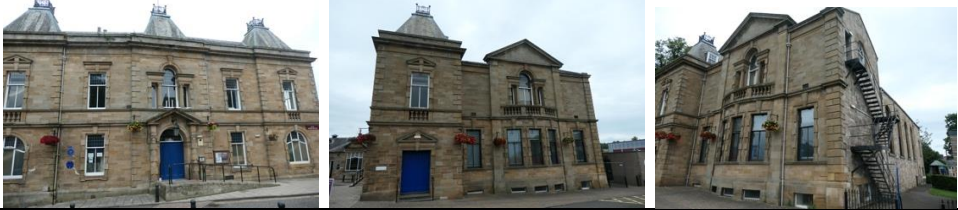
Facility Aspect	Current Condition	Operational Rating	Photographic Evidence
Exterior fabric	Generally in reasonable for its age condition with maintenance required	B

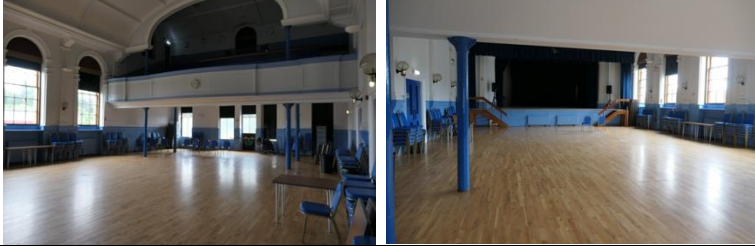
Auditorium/Main Hall	Generally in good condition	B

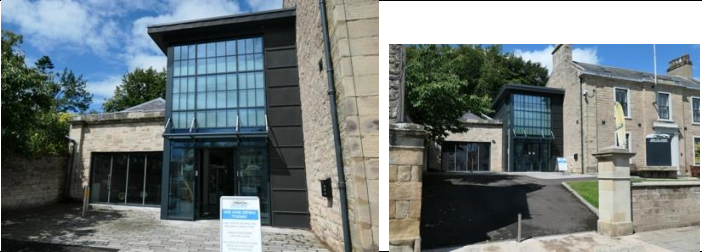
External fabric	Very good with some problems with downpipes blocking, causing water to run over stonework.	A

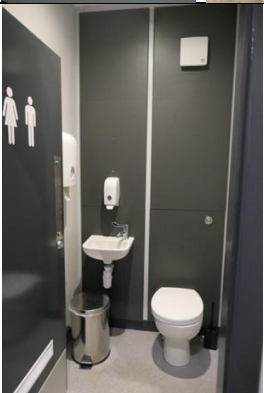
Toilets	Very good and to a high standard	A

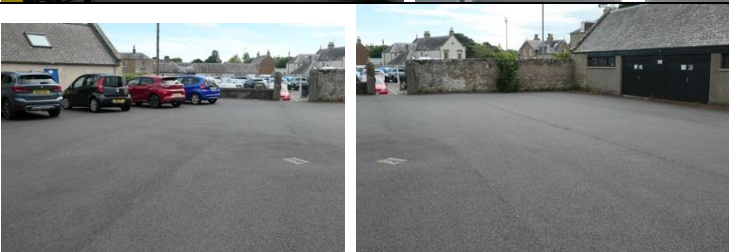
Parking	Within the grounds of the property	A

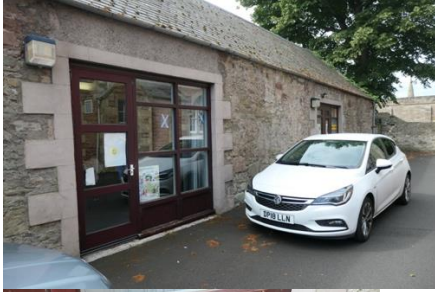
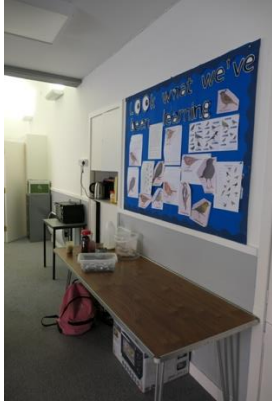
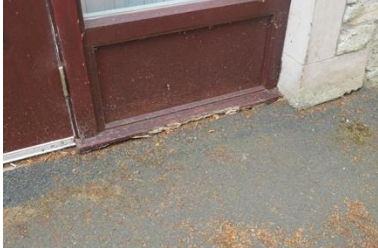
Annex	A separate building in good condition for its age. Could benefit from improvements to the internal fabric	B

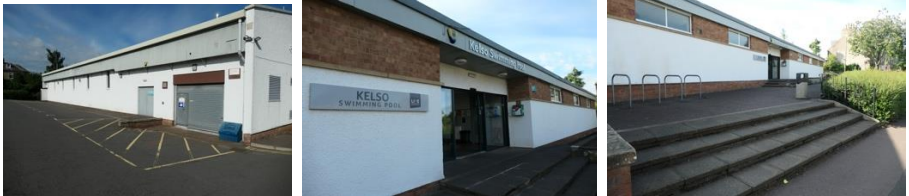
Facility Aspect	Current Condition	Operational Rating	Photographic Evidence
External fabric	Generally in fair condition with no obvious issues visible	<b>A</b>

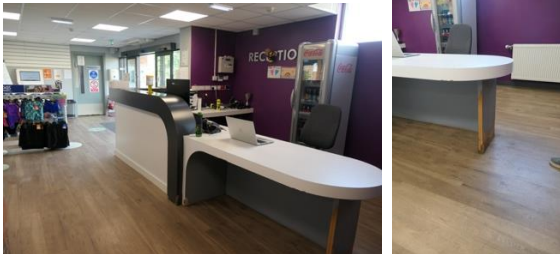
Reception area	Generally, in good condition but reception desk and associated area requiring maintenance/upgrading.	<b>B</b>

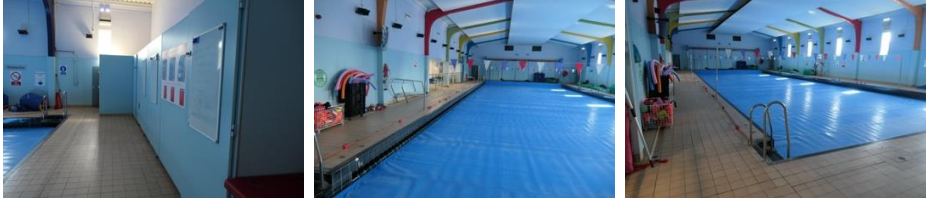
<p>Poolside</p>	<p>Generally in fair condition but with a lack of storage</p>	<p>B</p>

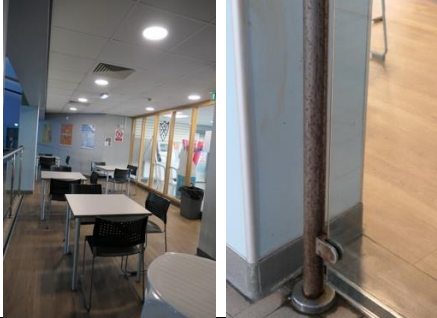
<p>Viewing area</p>	<p>Staff noted that this was inadequate as there was no full barrier between the pool and the visitor viewing which created operational problems during lessons. Poor maintenance evident in rusting of barrier stands.</p>	<p>B</p>

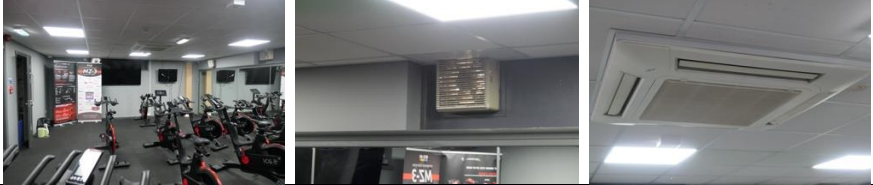
<p>Gym</p>	<p>Generally, in good condition but the central air-cooling unit was not operating and needed maintenance as two external fans had to be used to cool the gym by drawing external fresh air into the gym.</p>	<p>B</p>

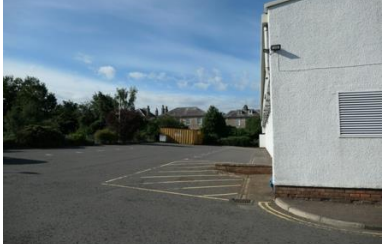
<p>Parking</p>	<p>There was parking to the rear of the building</p>	<p>A</p>

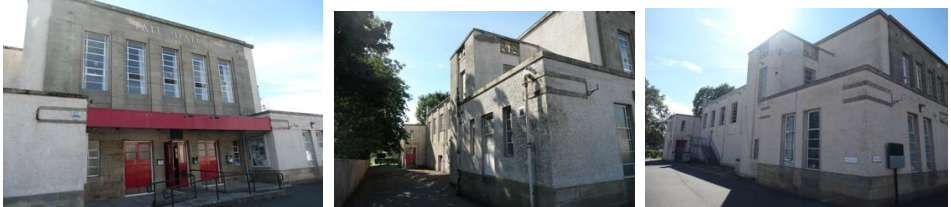
Exterior fabric	Generally in good condition with regular maintenance required	<b>B</b>

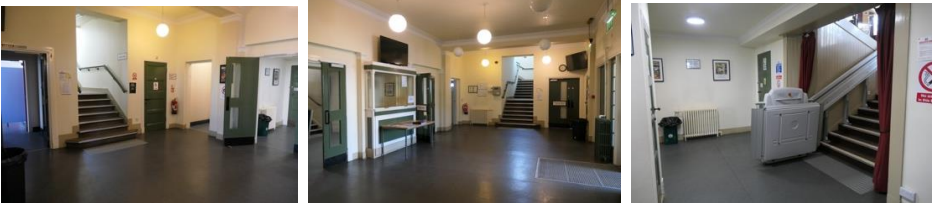
Entrance hall	Generally in good condition with a platform lift to access the main auditorium/hall	A

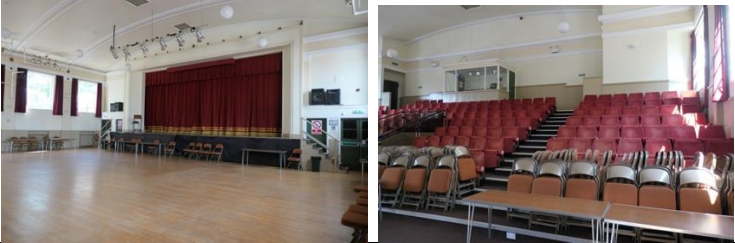
Auditorium/Main Hall	Generally in good condition	A

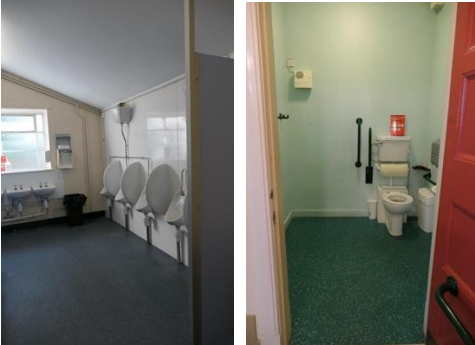
Toilets	Generally in good condition	B

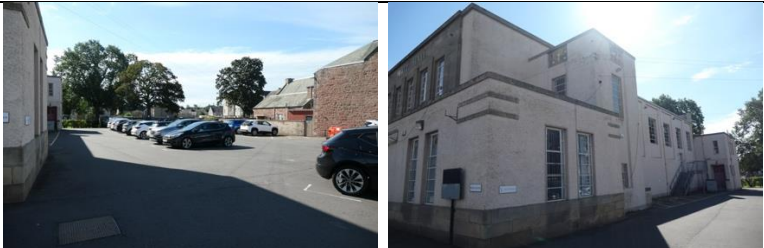
Parking	Within the grounds of the property	A

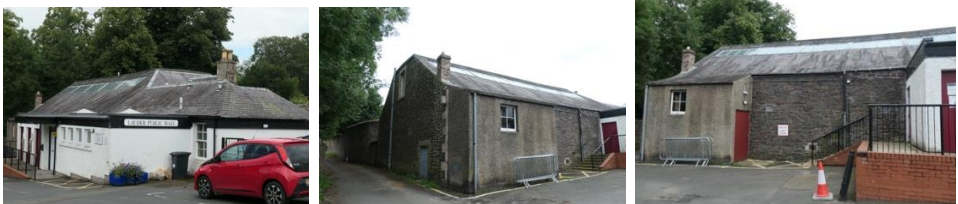
Facility Aspect	Current Condition	Operational Rating	Photographic Evidence
Exterior fabric	Generally in good for its age condition with ongoing maintenance required	B

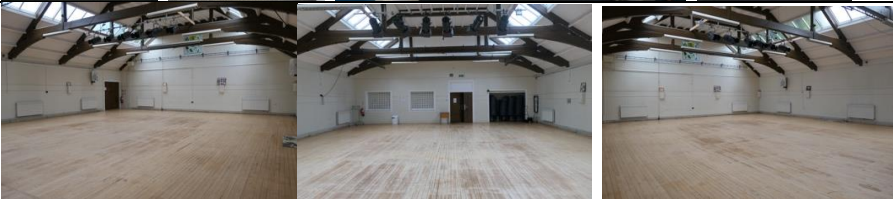
Main Hall	Generally in good condition with electric heaters. The floor needs sanded and sealed	B

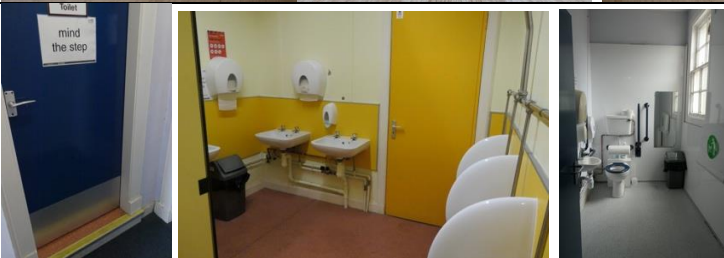
Toilets	Toilets in good condition but with one of them having a step up to access. Disabled toilet available	C

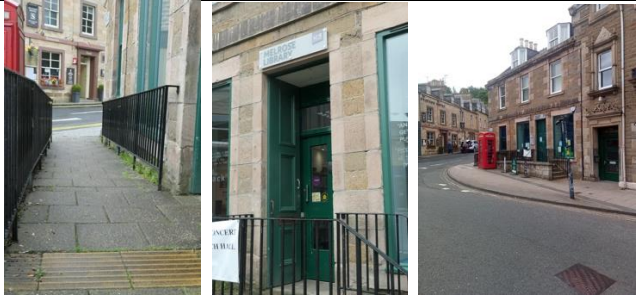
<b>Visual Audit 2 August 2023</b>		<b>Location:</b>	18 Market Square, Melrose	
<b>Melrose Library</b>		<b>Facility Age:</b>	Mid 19 <sup>th</sup> Century	
		<b>Ownership</b>	Scottish Borders Council	
		<b>Size:</b>	89m <sup>2</sup>	
		<b>Accessibility</b>		<b>Key Notes</b>
<b>Car Parking &amp; Public Transport</b>		There is disabled access via ramp.		The building is generally in a good condition for its age. Normal age-related deterioration, maintenance issues
On-street parking				
<b>AUDIT TABLE</b> <b>Ratings - A - Good condition / fit for purpose.</b> <b>B - Required moderate to significant investment</b> <b>C - question whether fit for purpose</b>				
Facility Aspect	Current Condition	Operational Rating	Photographic Evidence	
Exterior fabric	Generally in good for its age condition with ongoing maintenance require, particularly to the stonework. Front windows starting to mist and there has been a repair to rot around the window.	<b>B</b>

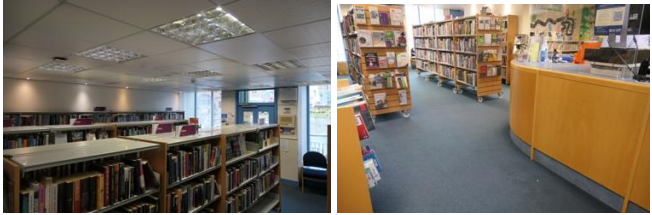
Main Library Area	In good condition for age	<b>B</b>

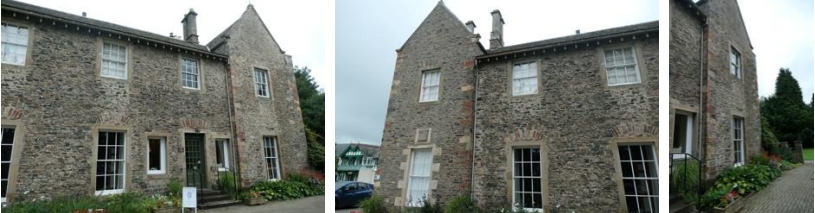
Facility Aspect	Current Condition	Operational Rating	Photographic Evidence
Exterior fabric	Generally in good condition with regular maintenance required around the whole external fabric.	<b>B</b>

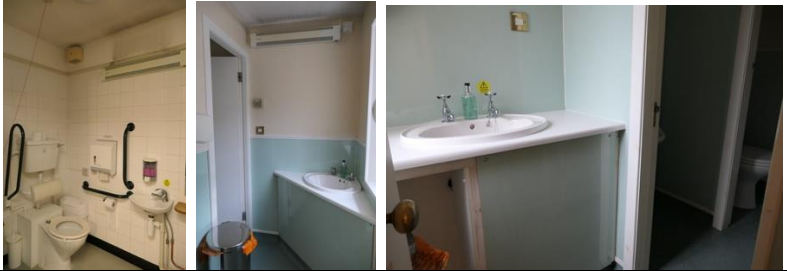
Toilets	Require upgrading to modern standards	C

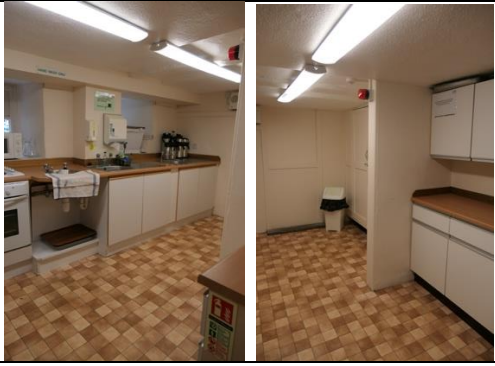
Kitchen	Requires upgrading	B

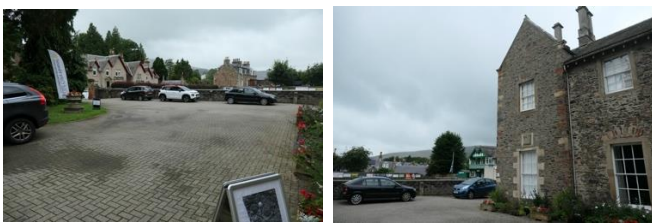
Parking	Within the grounds of the property. Evidence of root disruption to the surface/paviors of the parking area and concerns were expressed about the long-term impact on the property. Car parking can be difficult as it is used as an unauthorized car park by the adjacent bowling green members	A

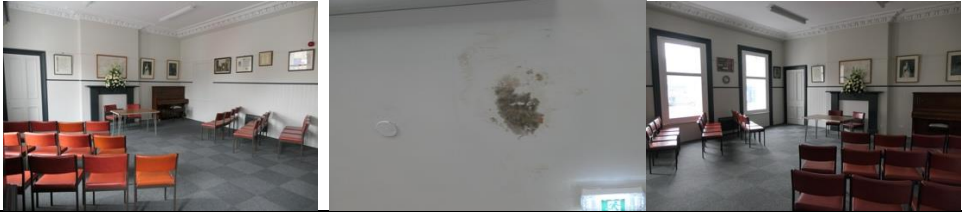
Upper Room/Marriage Room	Recently refurbished but with evidence of staining from dampness/water ingress	A

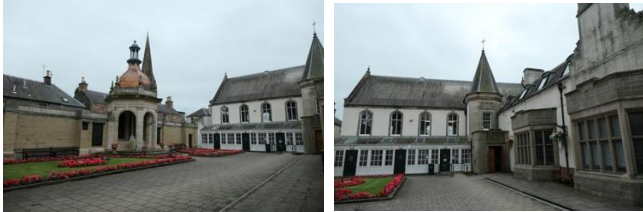
Facility Aspect	Current Condition	Operational Rating	Photographic Evidence
Exterior fabric	Generally in good for its age condition with ongoing maintenance required	B

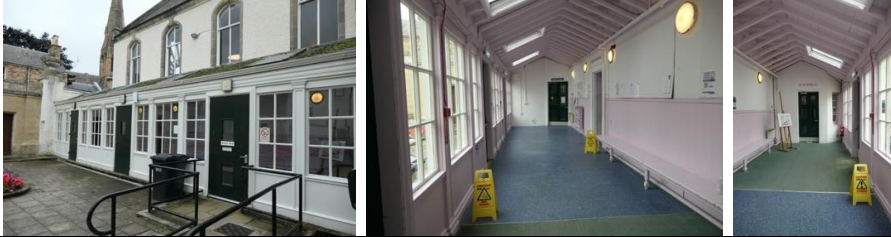
Hallway/Link corridor	Good condition	A

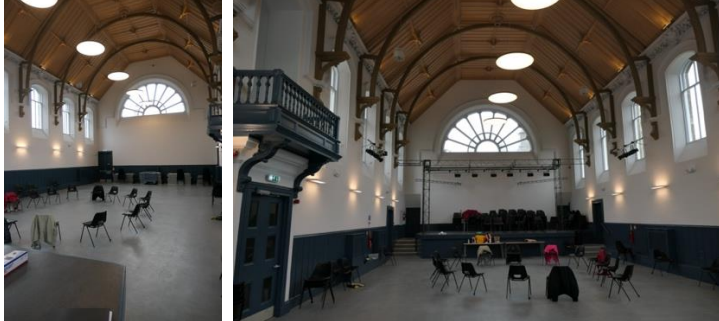
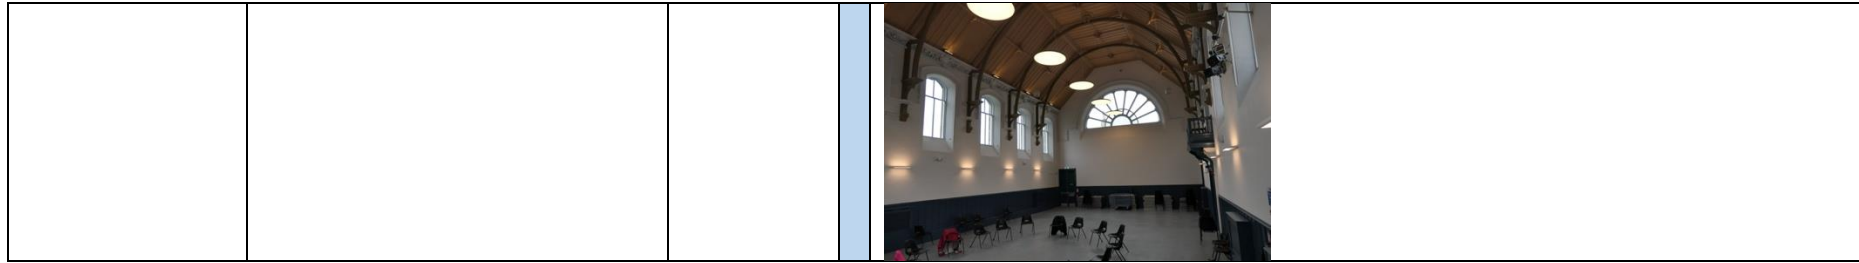
Main Hall	Recently refurbished	A

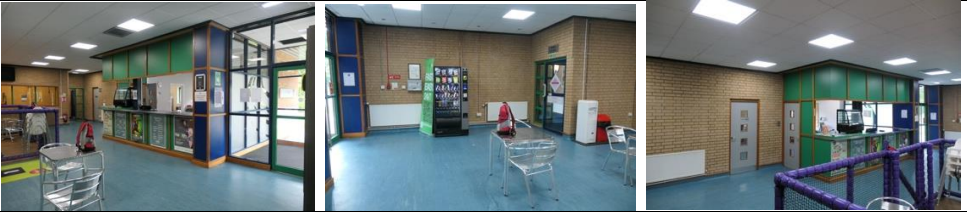
Reception	Good condition	A

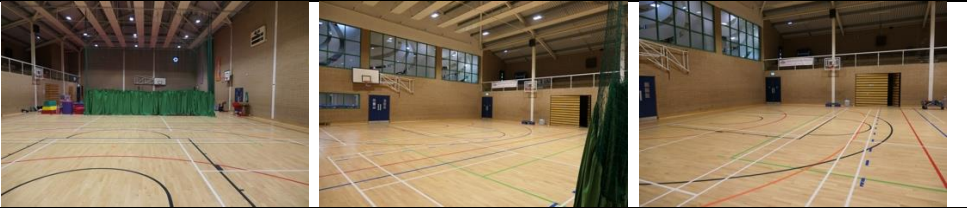
Main Hall	In good condition	A

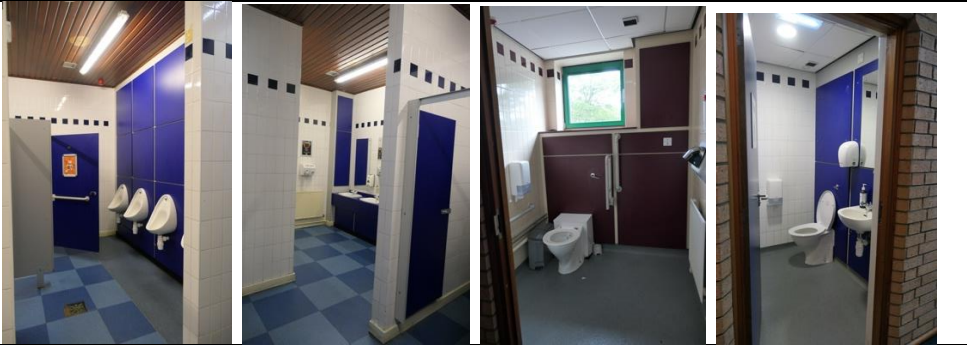
Toilets	Good condition	A

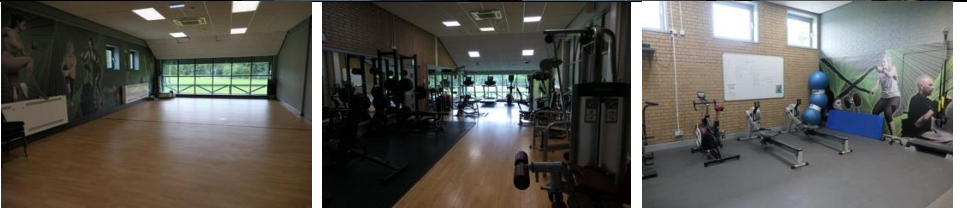
Fitness Suite	Good condition	A

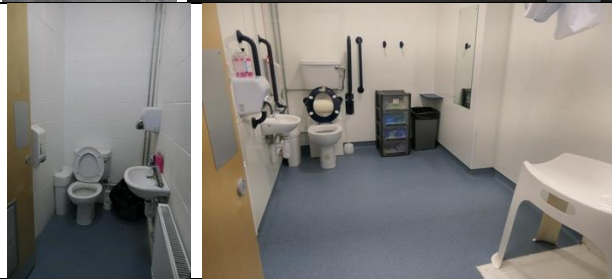
Toilets	Water pressure is low and do not flush as efficiently as they should.	A

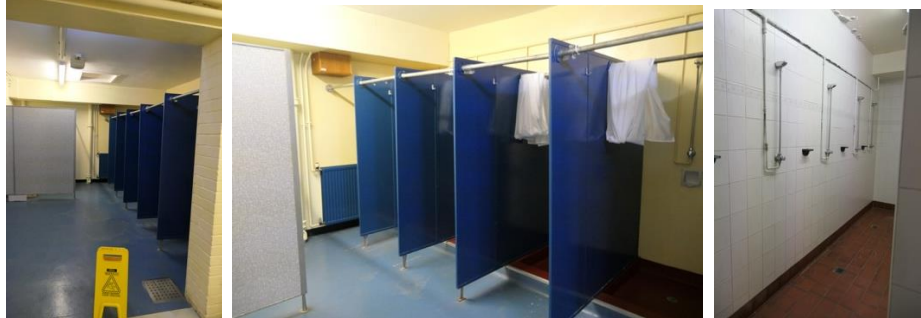
Shower/Changing Areas	Generally in good condition	B

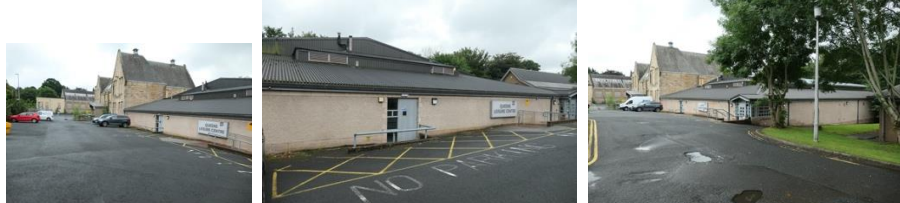
Parking	Within the grounds of the property	A

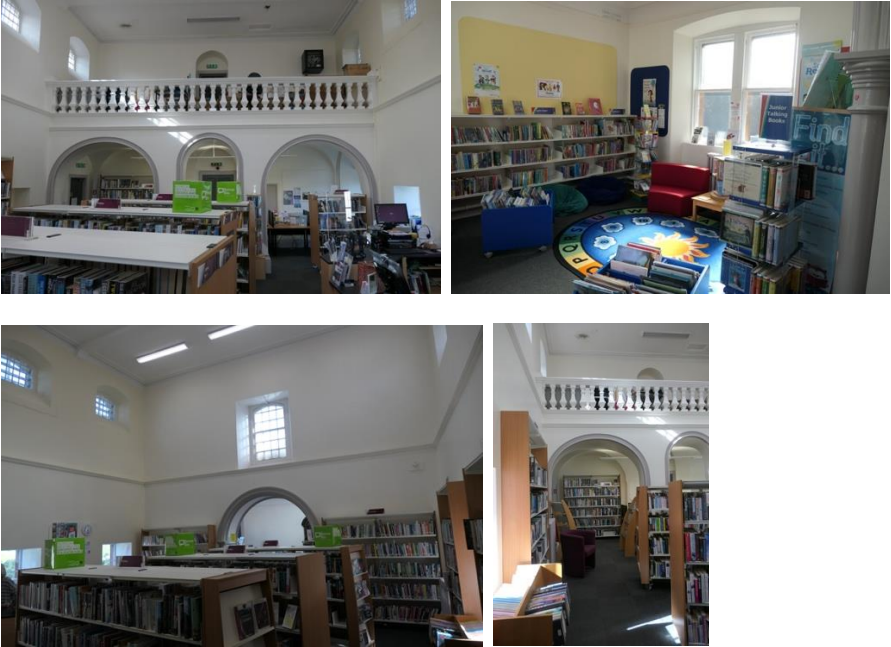
Library Hall	Generally in good condition	B

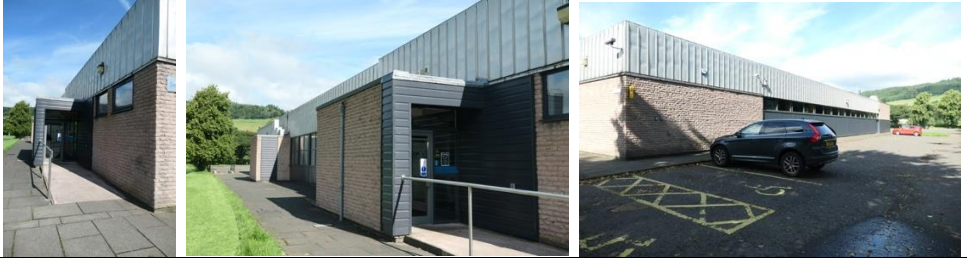
Facility Aspect	Current Condition	Operational Rating	Photographic Evidence
Exterior fabric	Generally in good for its age condition with ongoing maintenance require, particularly to the stonework and pointing. Extensive parking available	A

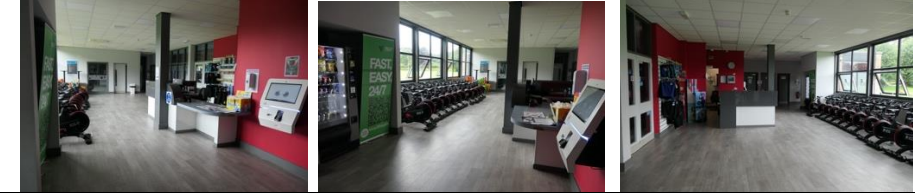
Reception	In good condition and appearing to be recently refurbished. In the summer the reception area is too warm, and, in the winter, there is significant condensations between the internal and external doors.	A

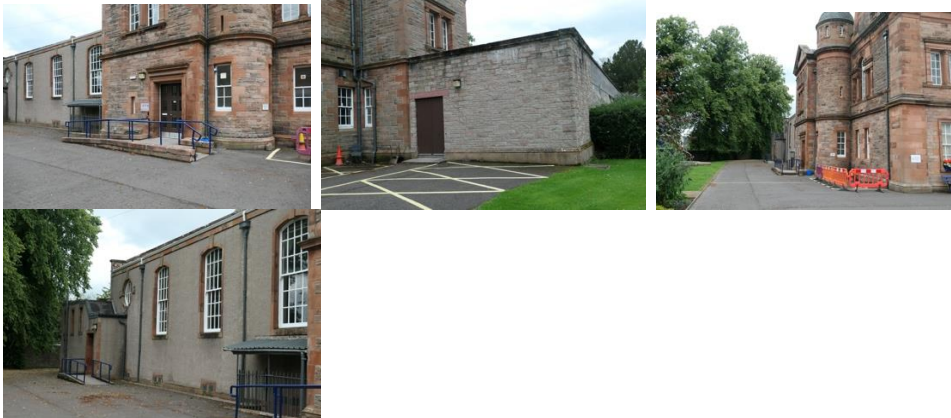
Facility Aspect	Current Condition	Operational Rating	Photographic Evidence
Exterior fabric	Generally in good for its age condition with ongoing maintenance required	B

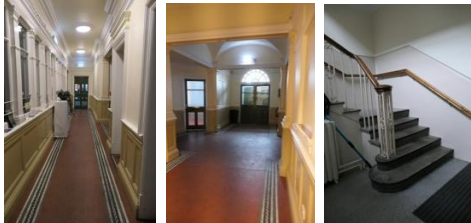
Reception Hallway	Good condition	A

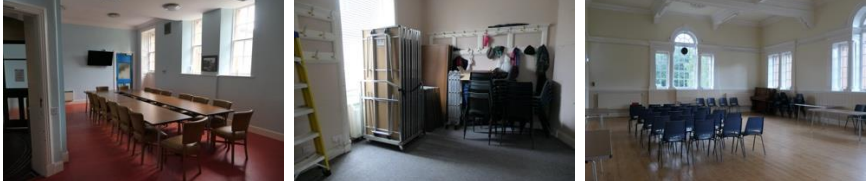
General Purpose Rooms	Good condition	A

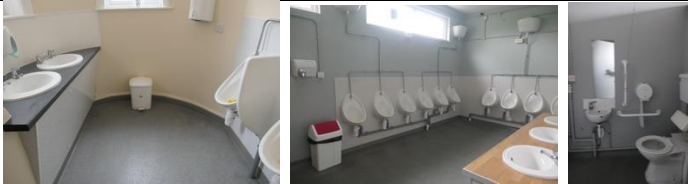
Toilets	Ladies toilets showing evidence of water ingress and dampness. And require upgrading	C

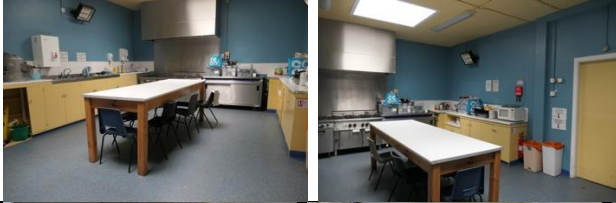
Kitchen	Requiring modernisation	B

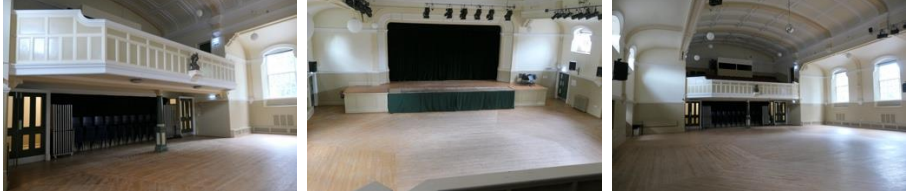
Auditorium	Good condition	A

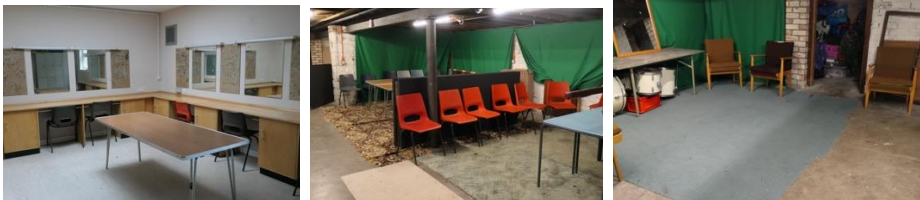
Changing Rooms	Require upgrading and some are under the stage	C

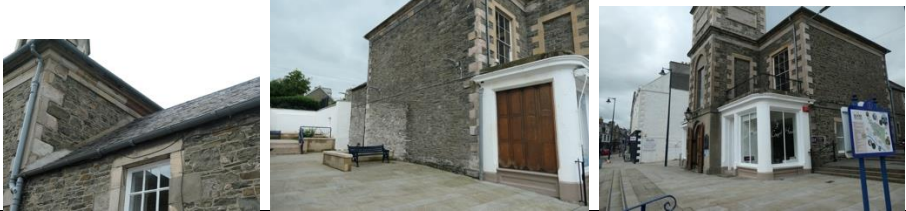
Facility Aspect	Current Condition	Operational Rating	Photographic Evidence
Exterior fabric	Generally in good for its age condition with ongoing maintenance required	<b>B</b>

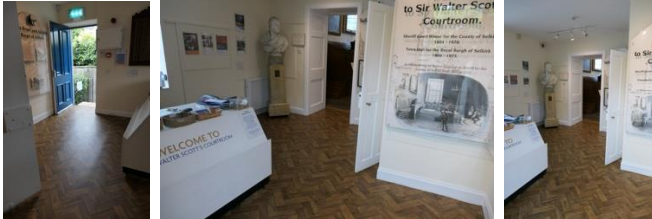
Reception	In good condition for age and use as a reception for the museum.	<b>B</b>

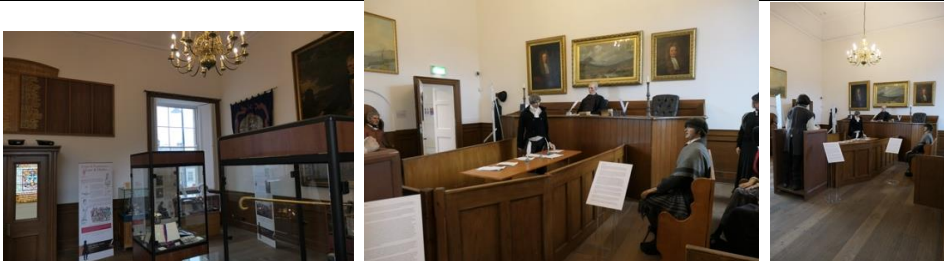
Gallery/ display areas	Good condition	<b>B</b>

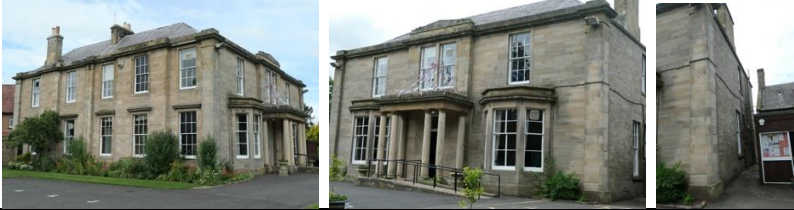
Facility Aspect	Current Condition	Operational Rating	Photographic Evidence
External fabric	The building is generally in good condition for its age	B
