# Annex Five

## Strategic Review of Sports, Leisure, Culture & Community: Building Audits

**Alan Jones Associates**

September 2023

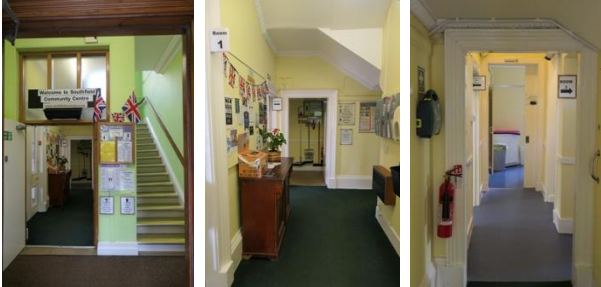
Reception area	The area is generally in good condition but has poor/no disabled access to various parts of the entrance hallway	C

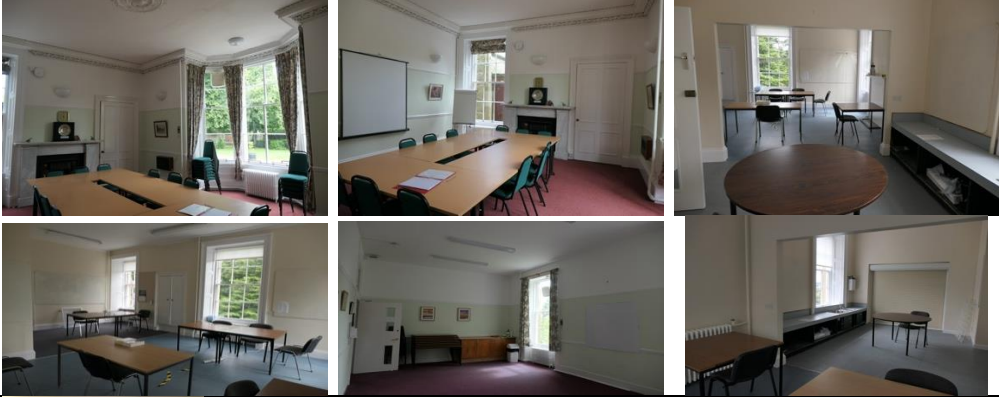
The main rooms	These are generally in good condition	C

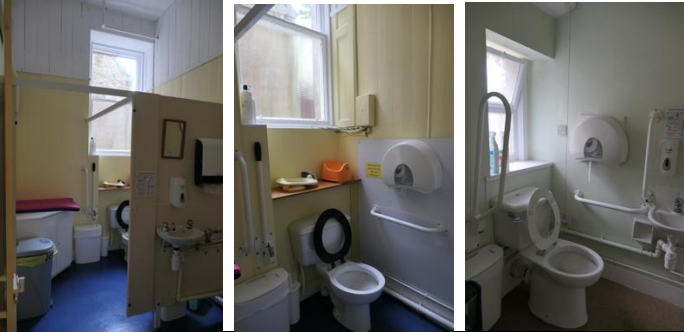
Toilets	These are generally in poor condition and require significant upgrading	C

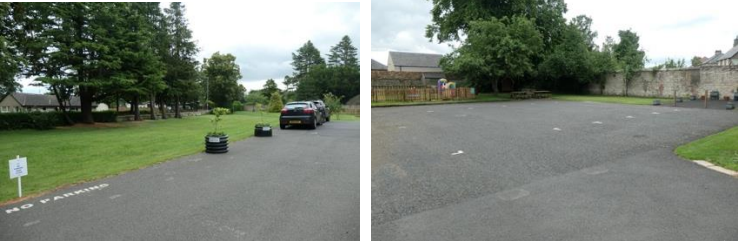
Parking	Parking was to the front but limited and extensive parking to the rear	A

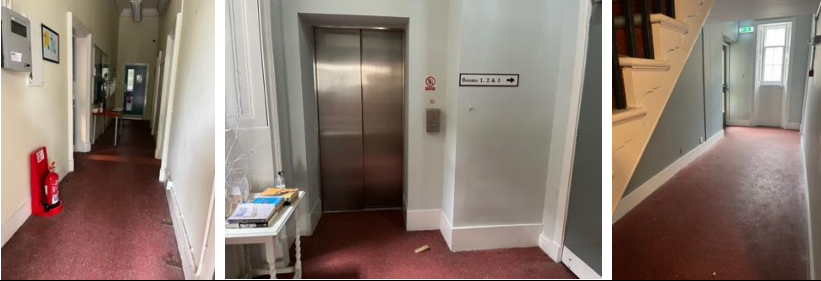
Entrance hall	Generally in good condition but with decoration required	B

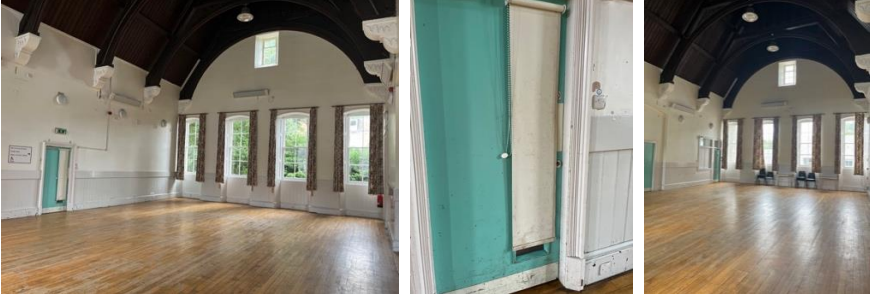
Auditorium/Main Hall	Generally, in good condition but redecoration required, and the floor sanded and resealed.	A

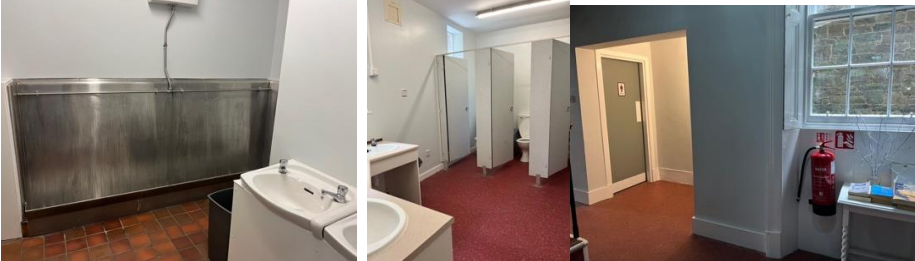
Toilets	Generally in good condition but with some modernisation required	B

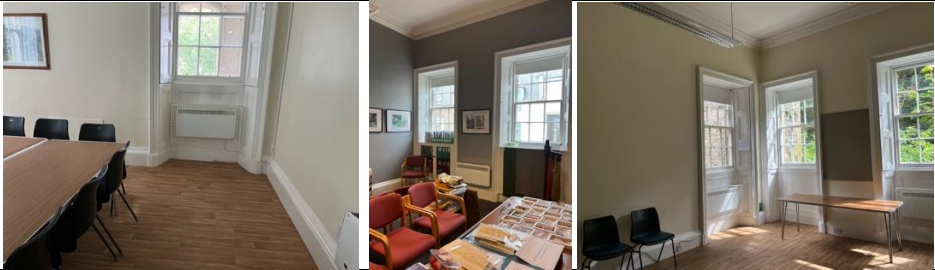
General purpose rooms	Generally in good condition	B

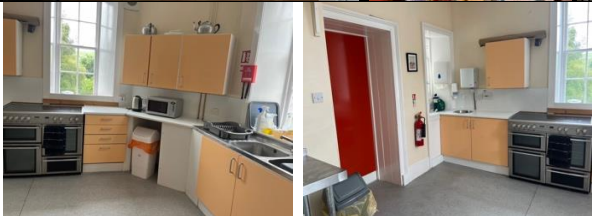
Kitchen	In good condition but unclear if it meets current catering standards	B

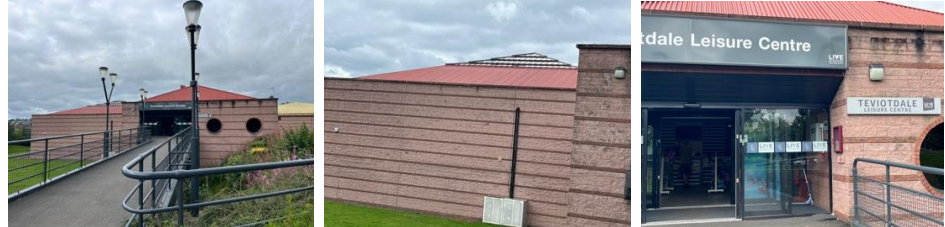
Facility Aspect	Current Condition	Operational Rating	Photographic Evidence
Exterior fabric	Good condition	A

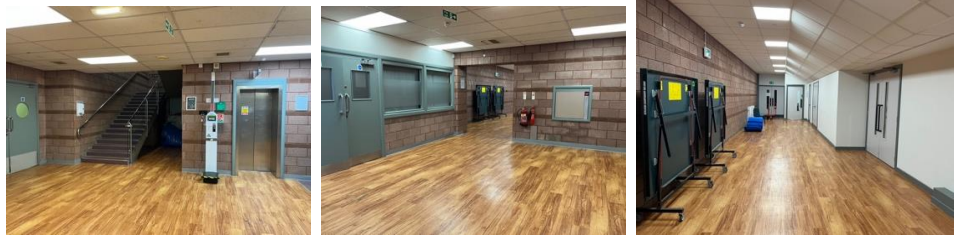
Corridors	Good condition	A

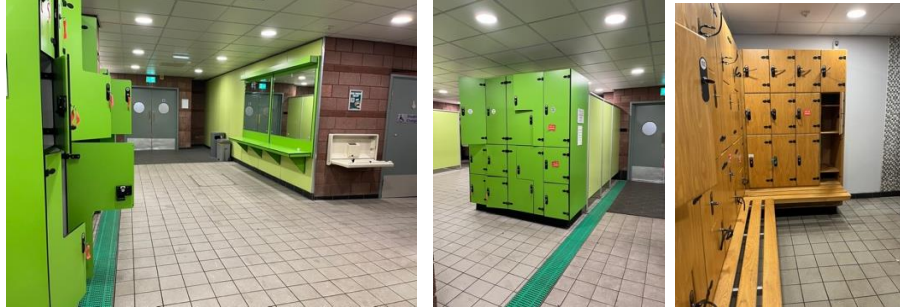
Changing Rooms	Good condition	A

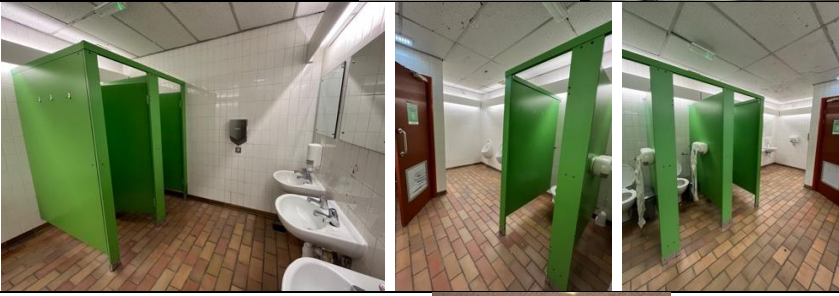
Toilets	Good condition	A

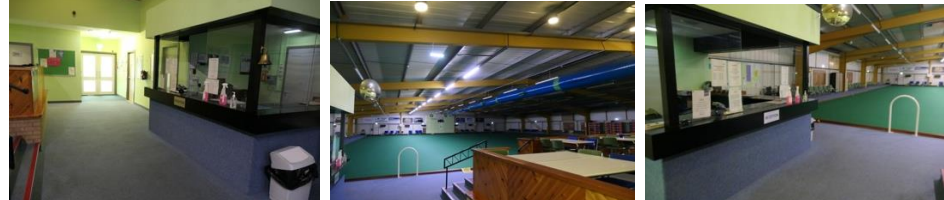
Reception	Generally in good condition	<b>A</b>

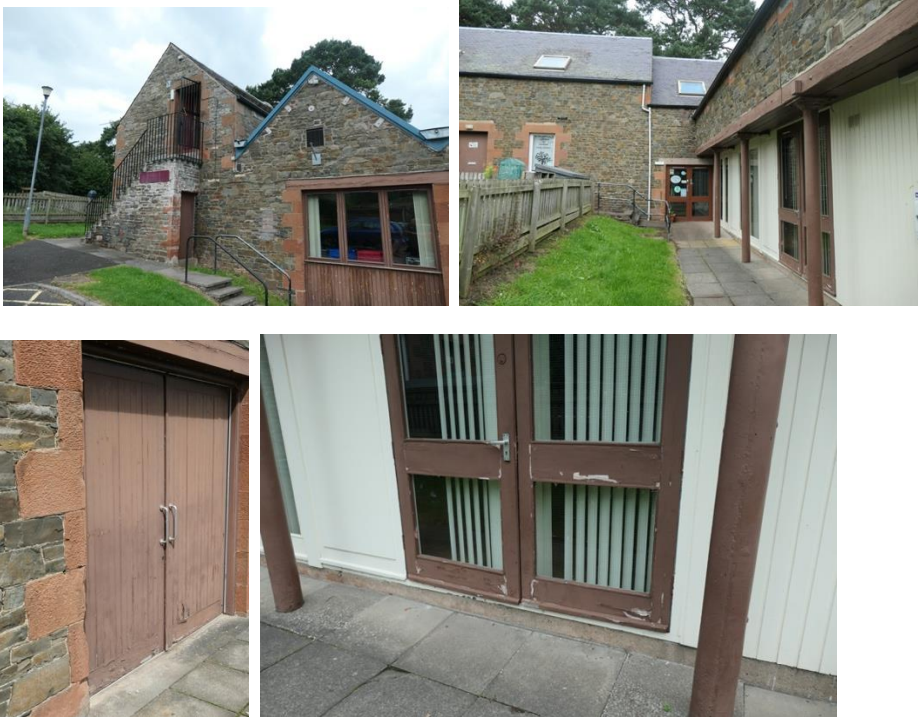
Facility Aspect	Current Condition	Operational Rating	Photographic Evidence
Exterior fabric	Evidence of the building requiring ongoing maintenance to the stonework, external stairs, and external paintwork	<b>B</b>

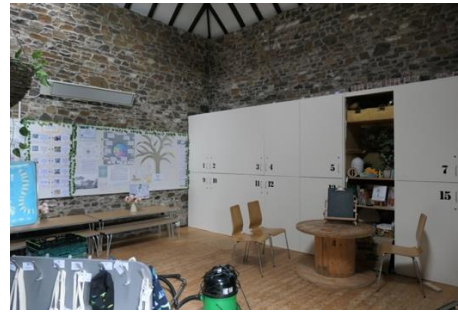
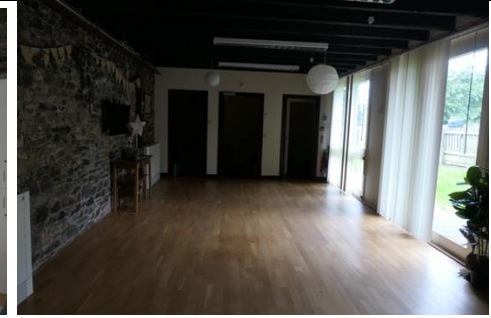
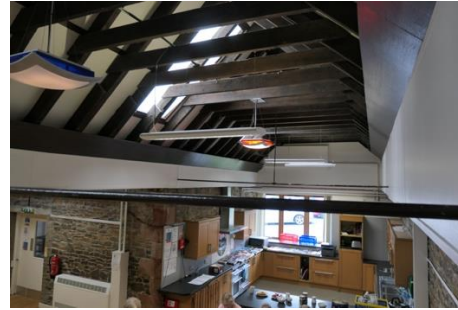
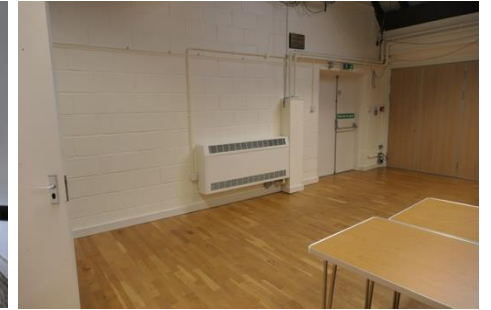
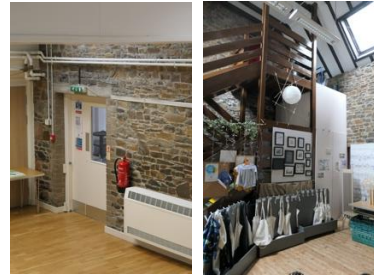
Rooms

Generally in good condition for the age of the building

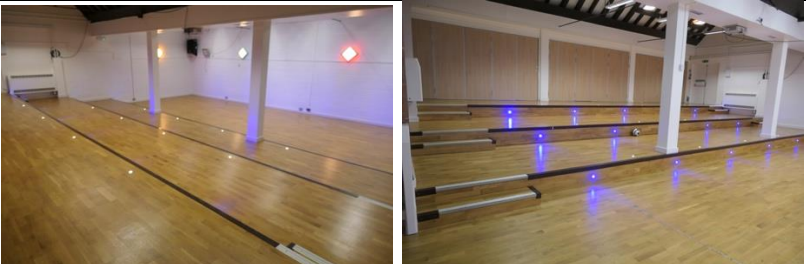
Auditorium	Good condition	A

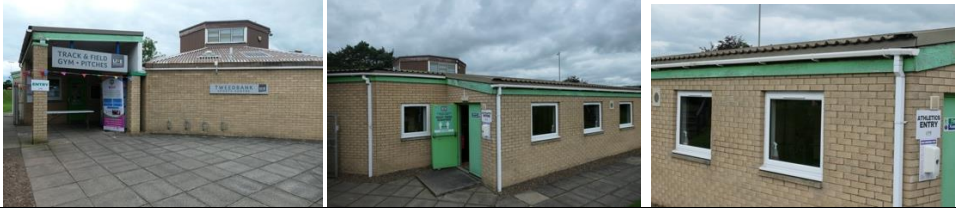
Reception/corridor	Requiring upgrading	<b>B</b>

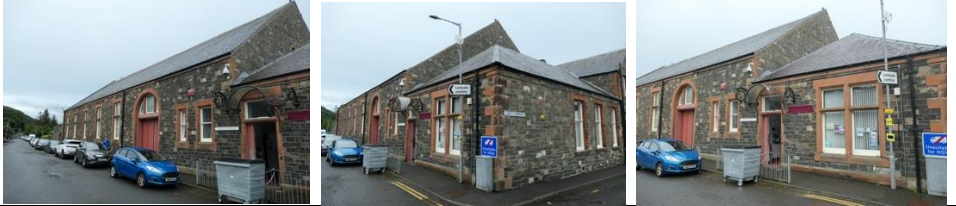
Reception	Good condition	A
